# HIGH-POTENTIAL FAILURE ANALYSIS

by Luis F. Sotto

A study to identify causes of hi-pot failures.

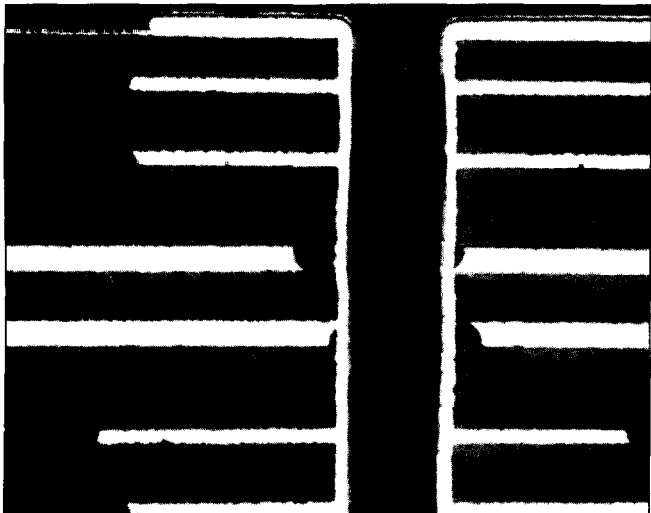
The front-to-back registration of different innerlayers helps prevent electrical shorts or opens between different networks as well as hi-pot failures. Drill misregistration has the same effect as innerlayer misregistration (also called innerlayer shift). In Figure 4, the innerlayers are not shorted but the clearance to the hole wall is such that arcing occurred.

Figure 4. Poor innerlayer clearance to the hole wall causes arcing.

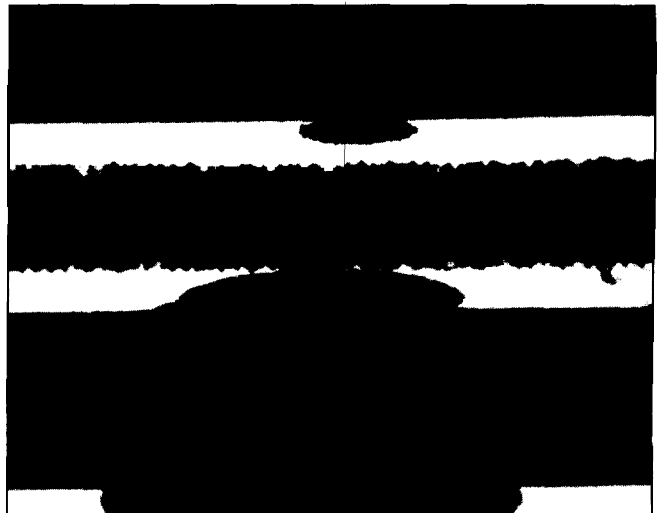
In the subtractive fabrication of innerlayers, a copper etching process defines the circuitry. If the foil copper is not completely etched between lines or planes, a microscopic trace of metal will remain. This condition will not necessarily cause a failure during electrical testing (ET), but arcing can occur during hi-pot testing if the metal trace is between the power and ground planes. Depending on the severity of the condition, AOI may or may not detect the defect.

Figure 5 shows incomplete etch. The area in the circuit was easily identified because the arcing caused abnormal delamination.

Figure 5. Incomplete etch.

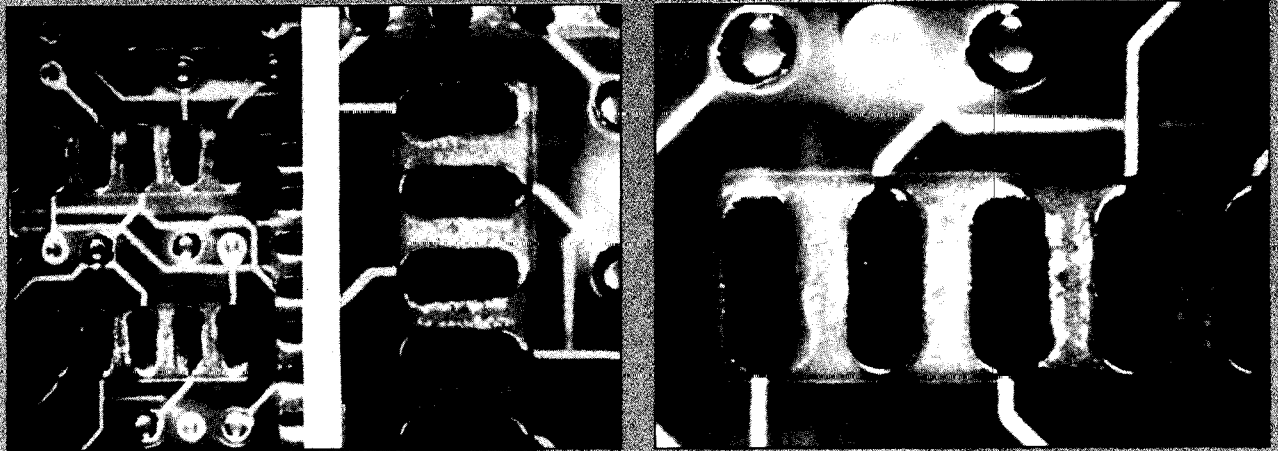
Most of the problems found during failure analysis for surface contamination were in products coming from HAL. Arcing occurred between surface-mount devices during hi-pot testing because a white residue left by the HAL process was conductive. The SMT footprint shown in Figure 6 is 25-mil pitch. The condition worsens with 12.5-mil-pitch surface-mount footprints. In fact, the latter represents a problem for hi-pot even with a clear space between pads; the clearance is such that arcing takes

After a series of additional tests, it was concluded that the stannous chloride was coming from the combination of the hydrochloric acid in the flux and the solder in the pot. Because of a poor flux rinsing after solder

coating, flux residues were trapping the stannous chloride. Once the circuit is dried, removing the flux using only water is very difficult. The chloride contamination can't be removed with high pressure water or pressurized air. strong organic solvent such as 1 1 1 -Trichlorethylene is needed.

This electrically conductive contaminate as not necessarily bridging the surface-mount pads but was substantially reducing the spacing. Consequently the circuits failed hi-pot because of arcing.

Figure 8. Contaminated surfaces with white residue after HAL.

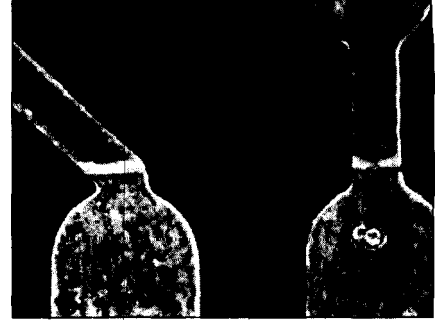
contaminated surface (Figure 8). Using a collimator aperture of one micron, the SEM's spectrum analysis showed the presence of tin and chlorides. Peaks of gold (Au) and palladium (Pd) are induced into the sample as part of the sample preparation, and a bromine peak matches the fire-retardant component in the dielectric.

Figure 8. SEM of crystals on contaminated surface.

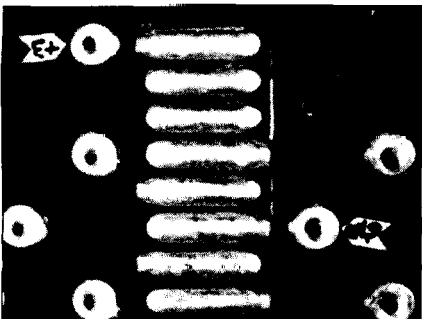
Figure 10 shows an incompletely etched circuit. No electrical connection exists between surface-mount pads but the clearance allows arcing to occur during hi-pot testing, making the circuits fail immediately. The underetch condition is difficult to see with magnification of seven times. Figure 11 shows surface-mount devices with 25-mil pitch. The dielectric surface between devices shows that a microscopic track of metal was left between surface-mount pads. It stops as it nears the center. This circuit was arcing between the two pads.

Figure 10. This circuit is incompletely etched.
