Advice & Counsel

Taking A Powder

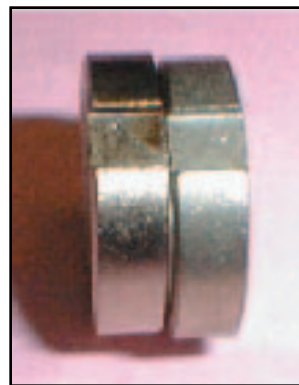
This part has been electroless nickel plated and

has a stain on the right side of the notched area (after one-hr boil in deionized water). Part on right is unplated sample submitted along with the plated sample.

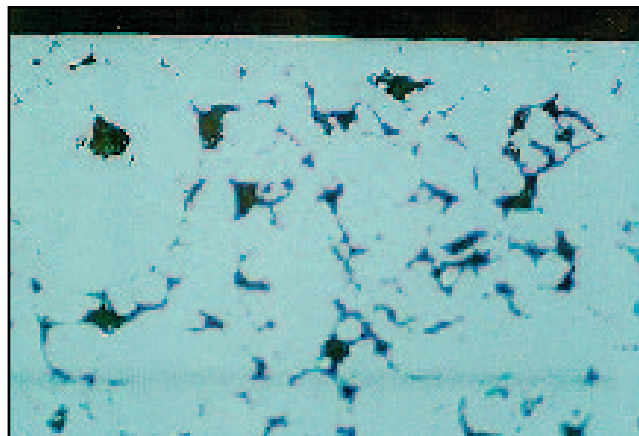
This is a cross section (400X) of a notch in the area where staining was observed on the plated parts. Note the deep, large surface pores present, and the absence of any resin filling the pores, indicating poor impregnation of this area.

large surface pores in the area where staining was found after plating. These large surface pores did not contain any resin from an impregnation operation.

Powder metallurgy must be adequately impregnated, in order to fill the voids that are normally present after the sintering process. The unplated sample we cross sectioned, along with the plated sample, showed

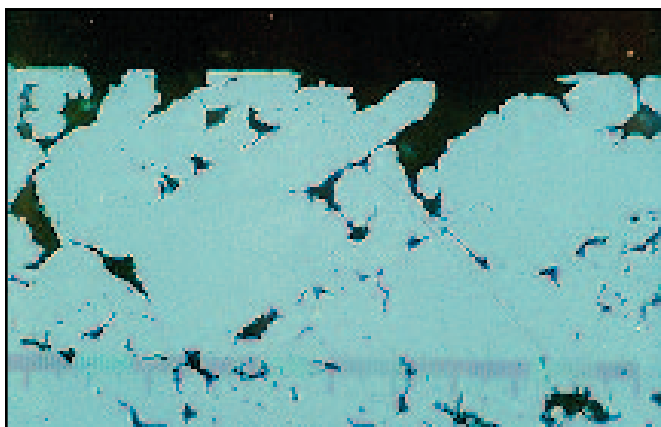
The stain is formed as a result of corrosion that occurs at sites where the powder metallurgy has not been adequately sintered, and evidences a severe amount of porosity, in comparison to areas that do not evidence the staining. The electroless nickel plates down—deep into the surface cavity—but as thickness builds and the plating on the sides of the cavity meet, a microscopic pore or tunnel is formed, which produces a “fissure” that travels down to the base metal (see photos).

The stain cannot be eliminated by additional plating thickness, because, as the cross section illustrates, the fissure is formed by the EN deposit

This is a cross section of a plated part in the area evidencing the stain (400X). Note the nickel plates deep into the surface cavity and, because all sides of the nickel meet in the center, a microscopic "tunnel" is formed by the intersection. This tunnel leads to corrosion test failures, and cannot be eliminated by more plating. The absence of impregnation resin is evidenced by the nickel depositing deep into the surface pores.
