# **EVALUATION OF COATINGS APPLIED ON LESS THAN IDEAL SURFACES**

**AUGUST 1995**

**PREPARED BY  
ASSOCIATED COATINGS CONSULTANTS, INC.  
AND  
JOHN W. PEART AND ASSOCIATES  
IN COOPERATION WITH  
PETERSON BUILDERS, INC.  
STURGEON BAY, WISCONSIN 84238-0650**

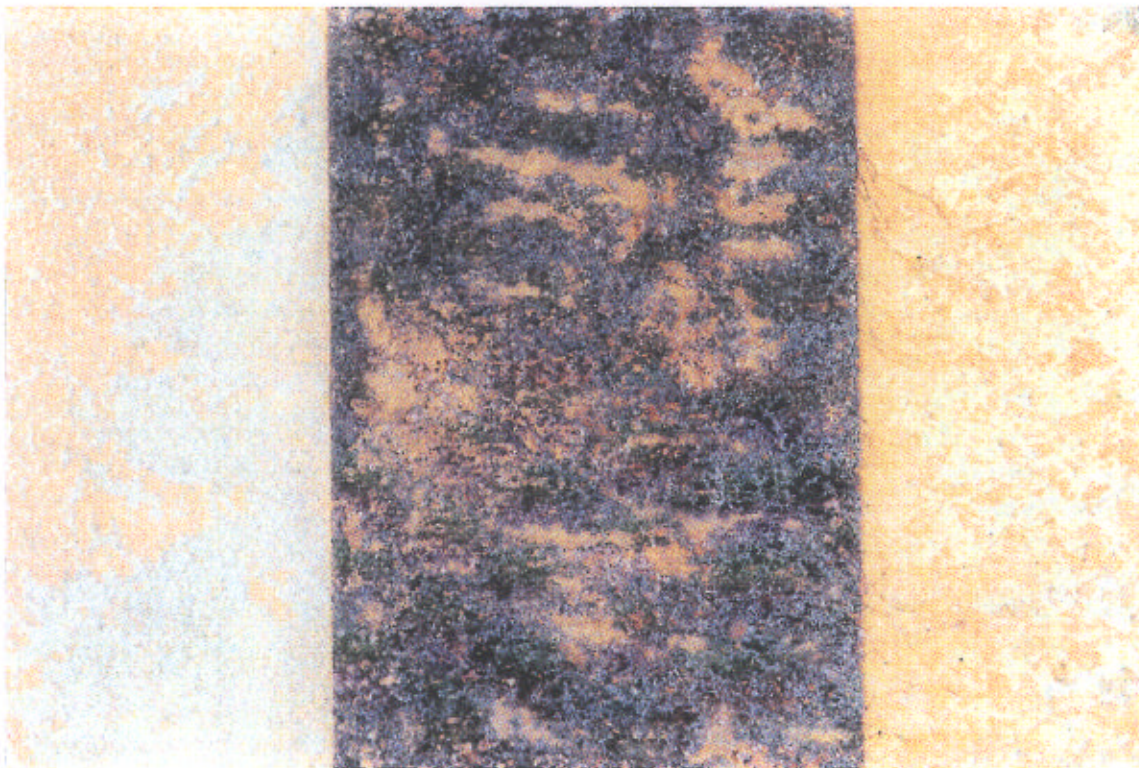
**FIGURE 1: CONDITIONED STEEL PANELS BEFORE SURFACE PREPARATION**

No attempt was made to remove soluble salt contamination with water from the bare repair area prior to or after surface preparation. The conditioned panels had a heavy rust deposit with a high concentration of salt. (Figure 1).

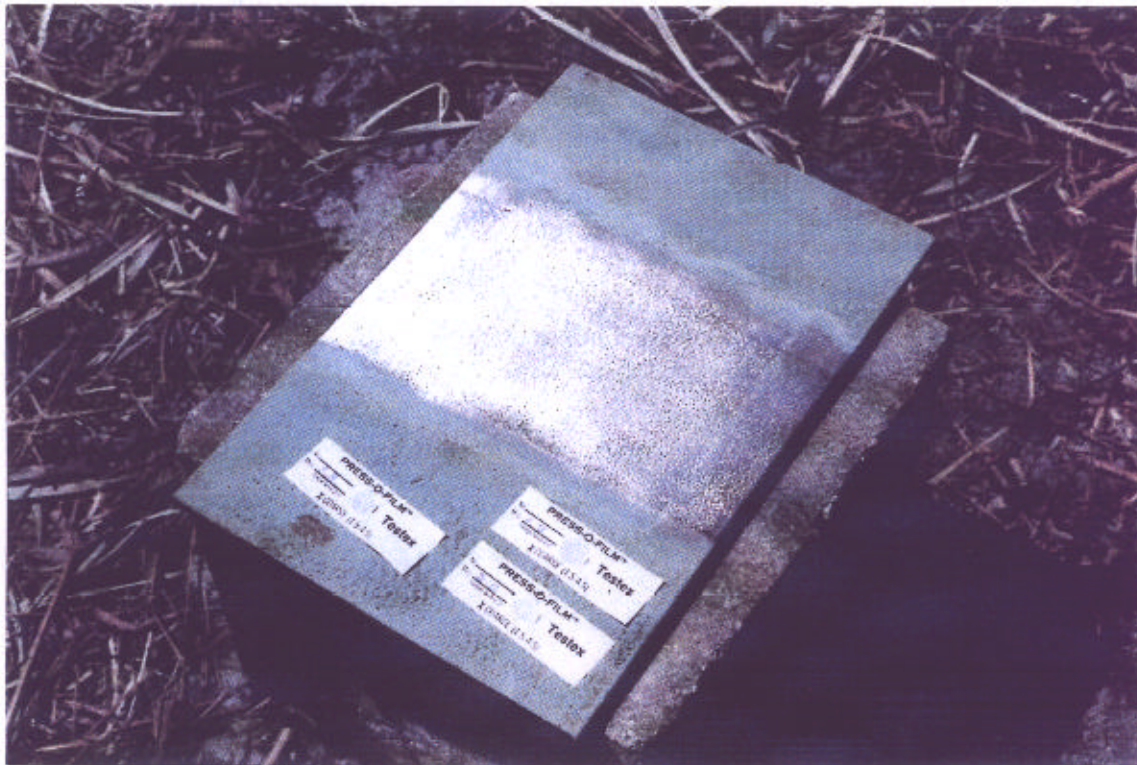
**FIGURE 2: POWER TOOLED CLEANED PANEL PROFILE MEASUREMENT**

The surface preparation procedure began with hand wire brushing the entire panel to remove the heavy rust stain from the initially applied control coating. Secondly, the bare corroded center section of each panel was prepared using one of the selected surface preparation methods, SSPC-SP 2 or SSPC-SP 11. A hand steel wire brush was used for SSPC-SP 2, and a coarse composition 3M wheel was used for SSPC-SP 11. The profile for the power tooled cleaned panels was not reestablished since these panels were originally abrasive blasted and had a residual profile. The measured residual profile after cleaning was 0.9 to 1.2 mils.

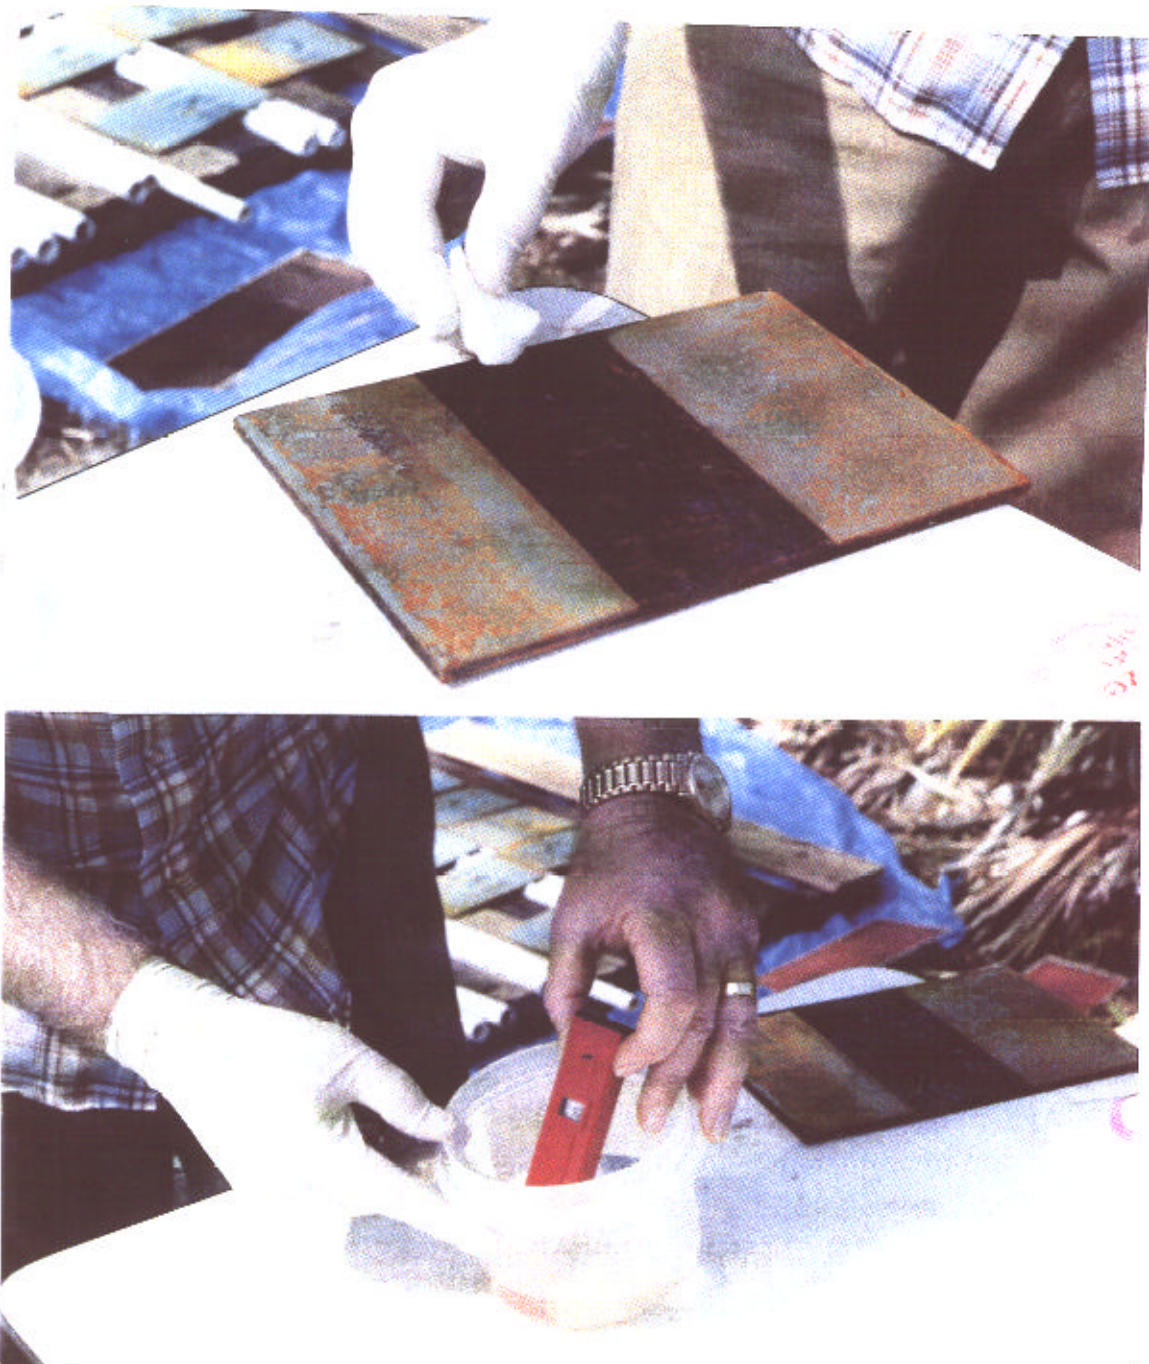
**FIGURE 5: PERFORMING SOLUBLE SALT TEST**

As can be seen from the tabulated results there is more remaining salt on the power tool cleaned SSPC-SP 11 panels than the hand tool cleaned SSPC-SP 2 panels. The swab test technique used which is described in detail in FHWA Publication FHWA-RD-91-001<sup>(7)</sup>.
