Corrosion of Electrolytically Gilded Silver: A Case Study

E. Cano, J. Simancas & J.M. Bastidas

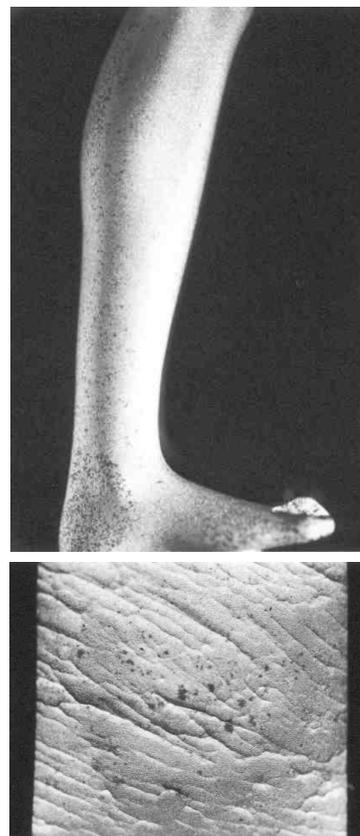
Figure 1 shows a leg of a gilded silver figure (~20 cm high) and a gilded silver sheet (1 x 1 cm) upon which some corrosion spots of red color were observed after eight months of storage in an unpolluted environment. Figure 2 shows a similar sheet (1 x 1 cm) without corrosion. Experimental specimens tested were of 1 cm² surface area.

Optical microscopy experiments of the specimens shown in Figs. 1 and 2 yielded the following thickness of the layers obtained in plating treatments (1) to (5): an inner layer of ~0.6 - 0.8 μm of gray color, an intermediate layer of ~3 μm of yellow color, and an outer layer of ~3 μm with a blackish color.

Fig. 1—Gilded silver with corrosion spots.

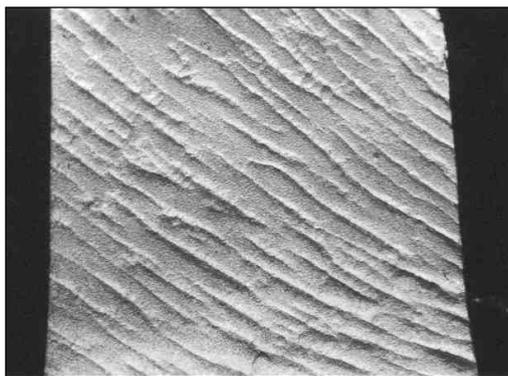
Fig. 2—Gilded silver without corrosion.

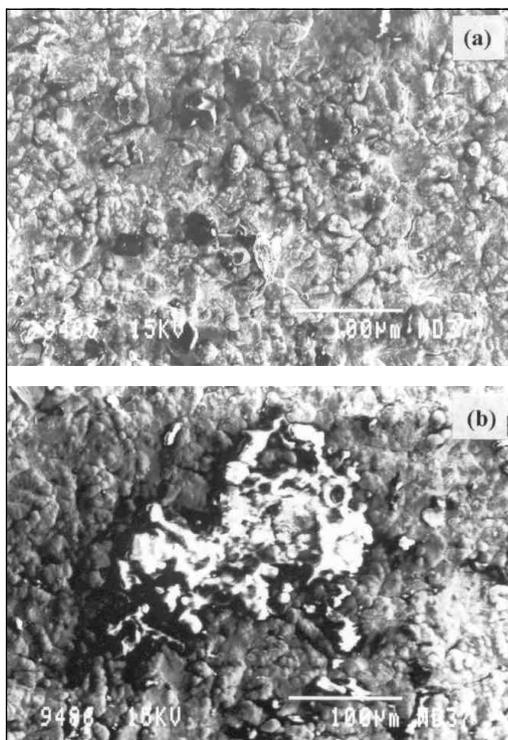
Figure 3a shows a SEM micrograph for a corroded specimen. The surface of the sample is very irregular and porous. Some darker zones can be observed, corresponding to the red spots. Figure 3b shows a magnification of one of these spots. Some bulky corrosion products can be seen over the gold layer.

Fig. 3—SEM results for a corroded specimen.

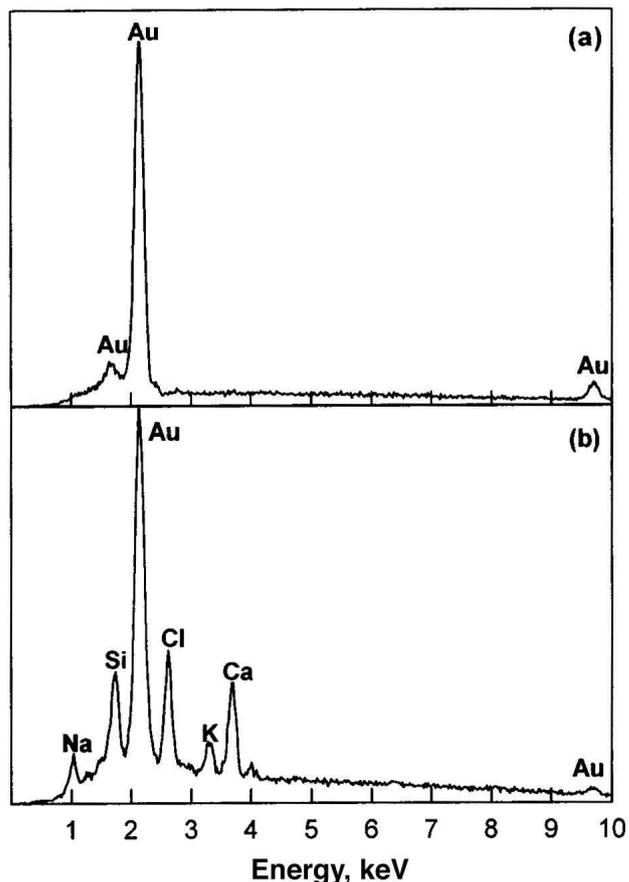
Figure 4a shows an EDX spectrum for the gold layer outside the dark spots; only the signal for gold can be seen. In contrast, the EDX spectrum in Fig. 4b, corresponding to the corrosion products, shows Au, Ca, K, Cl, Si and Na signals. The presence of Cl suggests that the cause of corrosion spots may be attributed to some chlorine compound. The source of Ca, K, Si and Na signals may be attributed to the different chemical compounds utilized in the electroplating processes.

EDX spectra (Fig. 4) do not show signals from the silver substrate or the palladium preplate, indicating that the gold layer entirely covers the surface of the specimen and that its thickness is greater than the depth of EDX analysis (~1 µm). EDX data on corroded specimens and the AES spectra (not included) agree with the results shown in Fig. 4.

Fig. 4—EDX results for the corroded specimen of Fig. 3.

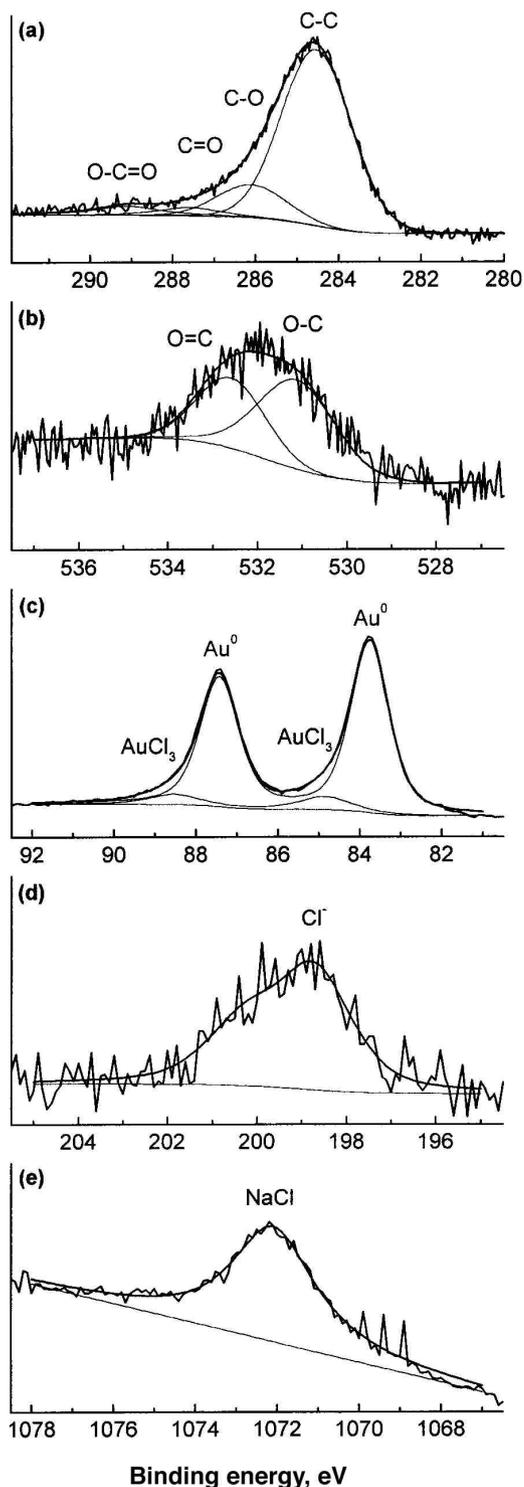
Figure 5 shows high-resolution XPS spectra for C, O, Au, Cl and Na of a corroded specimen. The carbon spectrum (Fig. 5a) shows four components at 284.6, 286.1, 287.6 and 288.6 eV, which can be attributed to C-C, C-O, C=O and O-C=O bonds, respectively, of the passivating organic layer. The two components of the oxygen spectrum (Fig. 5b) at 531.5 and 532.8 eV can also be attributed to the O-C and O=C bonds, respectively, of the same organic layer. Gold peaks (Fig. 5c) show a component at 83.8 and 87.5 eV, corresponding to the

metallic gold, and a second small component at 84.4 and 88.1 eV, that may be attributable to a gold chloride compound. Because of the very low analysis depth of the XPS technique (10-30 Å), the presence of the gold signal may indicate that the passivating organic layer is not covering the entire surface of the gold. The chlorine spectrum (Fig. 5d) shows a peak at 198.5 eV that can be attributed to a chloride compound. Finally, the sodium spectrum (Fig. 5e) shows a peak at 1072 eV, corresponding to sodium chloride. Using the atomic sensitivity factors and subtracting the NaCl contribution from the Cl peak, the Cl/Au atomic ratio is approximately 3, which corresponds to gold(III) chloride (AuCl_3).³

Fig. 5—XPS high-resolution spectra for a corroded specimen.
