Some Production Plating Problems & How They Were Solved—Part 3

By Dr. Samuel Heiman

Updated by Dr. James H. Lindsay, AESF Fellow

2. Chromium Plating of Hex Head Bolts

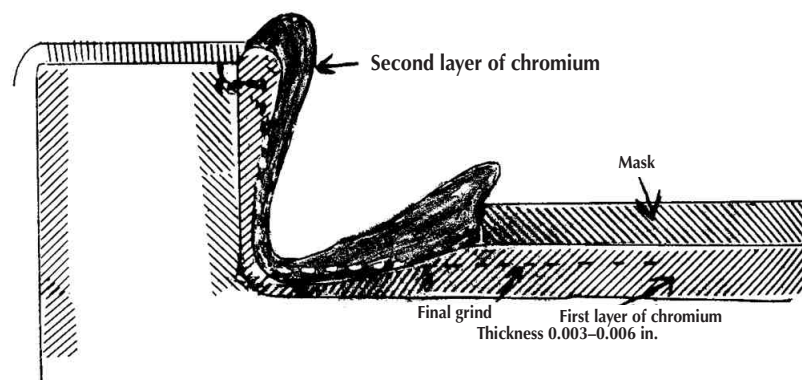
Fig. 1—The problem was to deposit enough chromium in the fillet radius for grinding.

The problem was to plate a minimum of 0.25 mm (10 mil) of chromium on the shank, underhead, and fillet radius of a 0.95 cm (0.375 in.) diameter by 7.00 cm (2.75 in.) long bolt. See Fig. 1. After plating, the chromium was ground to a final thickness of 76 to 152 microns (3 to 6 mil).

There was no problem getting the required chromium on the shank and underhead. The problem was getting it into the fillet radius. What was happening was that the shank and the underhead circumference were acting as thieves and diverting the current away from the fillet radius. Neither variations in the operating conditions nor the use of conforming anodes helped alleviate the condition.

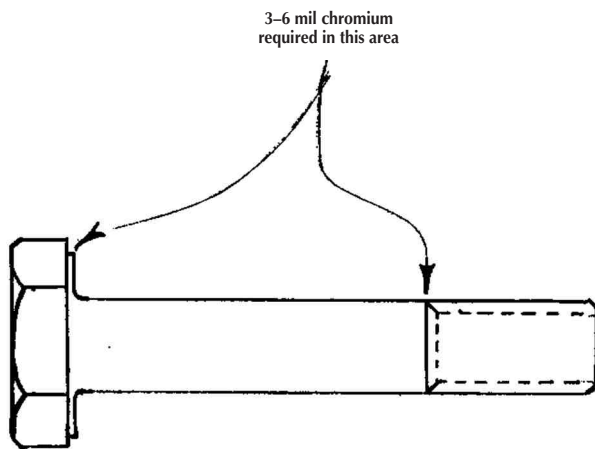
Fig. 2—An additional 24 hours of plating deposited enough chromium in the fillet radius for grinding.

The problem was solved by plating the shank, fillet and underhead until the shank had the required 0.25 mm (10 mil) of chromium. The shank was then masked off to within 6.35 mm (0.25 in.) of the head. The parts were then activated and plated for an additional 24 hours to get sufficient chromium into the fillet radius for grinding. See Fig. 2. Both the dimensional tolerances of the bolt and the required 76 to 152 microns (3 to 6 mil) of chromium were achieved after grinding.
