# Some Production Plating Problems & How They Were Solved—Part 7

Contributed & edited by Dr. Samuel Heiman  
Updated by Dr. James H. Lindsay, AESF Fellow

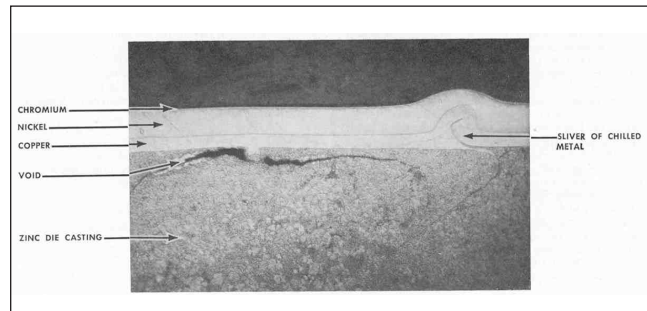
*Sliver of chilled metal protruding from the surface of a zinc die casting.*

Roughness is usually caused by solid particles in the plating solutions. An inspection was made of all of the filtration equipment, the clarity of the solution and possible sources of solid particles, such as broken anode bags and sediment on the bottom of the tanks. An inspection was also made of the work coming out of the various plating tanks to track down the source of the roughness. At the same time, as a matter of routine, a photomicrograph was made of the rough deposit.

This figure clearly pinpointed the source of the trouble. There were slivers of zinc metal protruding from the surface of the zinc die casting. This was caused by chilled metal forming on the walls of the die cavity, which was too cold during the casting cycle. Furthermore, voids under the surface of the zinc, which are also seen in the photomicrograph, were also caused by chilled metal. Once this was conclusively demonstrated by the photomicrograph, the die casting machine was adjusted to operate properly and smooth plating was once more obtained.
