Analysis of Component Failures Related to Surface Finish and Plating Problems

**Suess, S.J.
Stork Technimet, Inc.
New Berlin, WI U.S.A.**

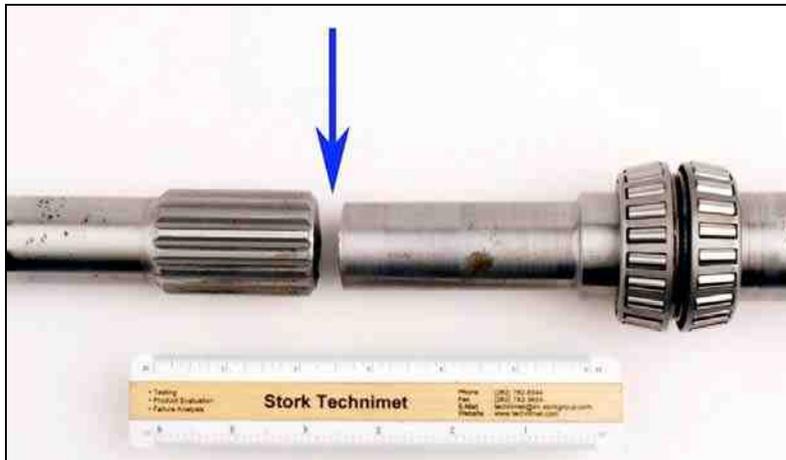
The shaft is shown as-received in Figure 1, where the transverse fracture occurred adjacent to the spline teeth, as indicated by the arrow. The fracture is shown along with the adjacent part surface in Figure 2. The fracture exhibits ratchet marks adjacent to the machined surface, and locations containing similar features were noted around the entire circumference of the section. These features are indicative of multiple crack origins around the circumference. Beach marks are evident outside of the origin area, and these features are indicative of progressive cracking. The adjacent part surface exhibits parallel machining grooves along with a few localized gouges.

Fig. 1 – The steel shaft exhibits a transverse fracture through the area adjacent to the spline teeth.

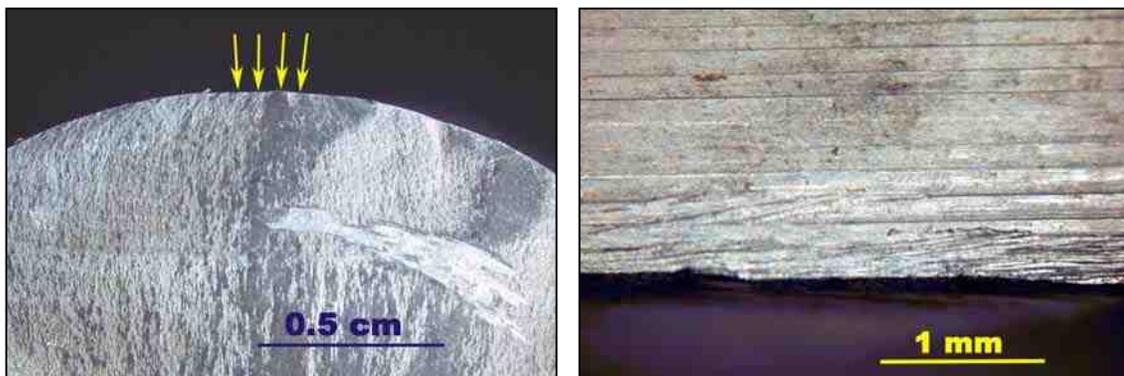
Fig. 2 – The fracture through the shaft (left) exhibits ratchet marks adjacent to the machined surface, and the general features are indicative of progressive cracking. A typical origin area is indicated by the arrows. The adjacent part surface (right) exhibits parallel machining grooves with some localized gouges.

This study showed that the fracture initiated at multiple locations adjacent to the spline teeth, and propagated under cyclic loading due to rotating bending fatigue. The machining process left the component with a rough surface texture containing localized gouges, thereby reducing the fatigue resistance to a great degree. Furthermore, the material was in the fully annealed condition, resulting in very low mechanical properties. In general, the failure was due to a combination of poor mechanical properties, rough surface finish and sufficiently high cyclic stresses to cause fatigue cracking in the component.

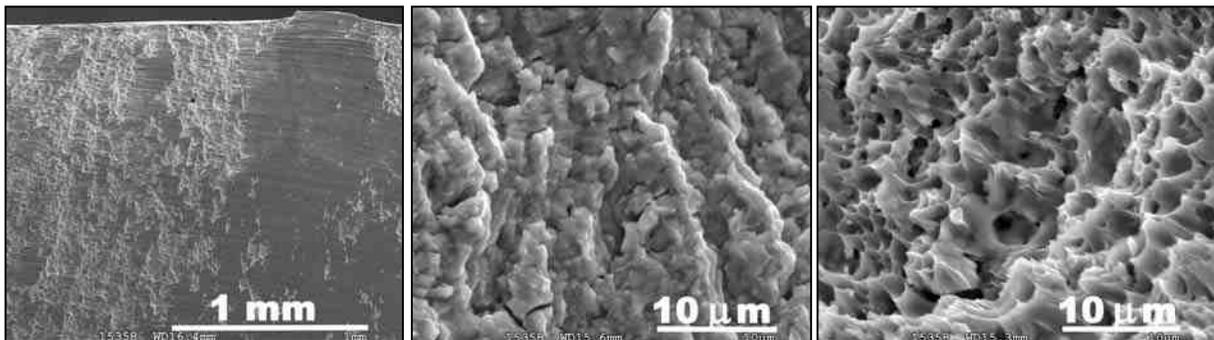
Further examination of the fracture surface was conducted via SEM. The fracture origin area is shown in Figure 3 along with typical regions at the mid-radius and center of the section. The features at the origin and mid-radius areas are indicative of fatigue and post-fracture mechanical damage. The center of the section exhibits dimples, which are indicative of ductile rupture at this area. This shows that final rupture occurred at the center of the section.

Fig. 3 – SEM evaluation of the fracture origin area (left) revealed features that are generally consistent with fatigue along with post-fracture mechanical damage. A typical area at the mid-radius position of the section (center) exhibits fatigue striations. The center of the section (right) exhibits a dimple morphology.

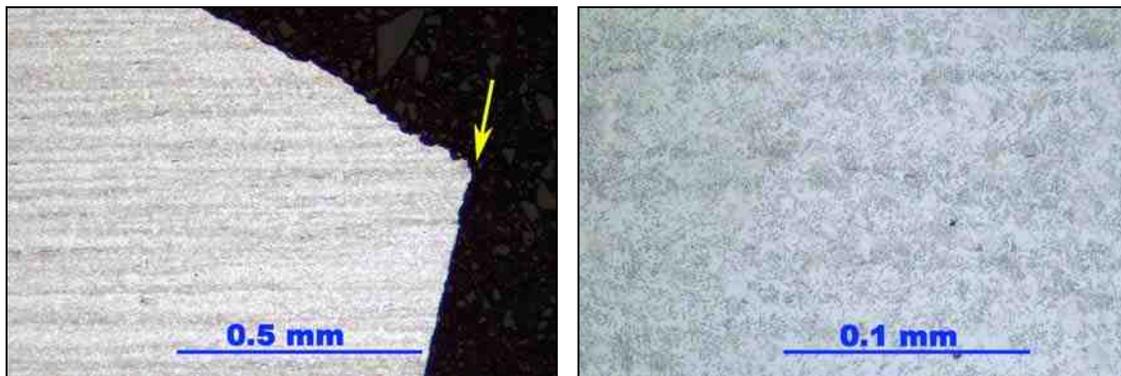
A longitudinal metallographic cross section was prepared through a typical fracture origin area, in order to facilitate examination of the surface profile and microstructure at this region. The cross section is shown after etching in Figure 4, where the surface exhibits a fairly rough profile from machining, and the fracture appears to have initiated within one of the machining grooves. The microstructure shows some evidence of segregation (banding), and this is typical for drawn

barstock. Significantly, the core microstructure is comprised of spheroidized pearlite and ferrite, and this is indicative of a fully annealed condition.

Fig. 4 – Longitudinal metallographic cross section through a typical fracture origin area of the shaft (left), showing a fairly rough part surface profile. The fracture origin (arrow) is located within a machining groove at this area. The core microstructure (right) is comprised of spheroidized pearlite and ferrite.

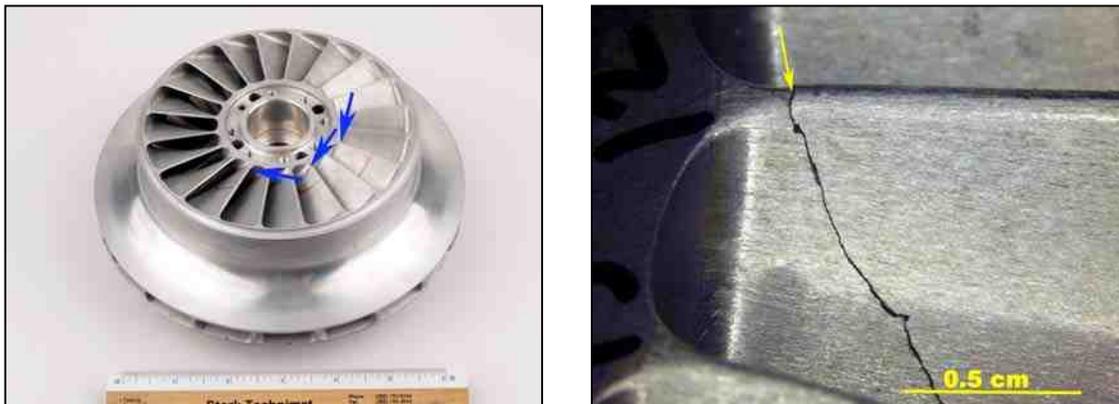
The part is shown as-received in Figure 5, where three blades exhibit cracks adjacent to the center hub. The cracks exhibit a somewhat jagged appearance. A typical opened crack is shown in Figure 6, where most of the original details appear to have been obliterated by secondary mechanical damage. The origin was identified near one end of the blade on the suction side, as indicated by the arrow in the view. The region well outside of the origin shows some features that are suggestive of progressive cracking.

Fig. 5 – The impeller is shown as-received (left), where cracks were noted in the blades adjacent to the center hub, as indicated by the arrows. A typical crack (right) exhibits a jagged appearance.

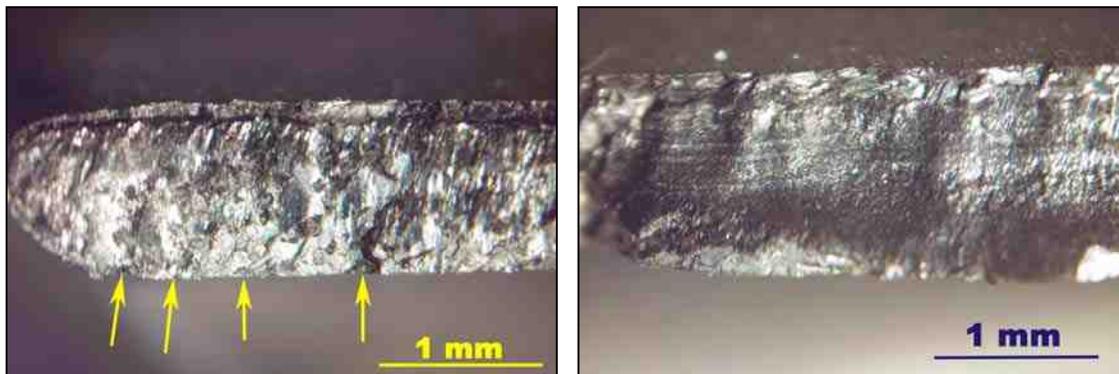
Fig. 6 – The origin region of a typical opened crack (left) shows significant mechanical damage, although multiple origins were identified near one end of the section, adjacent to the suction side of the blade (arrows). The adjacent region of the crack (right) exhibits some features that are suggestive of progressive cracking.

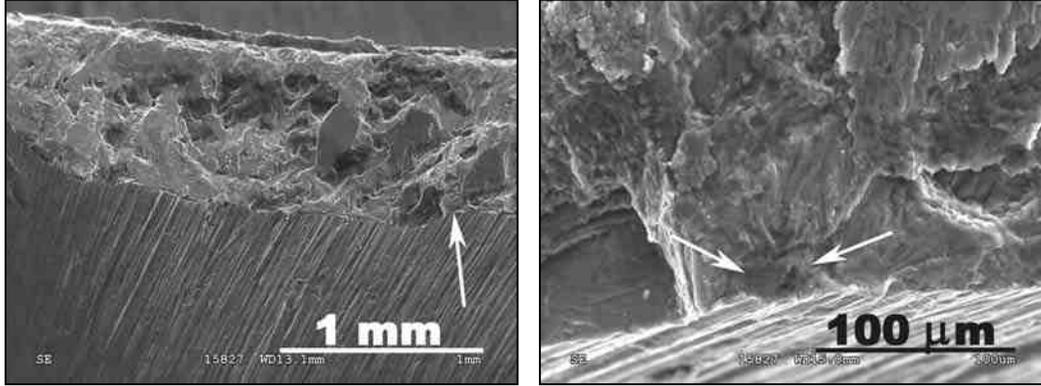
Further examination of the fracture, as shown in Figure 6, was conducted via SEM. The fracture origin region is depicted in Figure 7, where several origin locations were found adjacent to the suction side of the blade. The surface of the blade exhibits parallel polishing grooves with an overall rough morphology. The higher magnification view of a typical origin shows the presence of an included particle just beneath the blade surface. Ratchet marks are evident in the fracture immediately adjacent to this particle, indicating that cracking had propagated from this point. Other origin locations showed ratchet marks that were positioned immediately adjacent to grooves and localized gouges in the blade surface. As most of the fracture origins were devoid of any included foreign particles, the foreign material that was found near the surface is likely a minor contributor to the cracking phenomenon.

Fig. 7 – SEM evaluation of the origin region of the fracture that is depicted in Figure 6 revealed several fracture origins (left) adjacent to the suction side of the blade (bottom), and a typical origin is indicated by the arrow. A higher magnification view of this area (right) shows the presence of an included particle (arrows).

The particle at the crack origin, as depicted in Figure 7, was analyzed for elemental composition using EDS. The results are summarized in Table 2, along with the EDS results that were obtained from analyzing a freshly ground area of the base metal for comparison. The base metal contained primarily aluminum with lower amounts of iron, chromium, magnesium, copper and zinc. The origin area containing the particle was comprised of aluminum, magnesium, copper and zinc from the base metal, in addition to relatively high levels of silicon and oxygen, a moderate amount of carbon, and small amounts of potassium, sulfur and chlorine. The silicon and oxygen are likely indicative of silica sand.

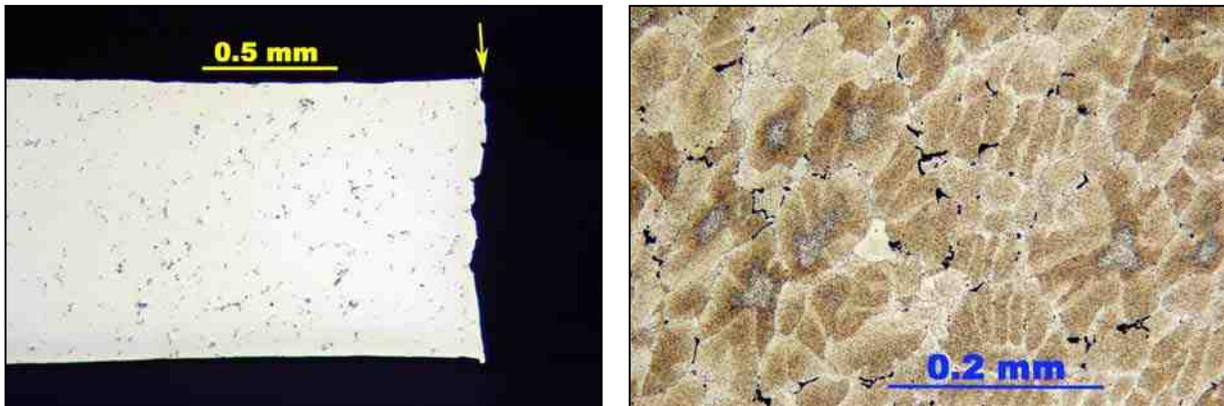
A metallographic cross section was prepared through the fracture in the vicinity of the origin, and is shown in Figure 8. The microstructure is comprised of magnesium/zinc-rich precipitates and iron-rich precipitates in a matrix of aluminum. Some fine, scattered porosity was also noted

in the section. Etching of the section revealed a microstructure that is indicative of an artificially-aged condition, as required.

Fig. 8 – Metallographic cross section through the fractured area of the impeller, showing the fracture profile (left) with the origin indicated by the arrow. The microstructure is comprised of magnesium/zinc-rich precipitates and iron-rich precipitates in a matrix of aluminum, and contains some fine, scattered porosity. The etched core microstructure (right) is indicative of an artificially-aged condition.

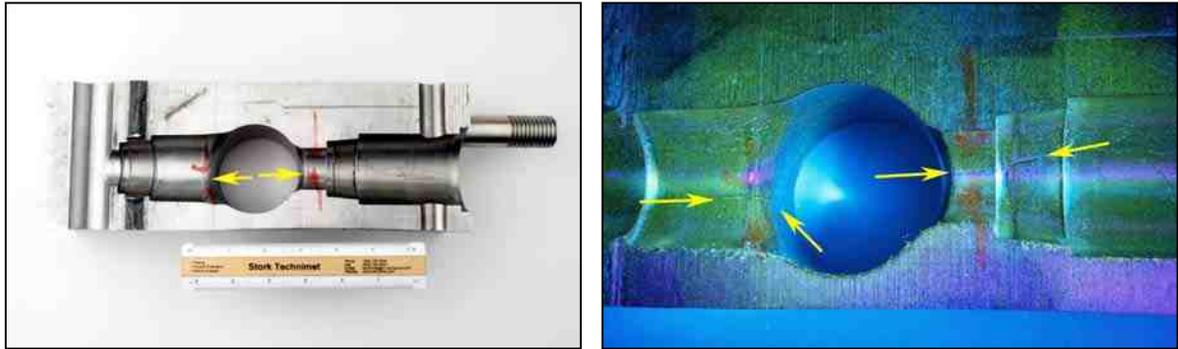
The cylinder block section is shown in Figure 9 with the cracks indicated by the arrows. Wet fluorescent magnetic particle inspection more clearly revealed the cracks. The larger crack was selected for more detailed evaluation. This area of the section was excised, and the opened crack is shown in Figure 10. A distinct origin was found adjacent to the ground surface, as indicated by the arrow in the view. The adjacent ground surface is also depicted in Figure 10, with the fracture oriented toward the bottom, and the origin location indicated by the arrow. The ground surface exhibits relatively deep grooves from grinding.

Fig. 9 – The cylinder block section is shown as-received (left) with the crack locations indicated by the arrows. Wet fluorescent magnetic particle inspection further revealed the crack locations (right).

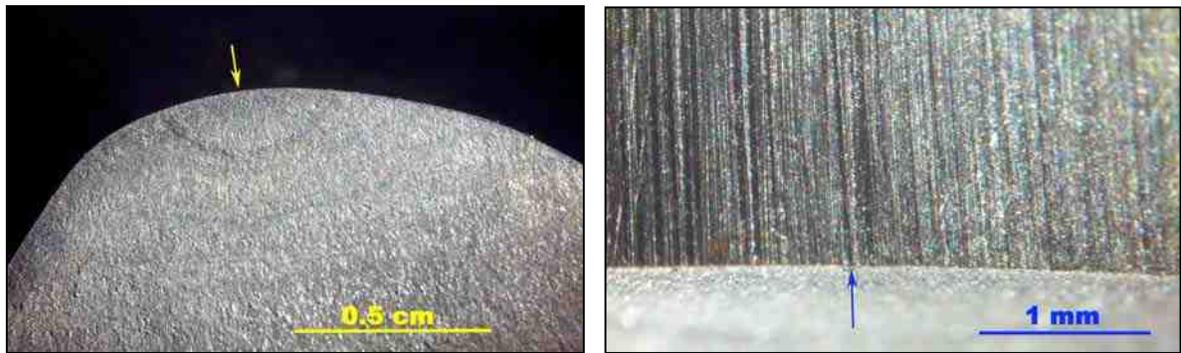
Fig. 10 – The opened crack in the cylinder block (left) exhibits features that are indicative of progressive cracking, and the origin is indicated by the arrow. The adjacent part surface (right) exhibits parallel grinding grooves, where the fracture is shown toward the bottom and the origin is indicated by the arrow

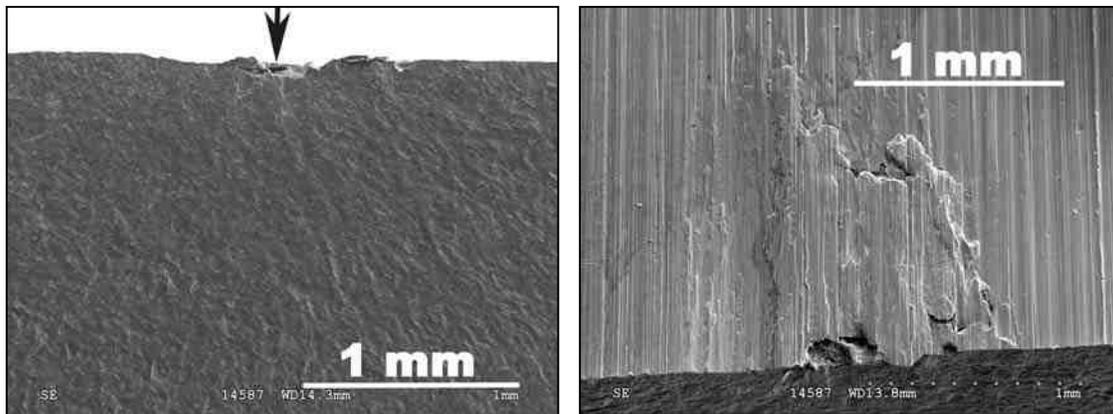
The fracture in the cylinder block, as depicted in Figure 10, was further examined via SEM. Scanning electron micrographs showing the fracture in the vicinity of the origin are presented in Figure 11. The fracture initiated at a relatively localized area, and a surface discontinuity was noted at this area. The discontinuity exhibits the appearance of severe localized deformation with surface tears. Such features are suggestive of overly aggressive grinding or inadequate removal of a machining chip prior to the grinding process. The fracture outside of the origin showed evidence of severe post-fracture mechanical deformation with localized features that are consistent with fatigue, as illustrated in Figure 12.

Fig. 11 – SEM evaluation of the fracture in the cylinder block revealed a surface discontinuity at the origin, as indicated by the arrow. The surface at this area (right) exhibits features that are consistent with localized deformation and tears.

The results of this study show that the cracks initiated at the machined and ground surfaces, and propagated under cyclic loading due to fatigue. Severe localized deformation and surface tears from overly aggressive grinding and/or inadequate chip removal were found at the origin location of a typical fracture. The localized anomalies served as sites for crack initiation when the part was subjected to cyclic stresses. Based on these findings, it was recommended that the machining process be reviewed in order to ensure that all of the chips are removed prior to grinding, and that lighter grinding passes be utilized in order to minimize the likelihood for surface damage from excessive localized deformation and heat.

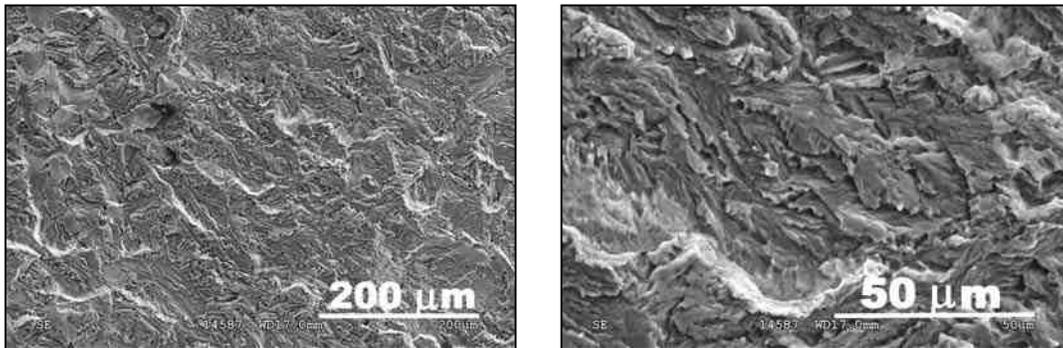
Fig. 12 – SEM evaluation of the fracture in the cylinder block, outside of the origin region, exhibited features that are indicative of fatigue.

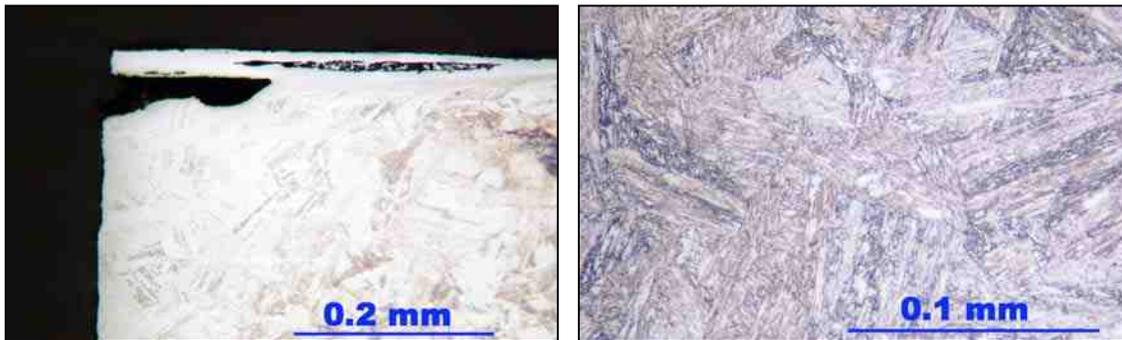
A metallographic cross section was prepared through the fracture origin area of the part. The fracture profile and core microstructure are shown in Figure 13. Discontinuities are clearly evident at the surface, along with some untempered martensite. The untempered martensite is indicative of overly aggressive grinding, resulting in excessive surface deformation. The core microstructure is consistent with the precipitation hardened condition.

Fig. 13 – Metallographic cross section through the fracture origin area of the cylinder block (left), where the fracture is located toward the left, and the part surface is oriented toward the top. Several discontinuities are evident adjacent to the part surface, along with untempered martensite (white layer). The core microstructure (right) is comprised of martensite.

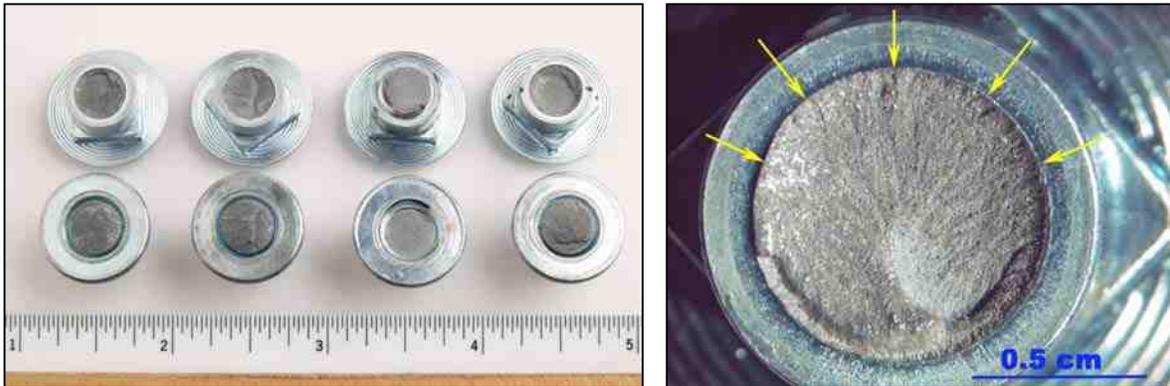
The fractured parts are shown as-received in Figure 14, along with a typical fracture. The fractures exhibit relatively little evidence of elongation. Multiple fracture origins were noted around a large part of the periphery, as indicated by the arrows. The fracture appears to have occurred in a relatively brittle manner, and similar features were noted in the other fractured bolts.

Fig. 14 – The four fractured bolts (left) exhibit transverse fractures with relatively little evidence of elongation. A typical fracture (right) is shown, where multiple origins were noted around a large part of the periphery.

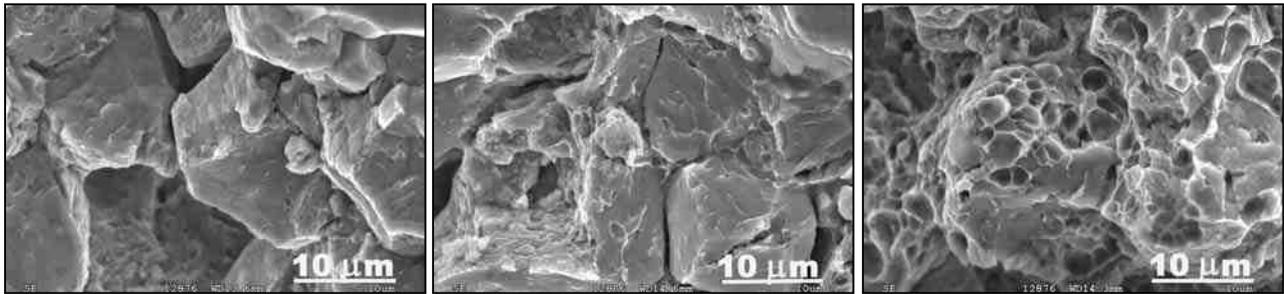
A typical fractured bolt was further examined via SEM. The fracture region, as illustrated by the arrows in Figure 14, is shown in Figure 15. The features at the origin are indicative of intergranular fracture at the origin adjacent to the surface. These features are characteristic of fracture in a steel that underwent hydrogen embrittlement. Similar features were noted at the mid-radius area, along with localized dimples, which are indicative of ductile rupture. The core area exhibited a purely dimple morphology. For the purpose of comparison, a new part from stock was intentionally fractured, and the fracture surface was examined. The features near the surface and at the center of the section are shown in Figure 16. The fracture exhibited quasi-cleavage near the surface, and this is indicative of brittle fracture. The area outside of the carburized region exhibited dimples from ductile rupture.

Fig. 15 – SEM evaluation of the origin area of a fractured bolt (left) revealed features that are indicative of intergranular fracture with grain boundary separation. Some features that are indicative of intergranular fracture were noted near the mid-radius area (center), in addition to localized dimples. The core of the section (right) exhibits a dimple morphology.

The findings of this study indicate that the fractures occurred through the bolts in a brittle and catastrophic manner as a result of hydrogen embrittlement. This phenomenon is known to occur to high strength steels that are subjected to sustained tensile loading after being exposed to hydrogen from processes such as pickling and electroplating. These processes involve the evolution of hydrogen, which is absorbed by the steel. When the material is subjected to sustained tensile stress, the hydrogen migrates to the prior austenite grain boundaries, causing embrittlement of the steel. Baking is commonly employed to reduce the levels of absorbed hydrogen in pickled and electroplated parts. One of the bolts that was randomly selected from stock was found to be susceptible to hydrogen embrittlement in its current state, and this rendered all of the other new bolts from stock questionable as to the safety of their use. Based on these findings, it was recommended that all of the stock bolts be baked in order to reduce the hydrogen levels, and that all recently installed bolts from this stock be removed from service.

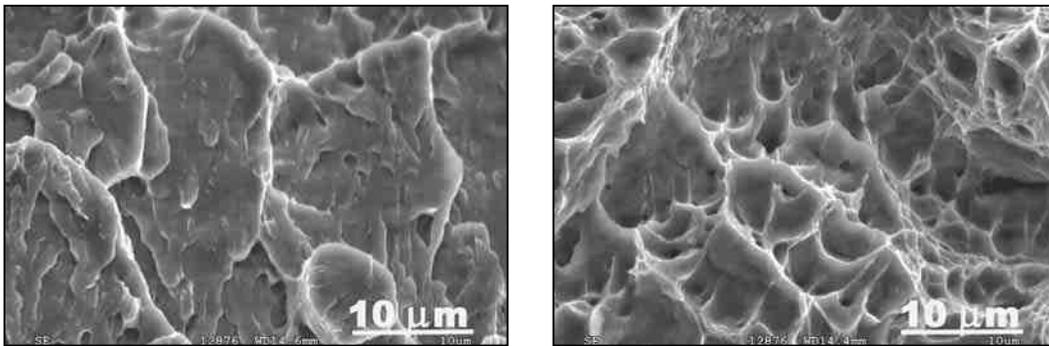
Fig. 16 – SEM evaluation of the laboratory fracture through a typical new bolt revealed quasi-cleavage within the carburized zone near the surface (left) with dimples in the core (right).

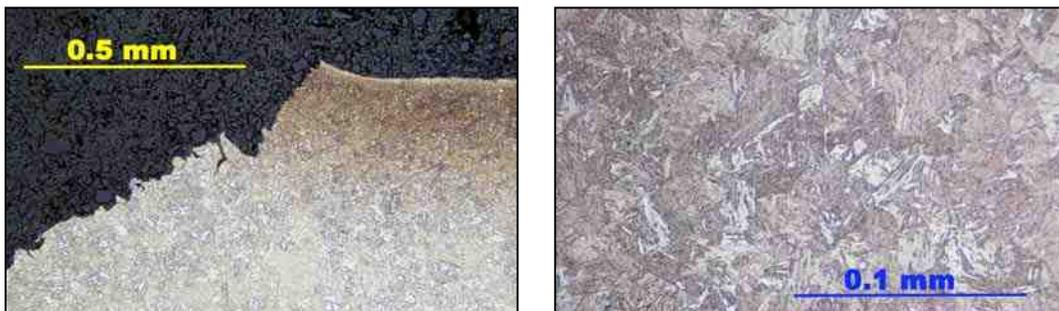
Longitudinal metallographic cross sections were prepared through additional fractured components, and the fracture profile of a typical part is shown after etching of the section in Figure 17. The microstructure is comprised of tempered martensite, and a carburized case was noted adjacent to the part surfaces. The fracture occurred through the reduced area immediately beneath the shoulder of the bolt, and the jagged profile is indicative of intergranular cracking. No material anomalies were found, and the microstructure is consistent with a carburized steel component.

Fig. 17 – Metallographic cross section through a typical fractured bolt, showing a jagged profile to the fracture, with evidence of a carburized case along the part surface (left). The core microstructure (right) is comprised of tempered martensite.
