Analytical Techniques for Problem Solving

The Effect of Chromium Contamination In a Tin Plating Bath

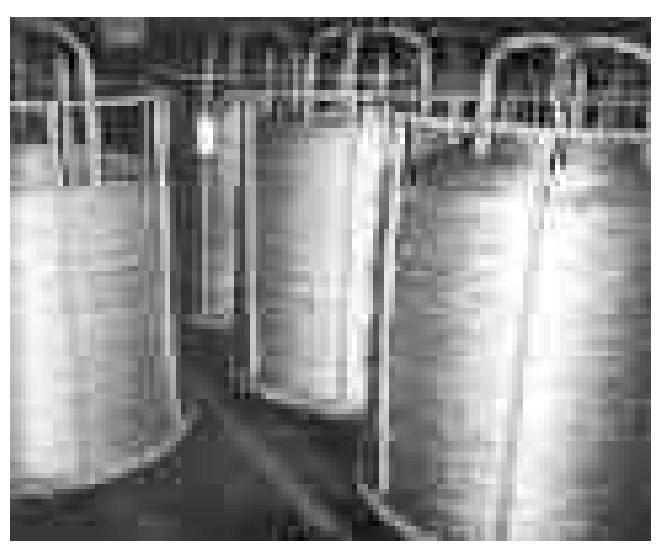
Removal of Cr³⁺ & Fe²⁺ After Carbon Treatment & Clarification

Two methods, standard carbon treatment and "clarification," were utilized to reduce the presence of Cr^{3+} in the plating solution. In the latter case, "clarification" entails the use of a polymeric flocculent to precipitate the unwarranted contaminant. Results are summarized in the table.

Treatment of Sample	Cr, PPM Fe, PPM	
As received	190	713
Carbon treatment	119	560
Clarification	not detectable	not detectable

- For the "troubled" plating bath, a clarification treatment is required.
- For future process control, periodic analysis of chrome should be implemented.
- Sources of chrome contamination should be identified for preventive maintenance.
