Frank Altmayer, MSF, AESF Fellow

What Causes Macro-Cracks In Chromium Deposits?

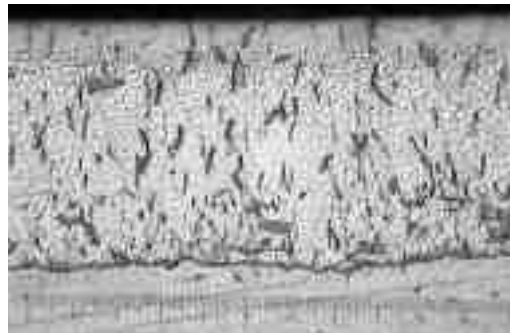
Cross section and crack pattern of a normal hard chromium deposit (photomicrograph at 400x).

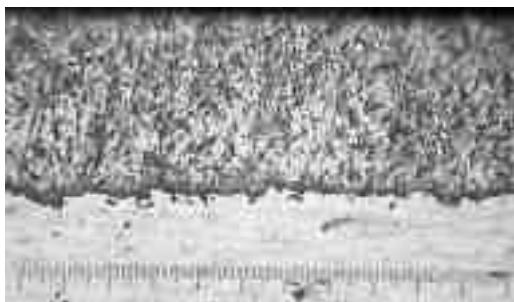
Cross section and crack pattern of a thin-dense hard chromium deposit (photomicrograph at 400x).

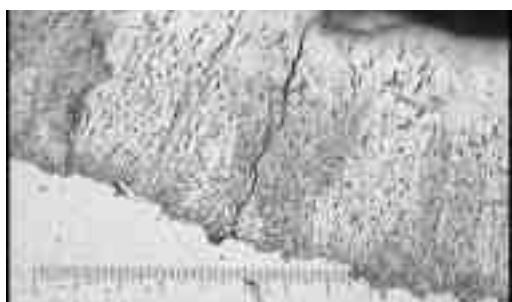
Macro-cracking such as you describe can be the result of poor control over any or all of the seven items listed here. **P&SF**

Cross section of undesirable macro crack in hard chromium deposit (photomicrograph at 400x).
