Some Production Plating Problems & How They Were Solved—Part 6

Nickel Plating: The Case of the "Dark Specks"

Bipolar Patterns in Decorative Chromium Plating

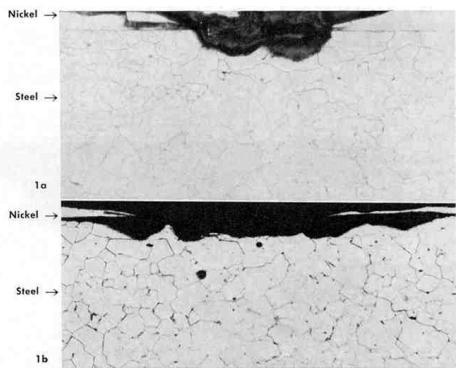
Fig. 1—Typical sections (a & b) through "dark speck" defects. Etchant: 2% nital; original magnification: 500X.

The next approach was to mount samples of the defect for microscopic study. Figure 1 shows typical sections through the defect obtained by mounting, etching and photographing at 500X. The photographs show that the basis metal at the surface of the defect was severely etched. Figs. 1(b) and 2 also show that at the edges of some defects, nickel had grown over a dark non-conducting inclusion.

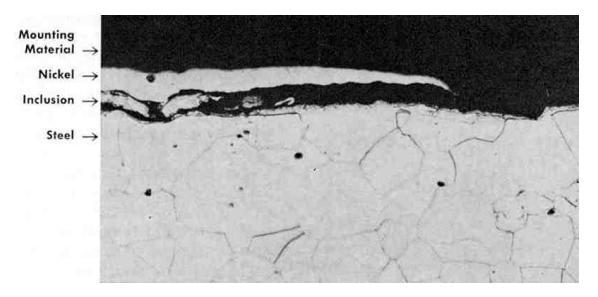
Fig. 2—Nickel deposit at the edge of a "dark speck" defect. The nital etchant has removed the dark non-conductive inclusion over which the nickel has grown. Etchant: 2% nital; original magnification: 500X

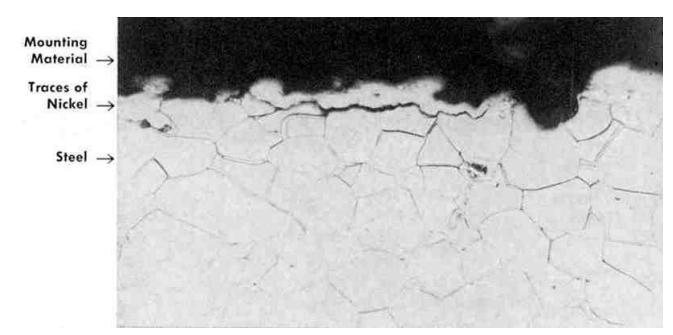
- 7. During nickel plating, the rusted area (being an area of high resistance) did not plate, but the acid plating solution in most cases partially dissolved the rust. Figure 3 shows one example where traces of nickel had been deposited over the severely etched surface at the base of a pit, indicating that the rust in the pit had dissolved, exposing some clean conductive steel surface during the last few minutes of nickel plating.

Fig. 3—Traces of nickel showing at the base of a "speck." Etchant: 2% nital; original magnification: 500X.

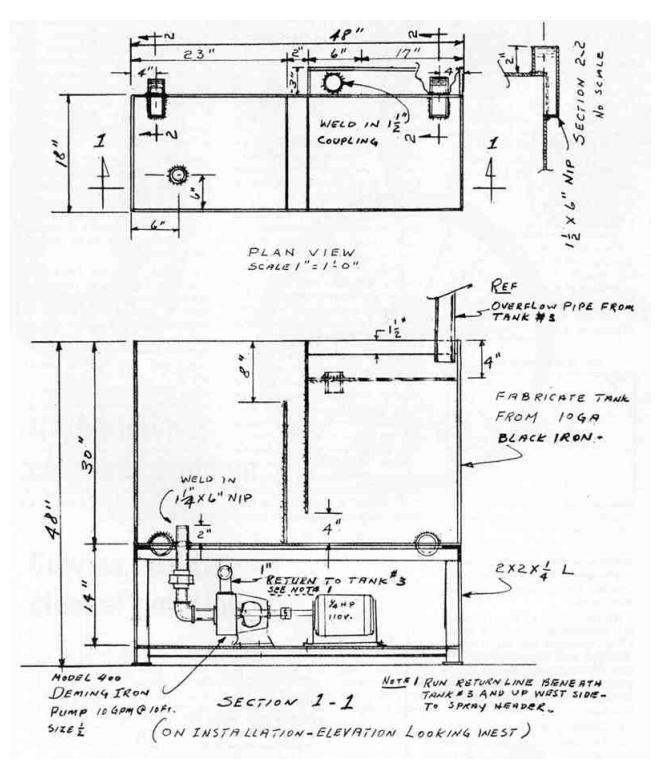
Fig. 4 - Auxiliary grease trap design.

The first three approaches were considered to be too costly and time consuming. Approach No. 4 was considered to be the best and most positive approach to the problem, but also the most difficult to accomplish without loss of production. Approach No. 5 was subsequently selected to reduce or eliminate the problem. Figure 4 shows the construction of the grease trap tank [*They didn't have drafting software when this article was originally written—JHL*].

The small steel tank with baffles and drains was set beside the first electrocleaning tank. The overflow pipe from the cleaner

tank was piped to direct the overflow from the cleaner tank into the grease trap tank as shown in Fig. 4. The small centrifugal pump was arranged to pump from the grease trap tank through a perforated pipe along the back side of the cleaning tank at the top opposite the dam overflow. The perforations in the pipe were placed just below the surface of the cleaning solution and directed so as to flush the grease from the surface over the dam and finally into the grease trap. Continuous recirculation through the grease trap essentially kept the surface of the electrocleaner free from floating grease.

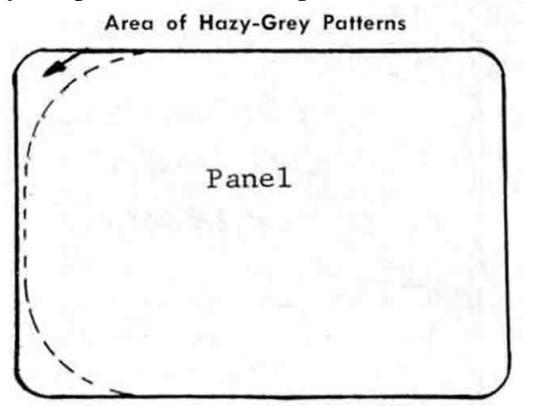
Fig. 5 – Areas of hazy grey patterns in chromium deposits on panels.

This problem began the day our new automatic nickel-chromium plater was first operated. Uneven hazy-grey patterns appeared in the chromium deposit on two small high-current-density areas on one end of rectangular panels as sketched in Fig. 5. This defect is difficult to describe in words, impossible to photograph, but easy to see when observed at a 45° angle in fluorescent light.

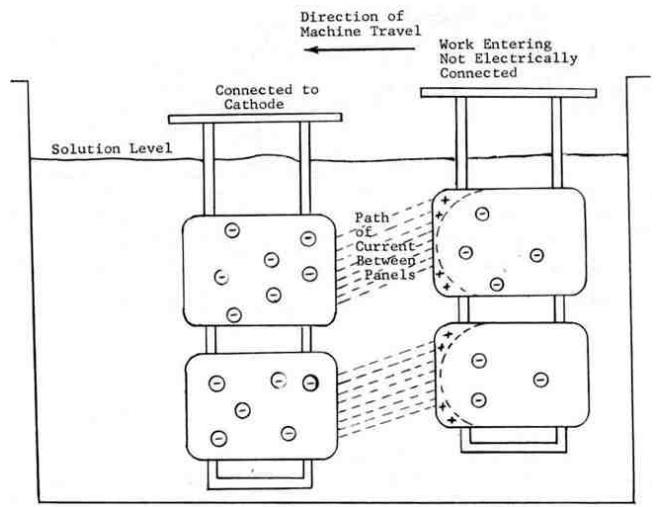
Fig. 6—Assumed bipolar pattern on work entering chromium plating tank. The path of least resistance from the end anodes in the tank is through the work entering to the work that is already plating.

Electrode rods, anodes and bus connections on the chromium tank were cleaned. The bath temperature and chemistry were checked. No solution to the problem appeared. The basic passivation theory was supplemented by assuming that the apparent passivity being observed was caused by a bipolar condition of the work as it was being lowered into the chromium plating tank and before it contacted the cathode bars. Figure 6 illustrates the conditions which were assumed to prevail at the time the work, although electrically neutral, was assumed to be bipolar with the two leading corner areas acting as anodes to the adjacent work which was plating. The current path of least resistance from the end anodes in the tank was assumed to be through the work entering to the work that was plating.

Naturally any area of a part which becomes anodic in a chromium plating bath prior to chromium deposition will passivate (oxidize) the surface, placing a film on the nickel. This oxide film would account for the lack of clarity of the chromium overplate in the particular areas noted. The application of this theory to the problem at hand led to providing a separate low voltage (3V) power supply to the work as it entered the chromium plating tank, thus assuring cathodic polarity to all areas of the work from the moment of entry into the plating tank until the final cathode contact was made. When this power supply was installed and applied, the patterns completely disappeared. Work of extreme clarity was produced giving substantial support for the bipolar theory.
