Shop Talk

Some Production Plating Problems & How They Were Solved—Part 16

2. Decorative chromium plating on zinc die castings—Misplating.

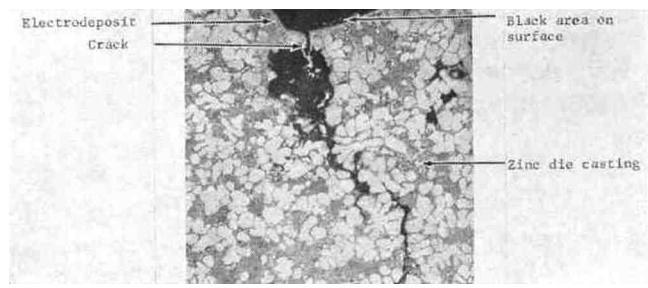
The solution to this problem was conclusively proven by a photomicrograph of the black smut area as shown in Figs. 2 and 3. It is evident that there were cracks in the sharp comer of the grime. The various solutions which entered this crack during the cleaning, acid dip and plating processes caused chemical reactions and gas evolution,

Figure 2-Original magnification, 480X.

which prevented plating in this area and resulted in the formation of the black smut.

When this was called to the attention of the die casters, it was found that the cracking was caused by too much flexing of the thin-walled grille during manufacture. When this flexing was eliminated, the black smut problem disappeared.

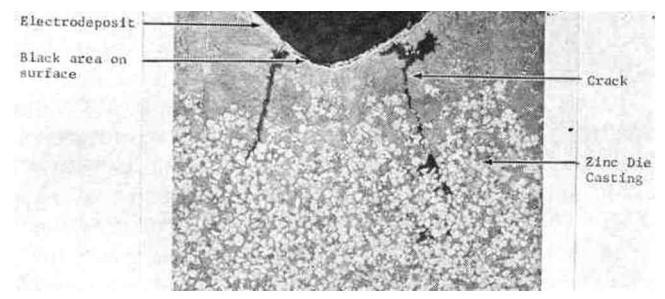
Figure 3–Original magnification, 190X.
