# A Comparison of Copper Bar Anodes

Competition in the PCB industry encourages platers to examine anode features.

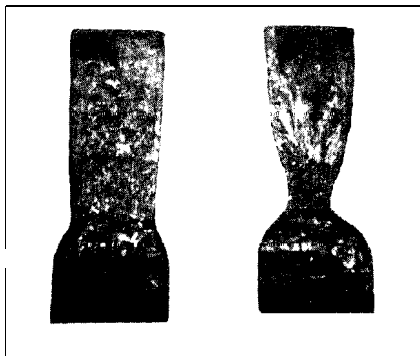
Figure 2. One Brand 2 anode showed considerable necking after Experiment 1.

Each of the stainless-steel cathodes plated by the three brands exhibited comparable quality in terms of their surface roughness. But, appreciably more necking occurred on Brands 2 and 3. That may be attributed to their original hexagonal shape (Figures 1, 2, and 3). The hexagonal shape of Brand 1 approaches a round configuration and appears to lead to more uniform corrosion.

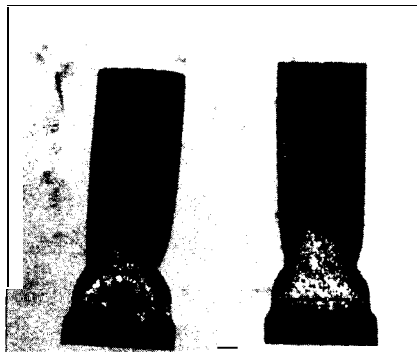
Figure 5. Brand 2 anodes Experiment 2, slight necking

Figures 4, 5, and 6 show the results of the second plating test. Brand 1 exhibited slight necking down, Brand 2 somewhat more, and Brand 3 was necked down to an even greater extent. The center and in Figure 6 represents the accelerated state of stress-accelerated corrosion, which almost reached a point where a piece of the anode would break off and be of no further use. In the second test, without anode bags, considerably less nodular copper growth occurred on the cathodes that were used with Brand 1 anodes (Figures 7, 8, and 9).
