Automation and Chemical Milling

Rick Wire, Manufacturing Research and Development, Boeing, Auburn/WA

In 1992 Boeing's Fabrication Division moved its chemical milling operation from an old facility in Seattle to a new sheet metal facility in Auburn. The main goals of the project were to decrease operating costs and down time and increase capacity and safety. This paper is about the design and start-up of this new partially automated chemical milling tankline, regeneration system and masking facility. This includes discussions on the approach used, areas automated (repetitive versus difficult), start-up, manufacturing difficulties, lessons learned, and some future improvements.

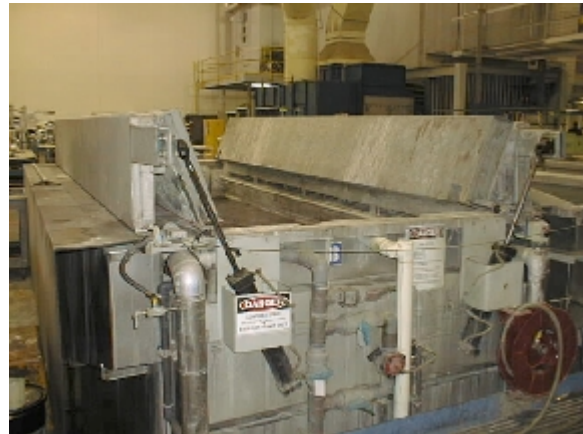
Figure 2 Bi-Fould Tank Lids

The addition of bi-fold lids to the processing tanks reduces employee exposure to chemicals, energy

consumption, and the scrubber size required. Figure 2 is a picture of the bi-fold tank lids.

- **Material Handling/Tank Integration:**
The original design called for the cranes to move past a tank when the lids were open. This was to enable the parts to drip into the tank and not on the lids. During the crane and tank design there was not enough attention paid to this feature. As a result the tank lids must be closed for the cranes to pass.
- **Software/Controls Definition:** The software was left entirely to the supplier, with little review. It would have prevented problems and improved maintainability if there were written descriptions of all the control loops. This was done for the regenerator, which simplified the start-up and maintainability.
- **Equipment Ownership:** Work hand in hand with the designers and contractors. Make sure they understand and communicate information to the subcontractors (i.e. mild steel is not compatible with nitric acid)

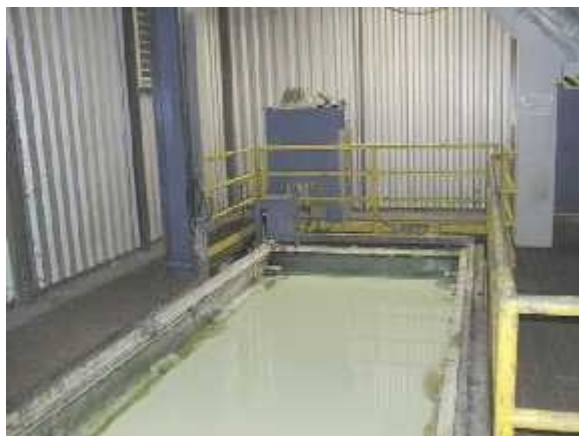
Figure 3 Maskant Dip Tank

The maskant application system was tested first using sheets of aluminum, representing the simplest parts. The first part through the system was nearly blown off the rack by the oven. The part was blown into the wall, which caused the maskant to be damaged. This pointed out an oversight in the oven set-up. In order to increase temperature uniformity, the oven airflow had been increased to turbulent velocities. By closing the baffling in the oven the airflow was decreased and the parts made it through the system successfully. Figure 3 is a picture of the maskant dip tank.

- **Maskant Dipping Process:** The maskant application process was automated using a power and free conveyor system with a lowerator. This was set up to accommodate the requirements of the water-based maskant. The previous facility applied solvent-based maskant using a manual flow coater. With the new system the operator racks the parts, pushes a button, and comes back later when the parts are completed.

- **Automated Maskant Dipping/curing:** The previous maskant application process was a flow coat system. By switching to dipping we were able to reduce the amount of labor. Parts are now racked, cleaned and then sent through an automated material handling system where they are dip coated and cured.

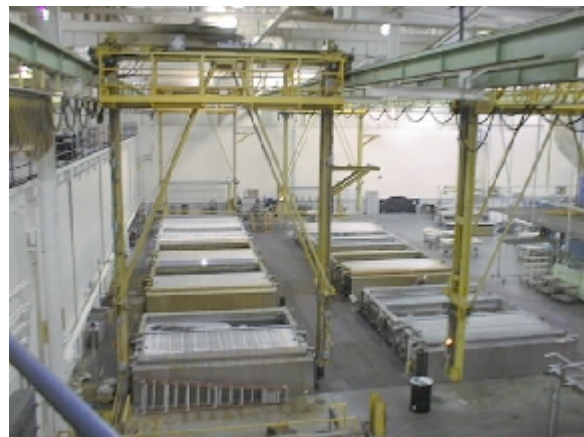
Figure 4 Tankline and Cranes

The next tests involved verifying crane movements and timing in the two main modes of operation, semi-automatic and automatic. In semi-automatic, the ability of the cranes to take directions was verified. In automatic, the ability of the system to execute a recipe with the appropriate timing was evaluated. In addition, the system interlocks were tested. There were no major problems here. The biggest difficulty was the photo eyes down the length of the tankline to check for crane clearance were frequently being accidentally set off. As a result the recipe was frequently interrupted. This was resolved by removing the sensors from non-essential areas and relying on manual e-stops. Figure 4 is a picture of the tankline and cranes.

- **Automated Crane Movement:** Since chemical milling is an iterative process, only the repetitive parts of the recipe were automated. Some examples of repetitive functions are rinse and deox times, drip times, opening and closing lids, and crane movement. The operator calculates the desired time and enters it into a recipe. The control system then takes over the process. The operator can stop and/or resume the recipe.

The tankline pre-production testing started by verifying that all the tank controls worked. This included verifying temperature uniformity, ventilation states, agitation set-up, recirculation, tank level/make-up, and conductivity. From the beginning all the controls seemed to work adequately, but the monitoring system was unreliable. The supervisory controller did not always accurately represent the state of the equipment as controlled by the PLC (programmable logic controller). This did not actually effect the operation that much, but it was a nuisance.

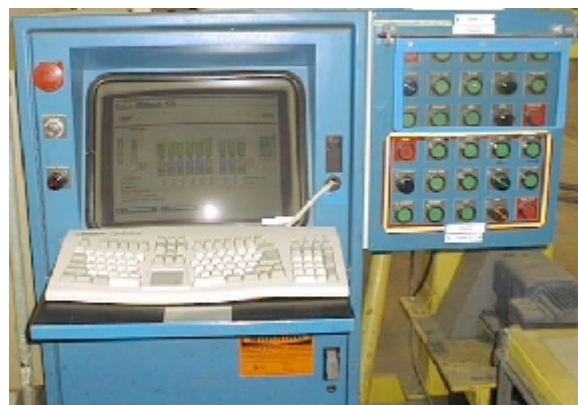
Figure 6 Tank and Crane Control Console

- **Automated Crane Movement:** The switch from manual pendant cranes to PLC controlled cranes went smoothly. The pendant cranes required the operator to walk with the crane as it moved and position it as required to get the load in and out of the tank. In semi-automatic mode the operator can give the crane commands from the supervisory computer or a push button station or walk with the crane and use a joystick to give the commands. Either way crane positioning is controlled by the PLC. In automatic mode the operator enters a recipe, which executes all the crane movements. This can be interrupted and resumed if circumstances require. The main benefits from these changes are allowing the operators to be away from the chemical fumes and permitting one operator run two cranes. Figure 6 is a picture of the tank and crane control console.
