## **Micro-Macro Behavior Near the Crack Tip In a Composite Materials Based on Anodic Hard Ceramics**

Institute of Machine Reliability (INDMASH), National Academy of Sciences of Belarus

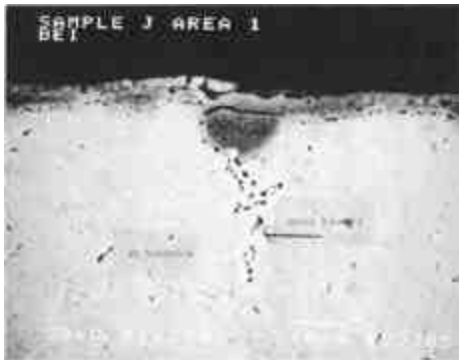
Fig 3. SEM micrograph of crack path at a grain boundary site of alumina layer.

Figure 3, 4 show a crack initiated from either an external in Fig. 3 or an internal Fig. 4 boundary of the layer. The lack of a steady-state regime in which stress intensity factor is independent of the crack length is very evident from these plots. Similarly, if a flaw initiates from a finite split in the layer, delamination is limited to the region around the split and scales with its length.<sup>22,23</sup>
