Application of Inorganic Silicon Sealer to Anodic Oxide Coating

Hideyuki Kanematsu, Suzuka National College of Technology

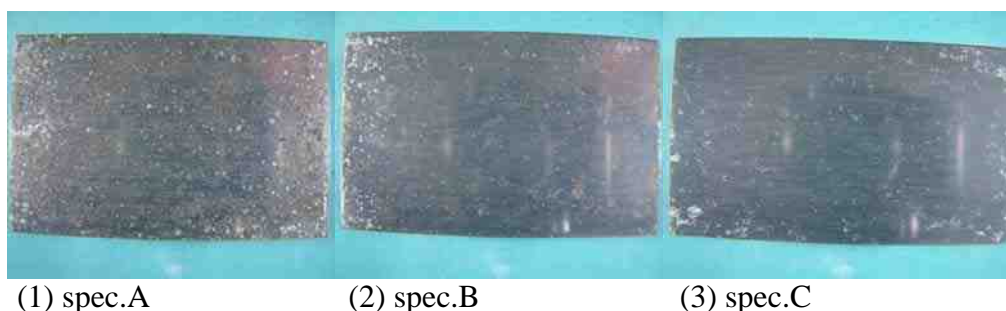
Fig.1 Surface conditions of Al-Cu alloys after CASS tests.

CASS tests were carried out for all of specimens shown in Table 1. Fig.1 shows the surface conditions after CASS tests for Al-Cu alloys. Fig.1-(1) shows the surface of spec.A. Many corrosion pits and iron rust were observed on the surface and it indicates that anodized Al-Cu without any sealing was very corrosive. We presume that some inevitable defects in anodized film for Al-Cu alloy would induce serious corrosion. Fig.1-(2) shows the surface of spec.B. Many corrosion pits and red iron rust were still observed. But the extent of corrosion decreased than that of spec.A. Fig.1-(3) shows the surface of spec.C after CASS test. It indicates that the application of the silicon sealer enhanced corrosion resistance drastically. The number of corrosion pits decreased and there were few iron rust on the surface in this case.

- (1) Anodized Al-Cu alloy without any sealing was corroded severely by CASS test. The conventional sealing in hot water increased the corrosion resistance of the alloy. And the application of the silicon sealer to the specimens with conventional sealing enhanced the corrosion resistance drastically.
- (2) Al-Mg-Si alloys applied by silicon sealer did not show any remarkable difference from those sealed in hot water, even though the corrosion resistance of both were higher than that of the specimen without any sealing.
- (3) For Al-Zn-Mg alloys, the results were very similar to those for Al-Mg-Si alloys. However, the effect of silicon sealer to enhance the corrosion resistance was higher for Al-Zn-Mg alloy than that for Al-Mg-Si alloy.
