Application of Autocatalytic or Electroless Nickel for the Recuperation of Corroded Electrolytic Cells

*Amnon Vadasz F., Ph.D., P.E., CEF - President of C.A. Tecnología Aplicada
Santa Teresa del Tuy, Edo. Miranda, Venezuela*

All wetted surfaces of electrolytic cells used in the generation of hydrogen gas, are typically nickel plated for corrosion protection. However, due to continuous use during the years, the nickel plating slowly wears off and fails to provide the proper corrosion protection. When this occurs, the corrosion process deteriorates the unprotected surfaces, particularly of the electrodes, where the dissociation of the water takes place.

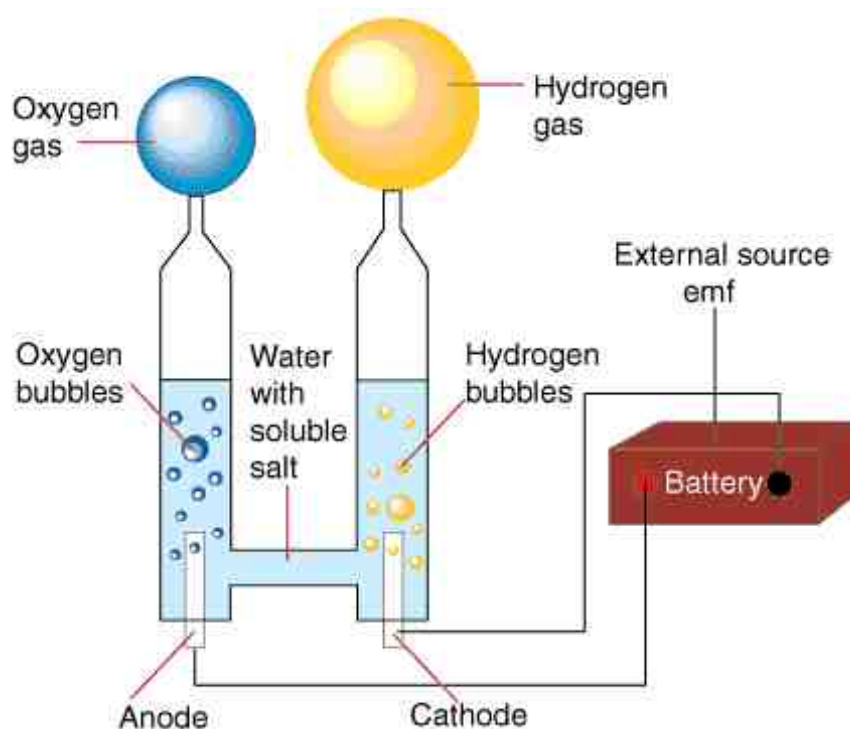
In an electrolytic cell, where the electrolyte is water together with a minor amount of soluble salts, hydrogen gas is produced at the cathode electrode and oxygen gas is produced at the anode electrode by dissociation of this

electrolyte when a direct current is applied to the electrodes, as is shown in Figure 1.

Figure 1.- Electrolysis of water.

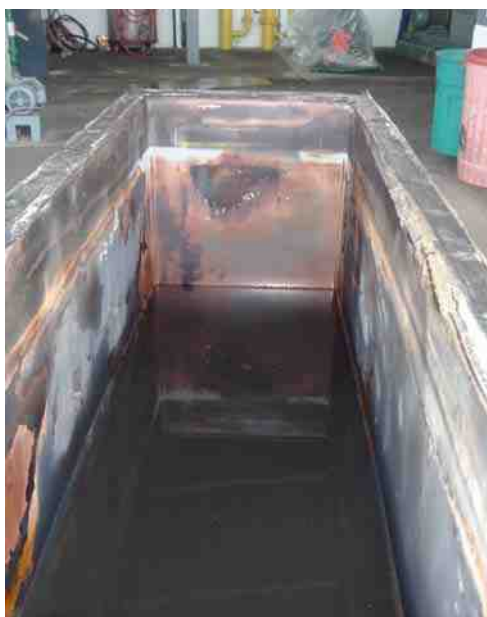
Photograph 1, shows the original condition of one of the cell boxes. In this particular cell box, corrosion has taken place on the walls. Please note that there is still some original nickel plating between the corroded areas.

Photograph 1.- Inside view of a cell box.

The corrosion in the inside walls of the cell box, was quite severe. Many deep corrosion pits and grooves were present, particularly right alongside of the welding between the panels.

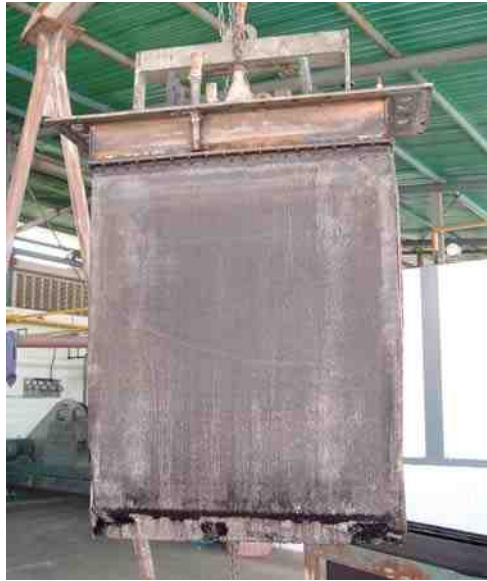
Photograph 2, shows the tank cover. Please note that most of the lateral area, which fits inside the cell box, is corroded. This same photograph shows the cloth bags that cover the anode and cathode electrodes.

Photograph 2.- A view of the tank cover to which the anode and cathode electrodes are fastened.

The tank cover presents a series of tubes and ducts for the continuous supply of the electrolyte, and for the extraction of the produced hydrogen and oxygen gas. It also presents a series of orifices through which the anode and cathode electrodes are supported by means of threaded copper terminals.

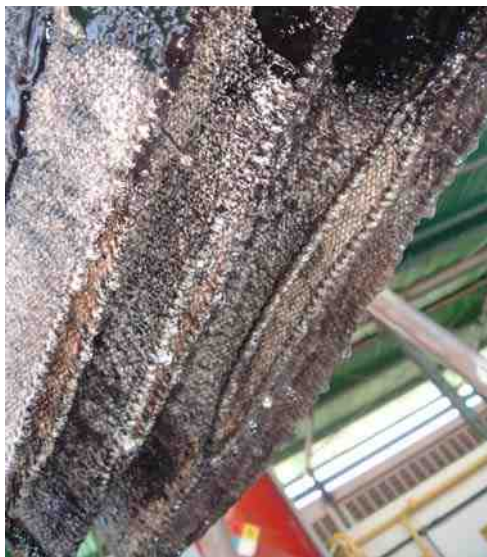
Photograph 3, shows a close up view of the cloth bags that cover the anode and cathode electrodes. Please note that in this particular case, the seams ripped apart and the corrosion present on the anode and cathode electrodes have stained the fabric.

Photograph 3.- Detail of the cloth bags that cover the anode and cathode electrodes.

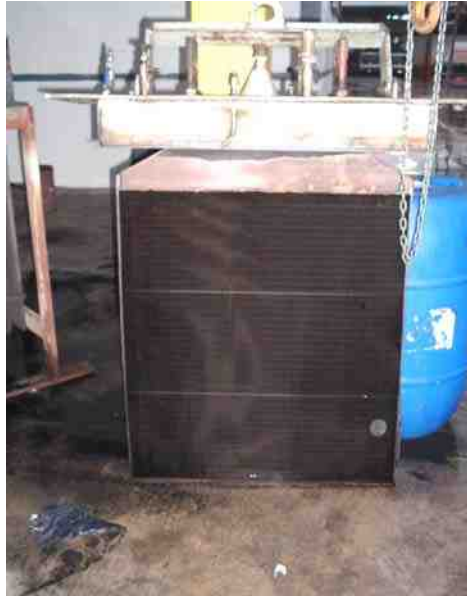
Photograph 4, shows an anode electrode. Please note that the strips of the grid are completely corroded (they appear with a dark brownish color); while the grid support frame is partially corroded.

Photograph 4.- View of a completely corroded anode electrode.

The corrosion damage in both anode and cathode electrodes, was quite similar.

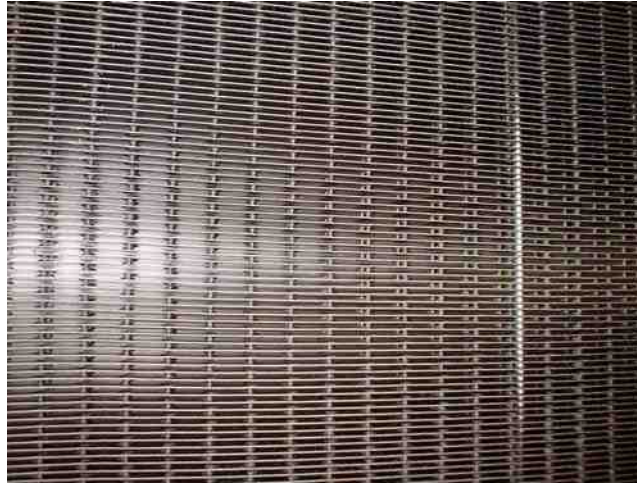
The expensive components of this electrolytic cell are the anode and cathode electrodes. Each of these components, in our case, have a grid comprised by 292 strips made of steel that are about one inch wide and about 1/32" thick, at approximately 1/8" distance between each other, as can be observed in Photograph 5 (corresponding to an already re-plated anode electrode).

At the areas where corrosion has taken place, the thickness of the above mentioned steel strips of the grid was in some cases, paper thin; and sometimes, it was corroded right thru.

Photograph 5.- A close up view of the grid where the electrolysis actually takes place.

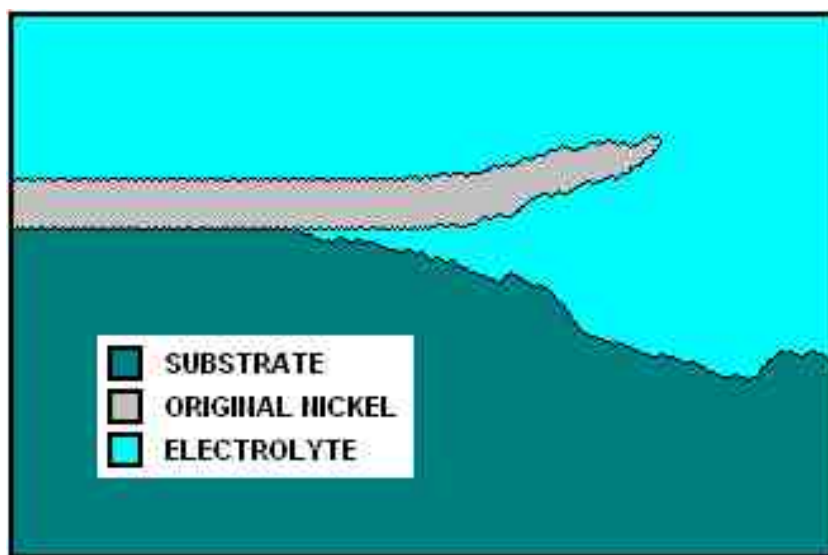
The original nickel that was still present on the different components (cell box, tank cover, anode and cathode electrodes) was basically porous, and in most of the areas presenting flakes, resembling fish scale; that is, part of the nickel was attached to the substrate, while the other part could be lifted with a sharp object.

Figure 2.- Typical flake, that resembles a fish scale, on an original nickel plated steel strip.

A slow acting alkaline stripping solution was developed to partially dissolve the original nickel. The basic idea was to allow the stripping solution to work on both sides of the original nickel plating that was not adhered to the substrate, and only on one side on the portion of the plating that was properly adhered to the substrate, as is illustrated in Figure 2.

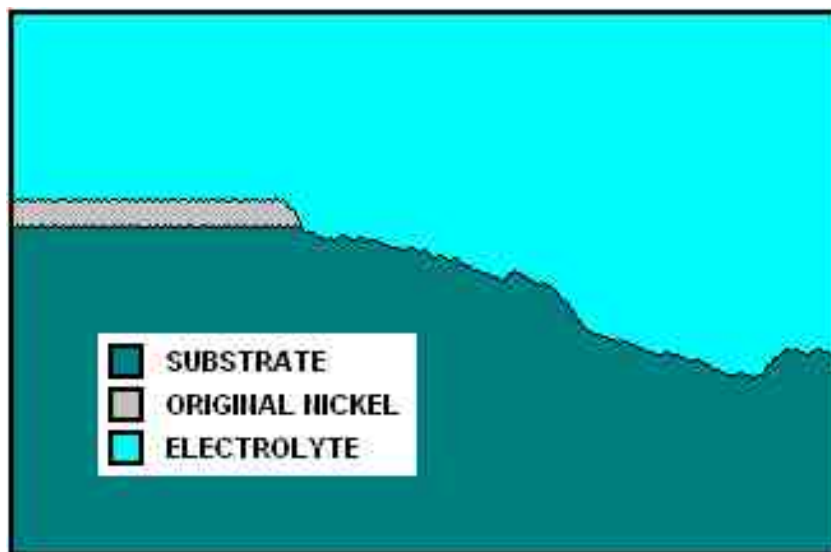
Figure 3.- Properly adhered nickel plating and exposed substrate.

In order to assure that the stripping process would not dissolve more than the necessary amount of nickel, the parts were lifted and washed frequently, until the flakes were no longer present, as is illustrated in Figure 3.

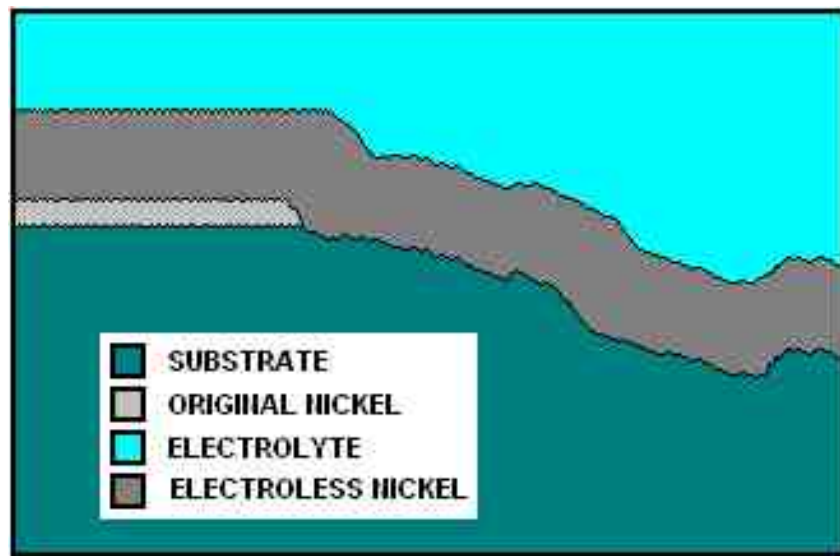
Figure 4.- Electroless nickel plating applied on the substrate and what remained from the original nickel plating.

Once dissolved the original nickel plating which was not properly adhered to the substrate, the components were ready for a subsequent electroless nickel plating process; since this is the most appropriate plating process for this type of application, due its property of uniformly coating uneven or very complex shaped surfaces, as is illustrated in Figure 4.

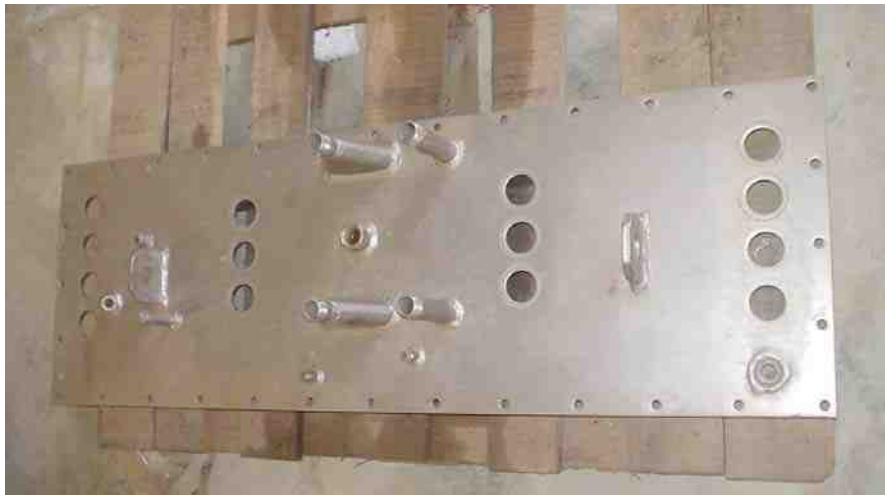
Photograph 6.- Electroless nickel plated tank cover.

In Photograph 6, a tank cover is presented. Please note the electroless nickel plating at the inside diameter of the protruding tubes (which were not protected with the original nickel plating).

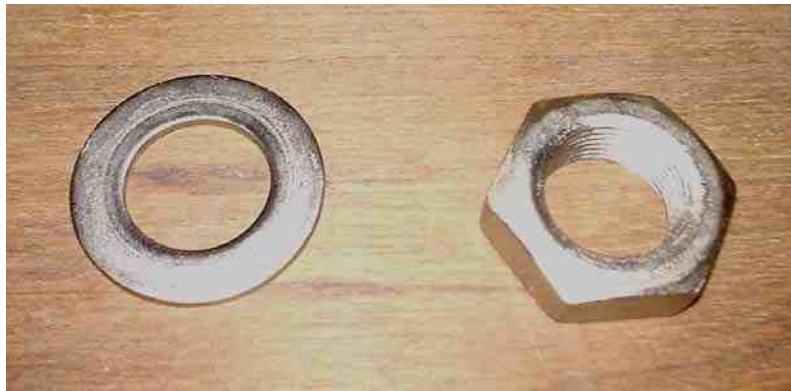
Photograph 7.- Electroless nickel plated Fasteners.

In Photograph 7, a set of protected nut and washer is presented. These components are used to fasten the anode and cathode electrode terminals to the tank cover, and were originally zinc plated. However, these components also presented corrosion, which made the assembly and disassembly of the electrolytic cells, a real chore. Now with the anti-galling property of the electroless nickel, these fasteners can easily be threaded on the copper terminals of the anode and cathode electrodes. For a proper corrosion protection, the nuts were coated in two separate processes: (a) a first coating of about 0.013 mm (0.0005 in) thickness was applied to all surfaces of the nut, including the threads; and (b) the threads were masked and a second coating was applied to the rest of the nut with thickness of about 0.037 mm (0.0015 in). The washers were coated to a thickness of about 0.050 mm (0.002 in).

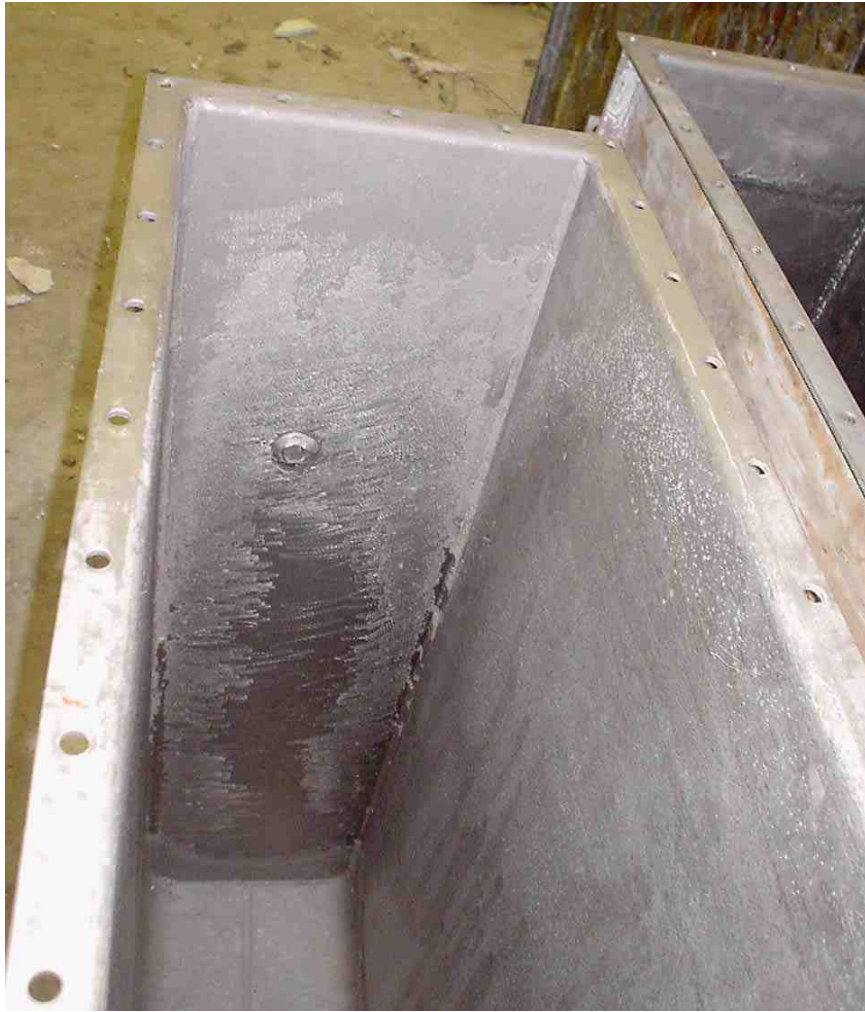
Photograph 8.- Electroless nickel plated cell box.

In the same photograph, deep corrosion grooves can be observed at the welding between the front and side panels. Those areas turned out to be the most difficult ones to coat, since corrosion would show up within a few days, requiring further plating processes.

In Photograph 8, the inside surface of a cell box is shown. Please observe the large quantity of protected corrosion pits present on the walls. Some cell boxes required to be re-plated up to three times, until no corrosion could be observed at the pits.

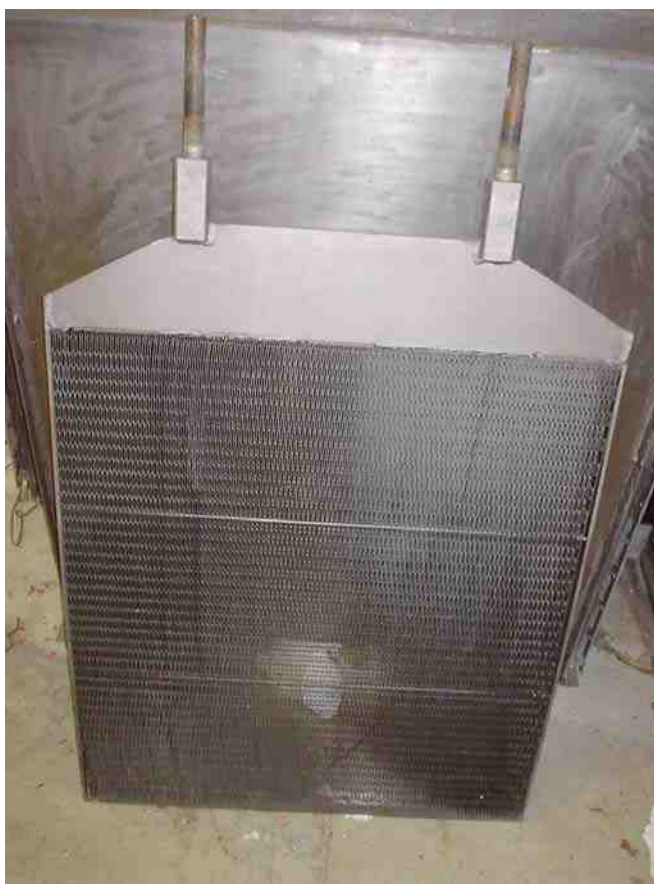
Photograph 9.- Electroless nickel plated anode electrode.

In Photograph 9, a protected anode electrode is presented; while in Photograph 10, a protected cathode electrode is shown. The copper terminals at the top of the anode and cathode electrodes are threaded, and permit these components to be fastened to the tank cover by means of nuts and washers, similar to the ones shown above in Photograph 7.

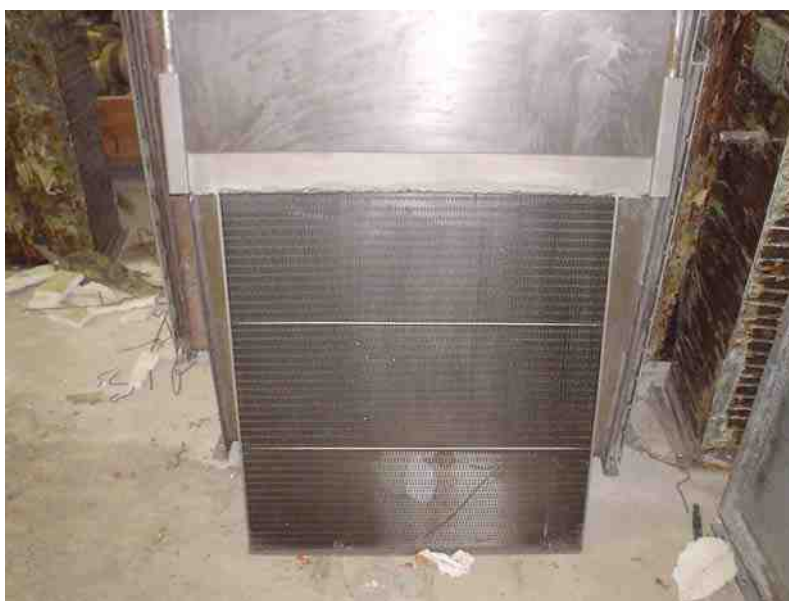
Photograph 10.- Electroless nickel plated cathode electrode.

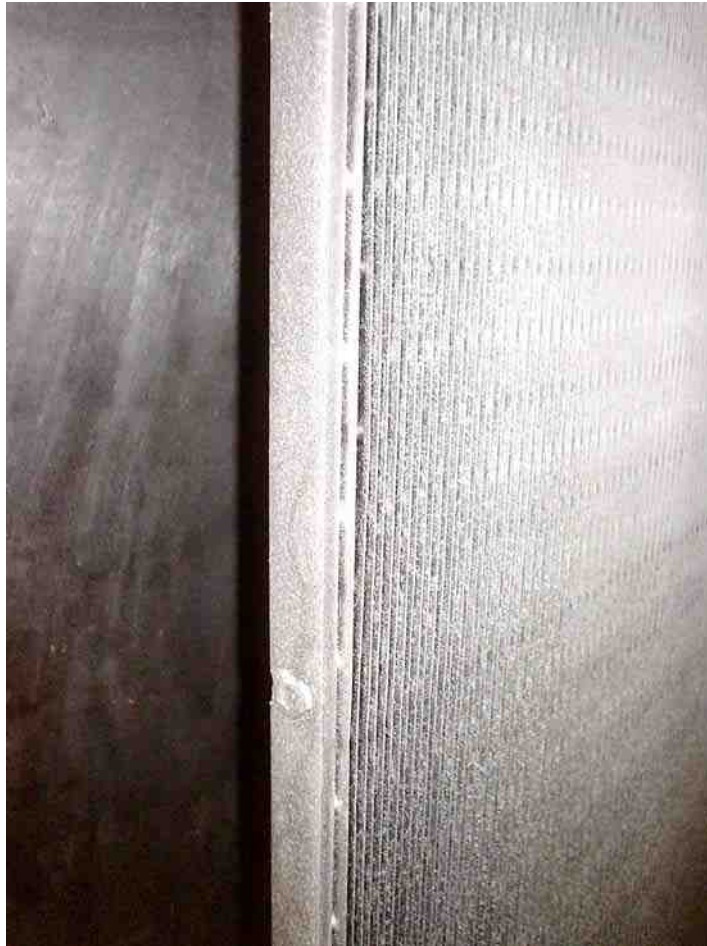
Photograph 11.- Corrosion pits protected against corrosion with electroless nickel.

Photograph 11 is presented, just to show how the large quantity of corrosion pits were protected at the steel strips of the grid and frame of an anode electrode. This photograph is interesting, because each of the surface marks at the grid correspond to a partially stripped flake, resembling fish scale.

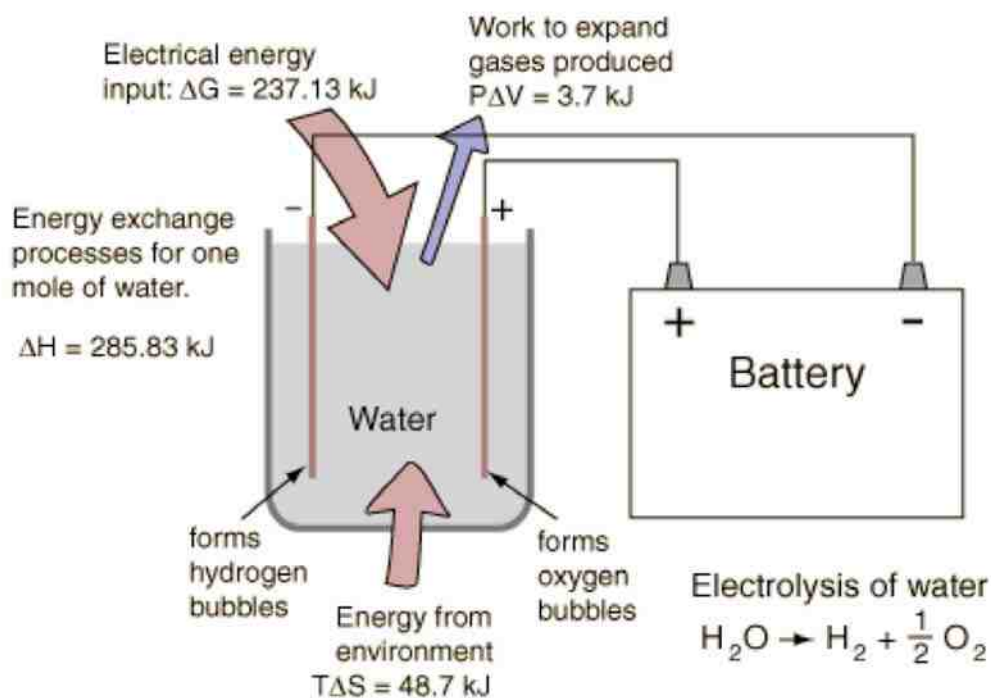
By providing energy from a battery or any other direct current source, water (H_2O) can be dissociated into the diatomic molecules of hydrogen (H_2) and oxygen (O_2), as is shown in Figure 5.

Figure 5.- Energy relationships in the electrolysis of water.
