Exterior Decorative Coatings Improvements on Commercial Airplanes

*Elden Altizer, Material & Processes Technology, Boeing Commercial Airplanes,
Seattle WA, USA*

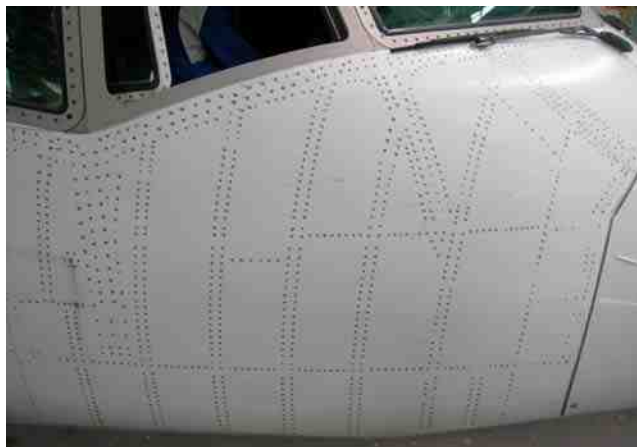
Figure 1- Severe “Rivet Rash” by flight deck window.

The selective loss of paint adhesion on aluminum rivets, shown in Figure 1, is known in the aerospace industry as “rivet rash”. This condition has existed to varying degrees since the beginning of the jet aircraft age. It is such a common condition that there is a good chance that every reader has boarded an airplane with rivet rash and never given it a thought. But rivet rash started to appear earlier and more severe after the change to ANESHAP compliant coatings.

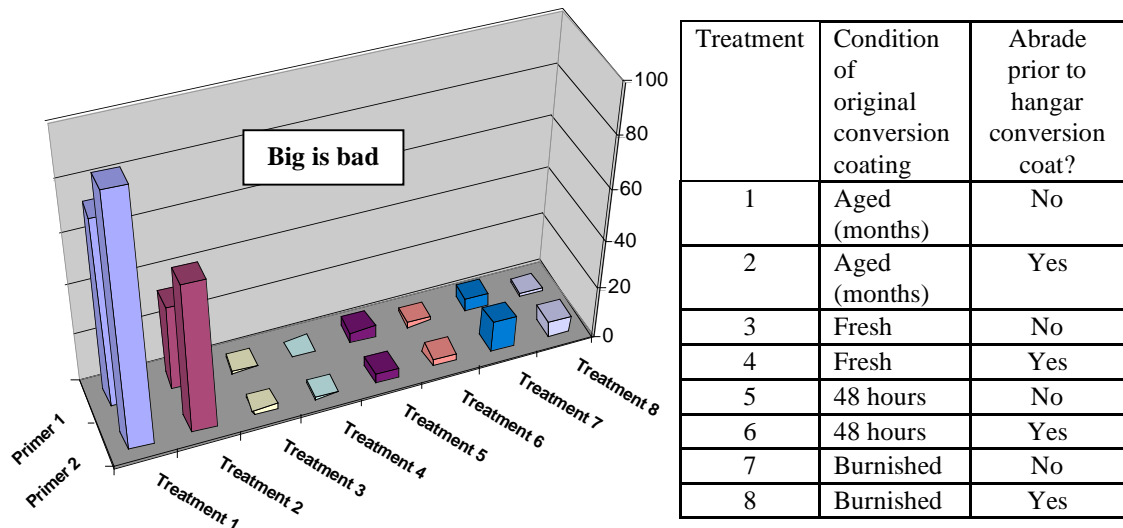
(Average % Paint Area Removed)

Figure 2 - The adhesion of primers based on the surface treatment following the rivet manufacturing processes.

This investigation was quite extensive and this paper will not cover the details of that effort. However, the key finding of this investigation was that the conversion coat applied to the raw rivets at the manufacturer became detrimental to adhesion of primer as it aged. Figure 2 shows the impact of primer adhesion on aged and fresh conversion coated rivets and alternative finishing processes (burnishing and abrading of the rivet head only to remove the conversion coat).

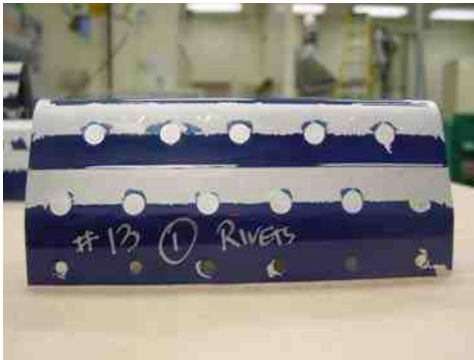
Figure 3 - Standard rivet finish.

Rivets were installed in test foils for the Boeing Whirling Arm Rain Erosion test, which subjects foils to simulated rain at high speed. A decorative paint system was applied to the foils and the adhesion to the rivets was noted. Figures 3 and 4 show a dramatic improvement in adhesion provided by the sol-gel coating.

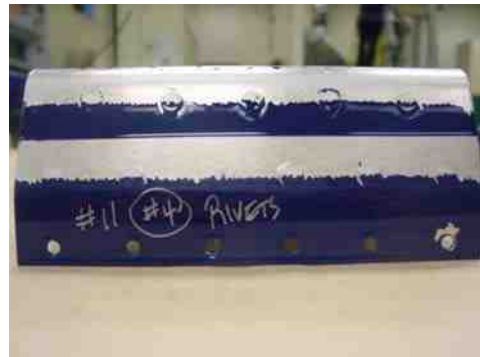
Figure 4 - Sol-gel rivet finish.

A solution that avoided most of the issues above was the addition of an extra conversion coating to promote adhesion. Boeing and our rivet manufacturer, Allfast Fastening Systems, developed a process that added a sol-gel coating to the rivets while the initial conversion coating was not aged.

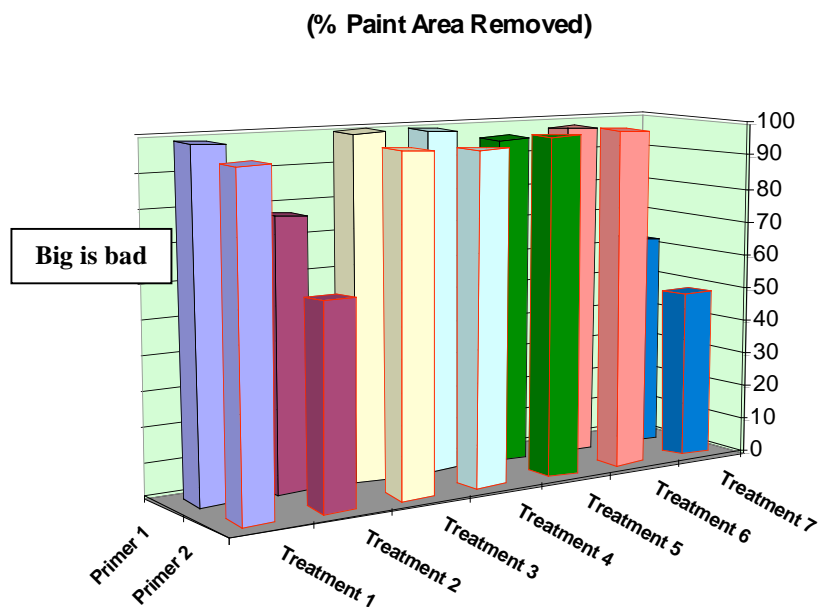
Figure 6 - The effect of the standard aged rivet finish as painted in production.

The benefit of the sol-gel technology for promoting primer adhesion on rivets that are prepared with different cleaning processes (defined in Figure 5) and primers are shown in Figures 6 and 7.

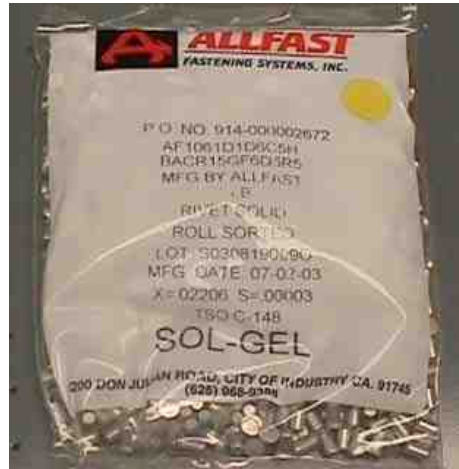
Figure 8 - Standard one Pound bag of aluminum rivets with sol-gel noted on packaging.

clear sol-gel coated rivets are not visibly different from the non-sol-gel, the main tool to identify them is by the packing as shown in Figure 7.

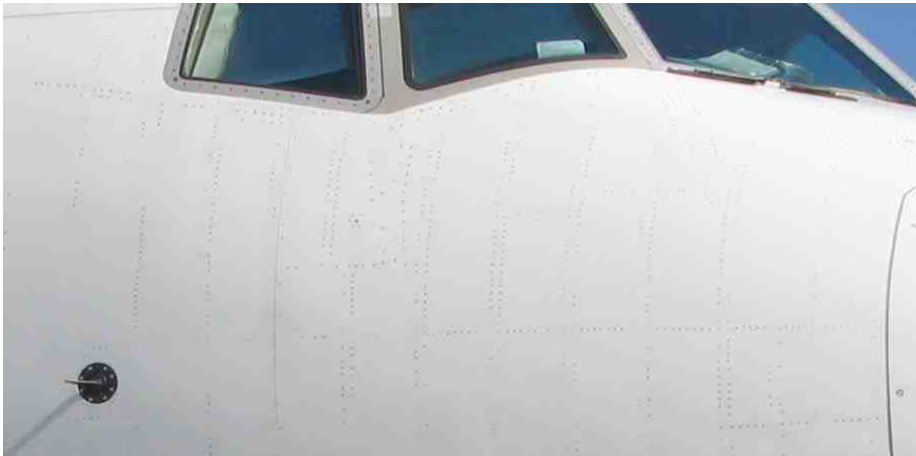
Figure 9 - Rivet rash on a Boeing 777 painted prior to sol-gel rivet conversion after 18 months in-service.

The year following the implementation of the new rivet coating, Boeing surveyed the performance on various models operating in Europe, Asia, and North America. The results were encouraging as the onset and occurrence of rivet rash was significantly lower than prior to the sol-gel coating, but it was not completely eliminated (see Figures 9 and 10).

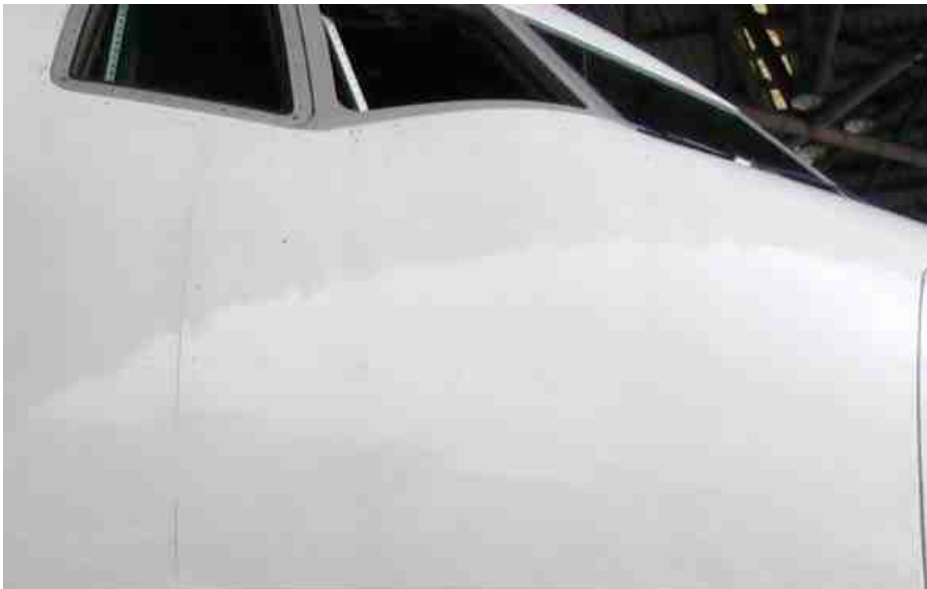
Figure 10 - Minimal rivet rash on a Boeing 777 painted after sol-gel rivet conversion after 14 months in-service.

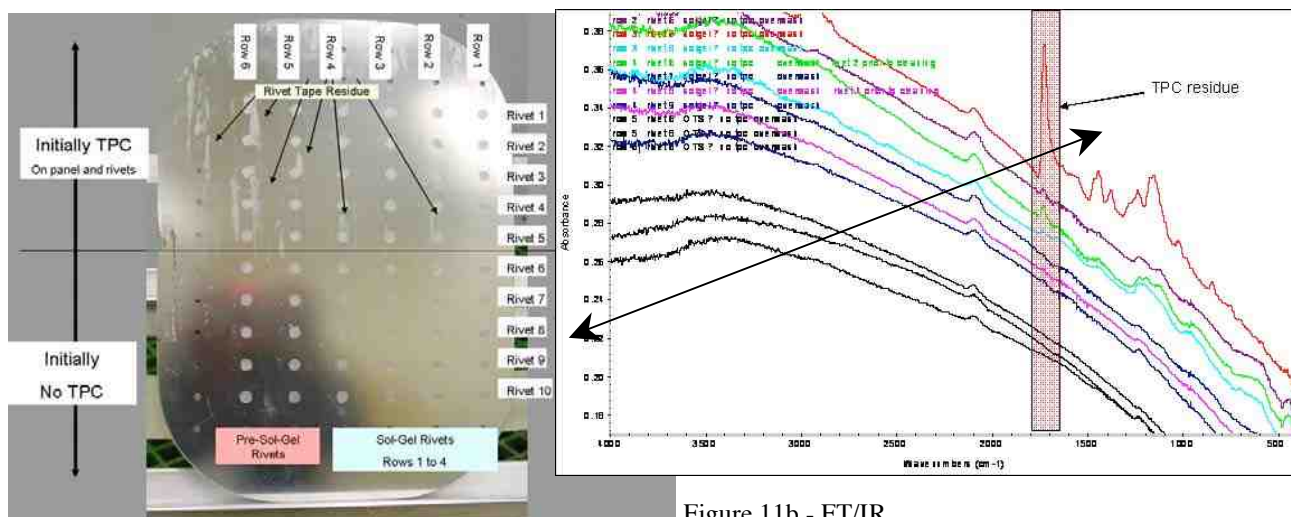
Figure 11b - FT/IR showing TPC residue.

Figure 11a - Riveted test panel evaluating the impact of TPC residue.

Further laboratory testing found that sol-gel coated rivets made in-process contamination a significant issue. Testing the new sol-gel coated rivets in skin panel cutouts revealed the TPC removal process allowed TPC residue to be deposited on the rivet surface and interfere with the primer adhesion. The properties of sol-gel that promoted adhesion with the primer also bonded well with the TPC resin. A test carried out to verify the impact of TPC contamination is presented in Figures 11a and 11b.

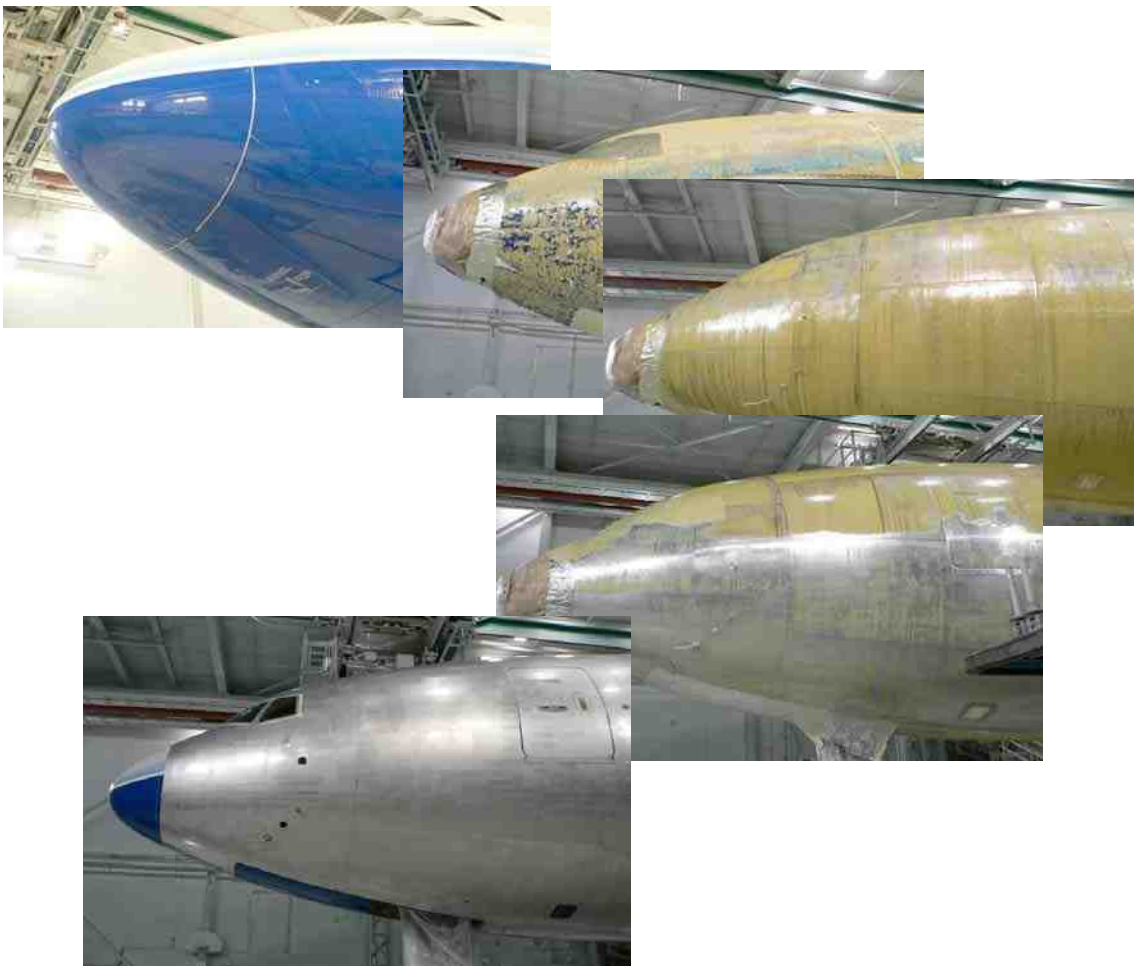
Figure 12 - Paint stripping sequence and complete coating removal from the sol-gel treated metal surface.

The full scale airplane test also provided an additional important test with the chemical stripping required prior to repainting the airplane in the airline customer's livery. The paint applied to sol-gel conversion coat, while requiring slightly more time to strip, was completely and successfully removed with a peroxide activated, benzyl alcohol paint stripper commonly used today for environmental compliance (see Figure 12).
