Field Application of EMI Coatings

Investigation of Coating Materials and Stylus Electroplating Protocols for Shielded Facilities

by
L.D. Stephenson and L.H. Donoho

REFERENCE: USACERL Technical Report 96/55, *Field Application of EMI Coatings: Investigation of Coating Materials and Stylus Electroplating Protocols for Shielded Facilities*

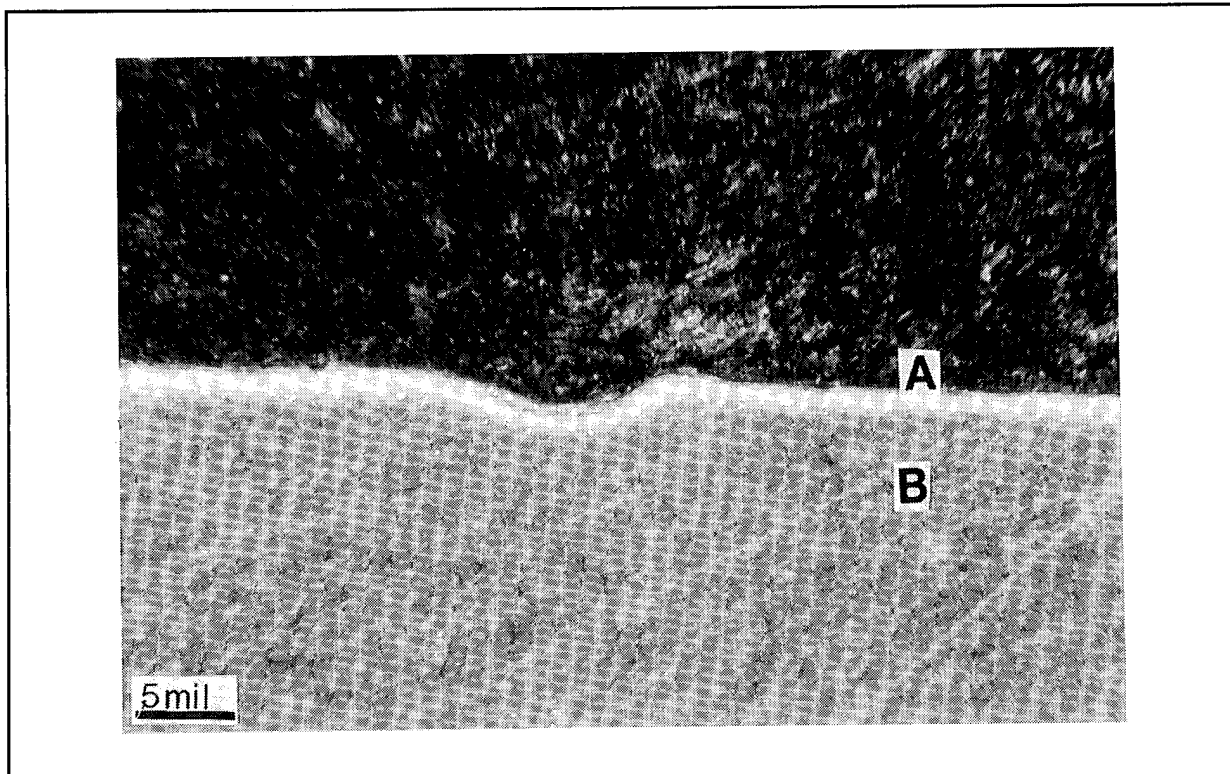
Figure 1.6. Optical micrograph of cross-sections of a 6061-T6 aluminum substrate scratched to a depth of 1.0 mil and then coated with 95%Sn/5%Pb over 60%Sn/40%Pb over Ni—(A) coating and (B) substrate of Sample 10 BF.

Arrow indicates approximate center of scratched area.

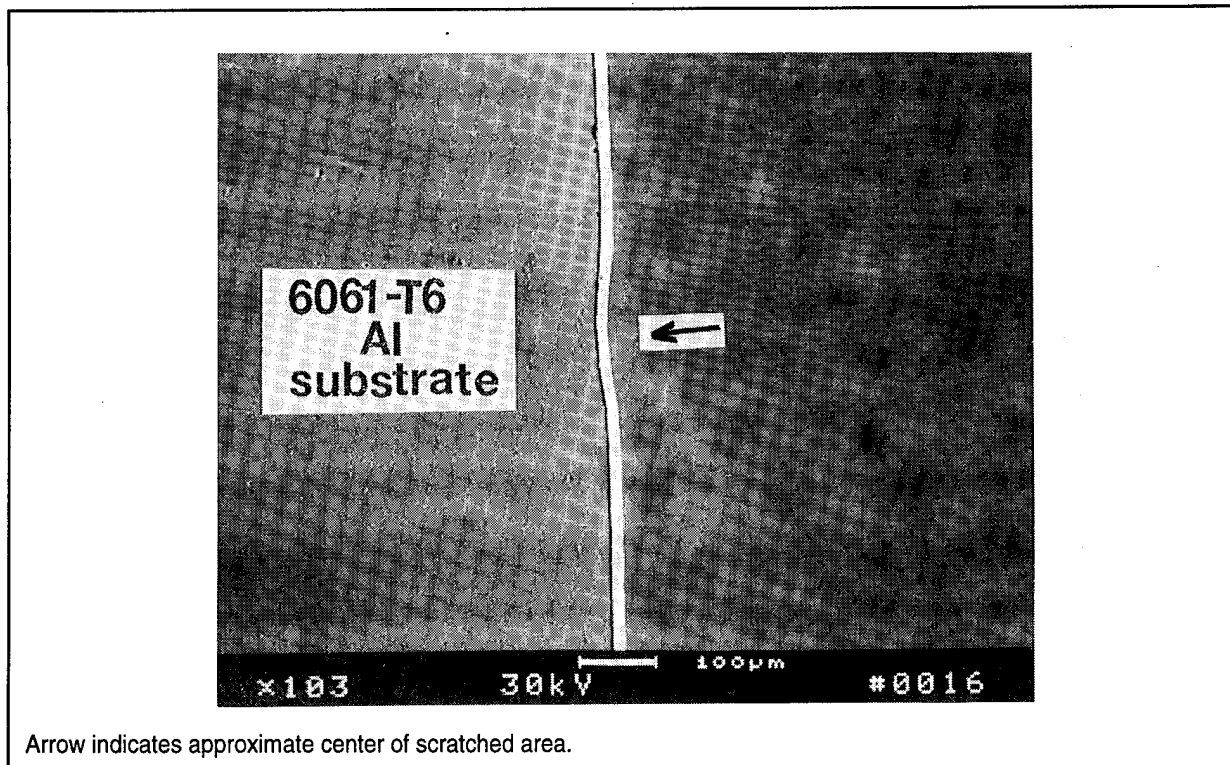
Figure 1.7. Scanning electron micrograph of cross-sectioned 6061-T6 aluminum substrate scratched to a depth of 0.5 mil and then coated with 95%Sn/5%Pb over 60%Sn/40%Pb over Ni.

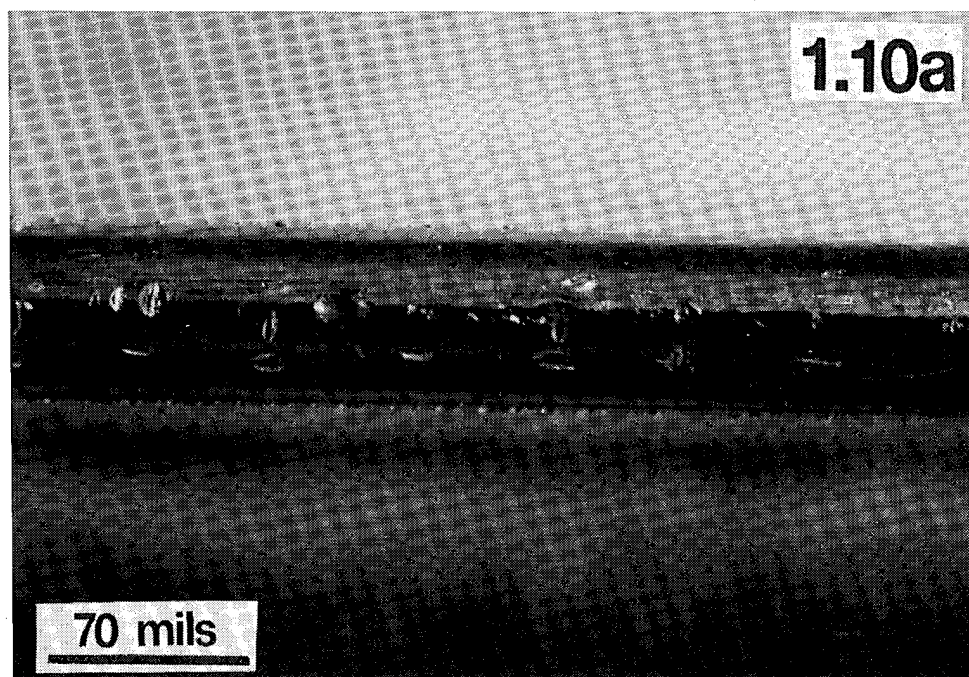
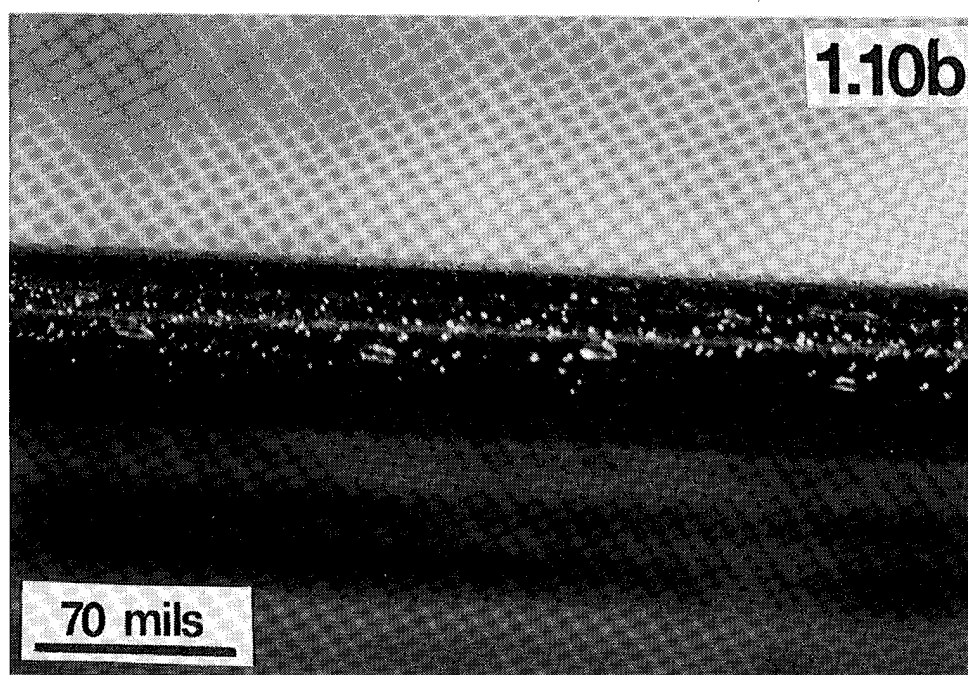
Figure 1.10. Optical micrographs of a Pb/Sn coated knife edge samples (a) 1KE and (b) 6KE, showing "bite marks" after 9,000 cycles on the USACERL Gasket Cycler Test System.

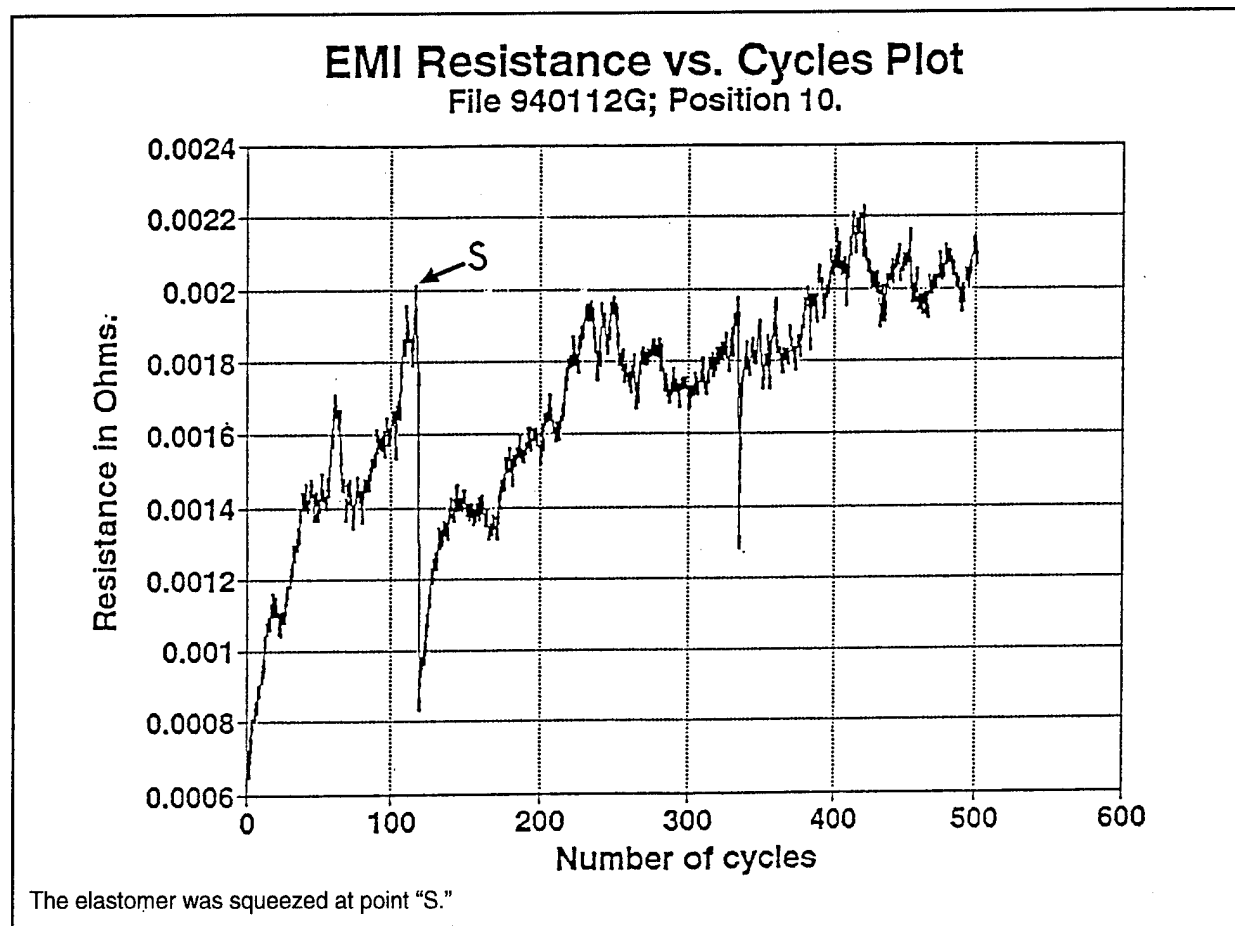
The elastomer was squeezed at point "S."

Figure 1.11. Resistance vs. Cycles of a cycled knife-edge test sample showing the "squeeze effect."

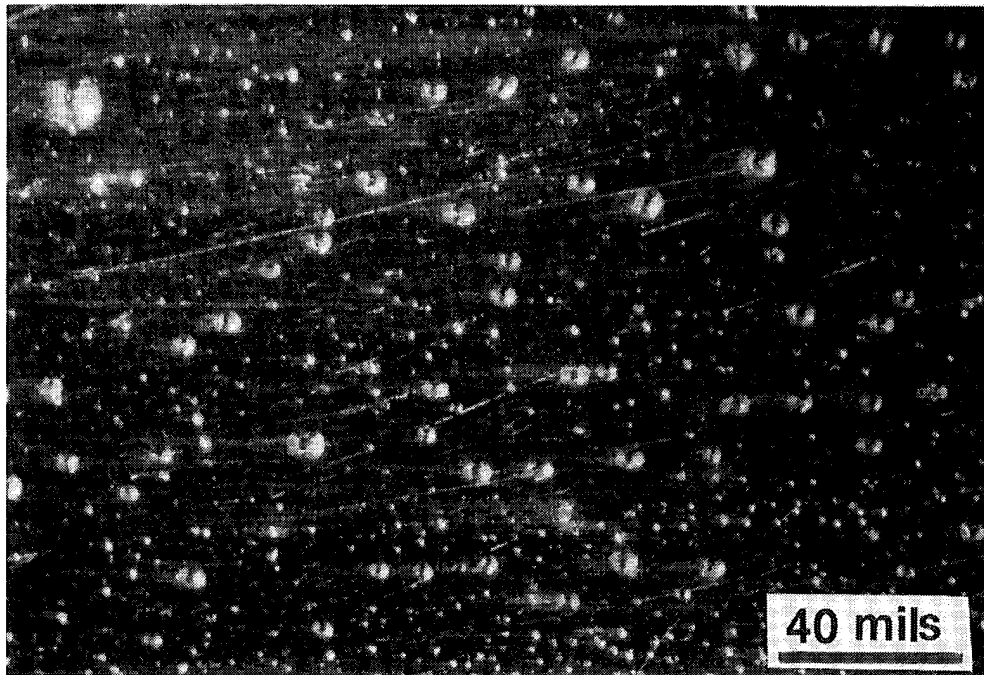
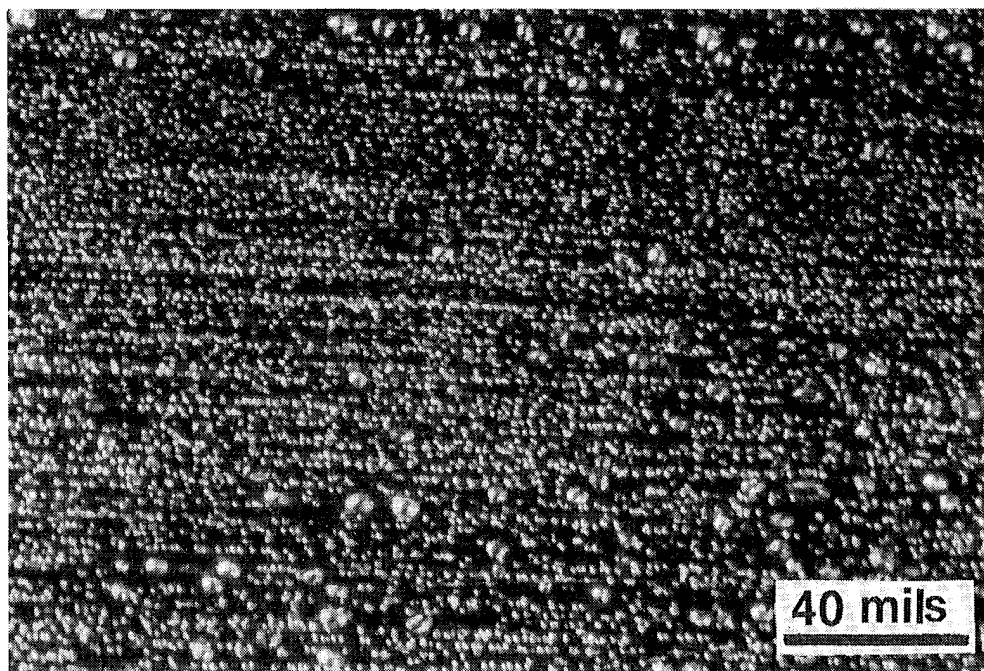
Figure 2.2. Optical micrograph showing a broadface view of a 6061-T6 aluminum substrate coated with 95%Sn/5%Pb (a) with randomly oriented blisters and (b) with lines of small blisters that appear to follow the brush strokes.

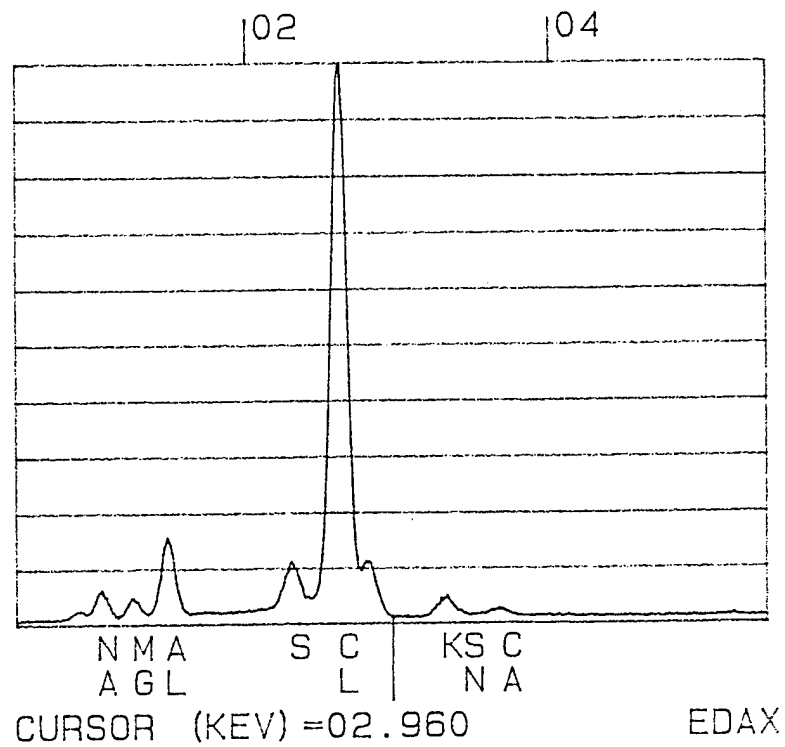
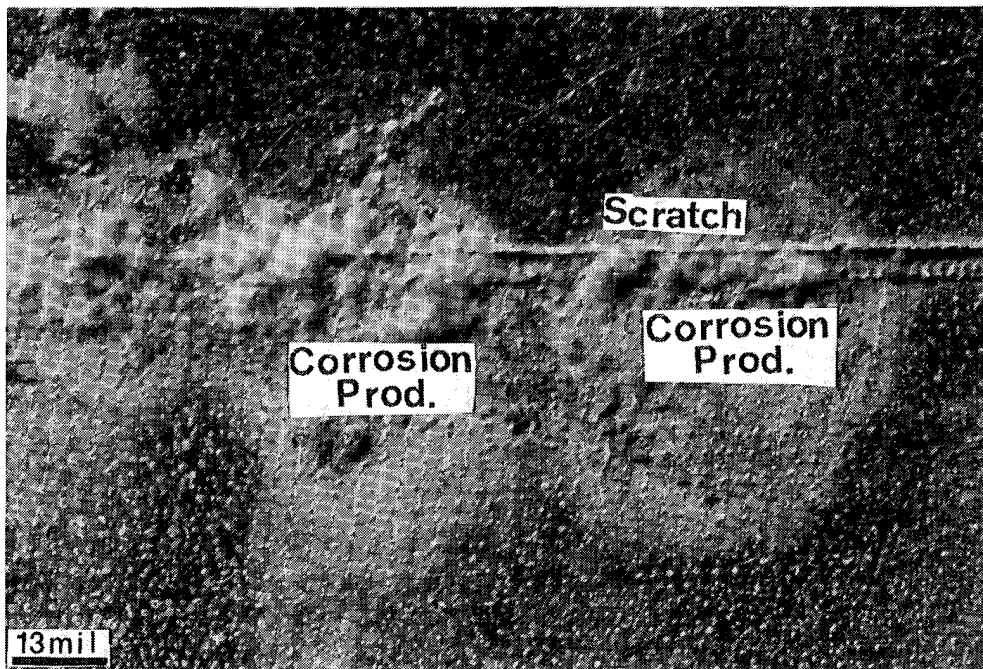
Figure 3.4. (a) Energy dispersive x-ray analysis of corrosion product and (b) Corrosion of
aluminum substrate exaggerated by high cathode (Sn coat) to anode (Al) ratio.

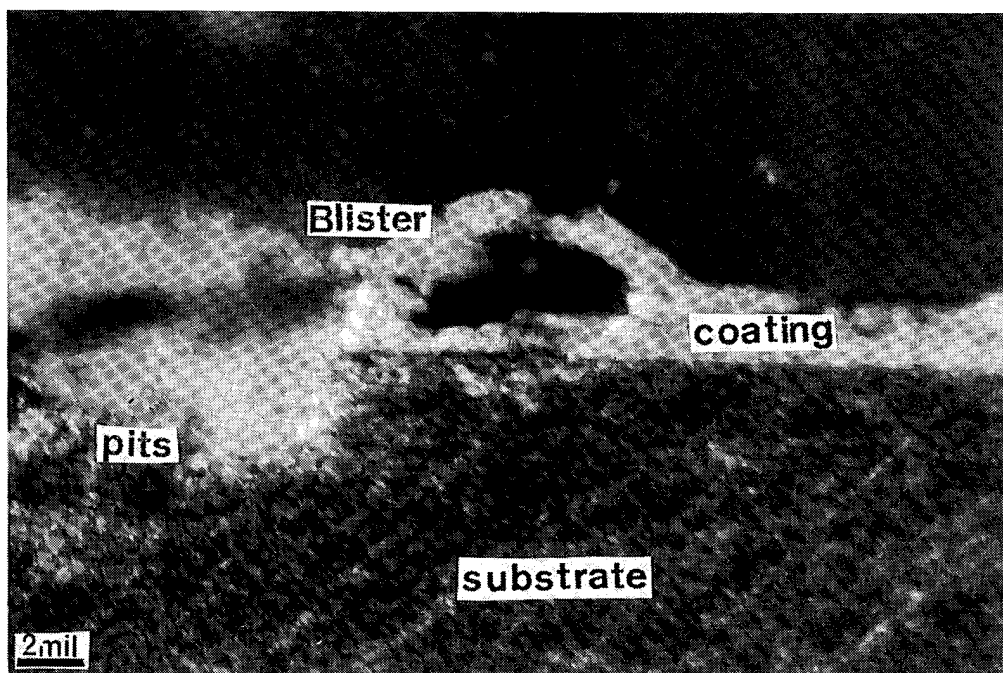
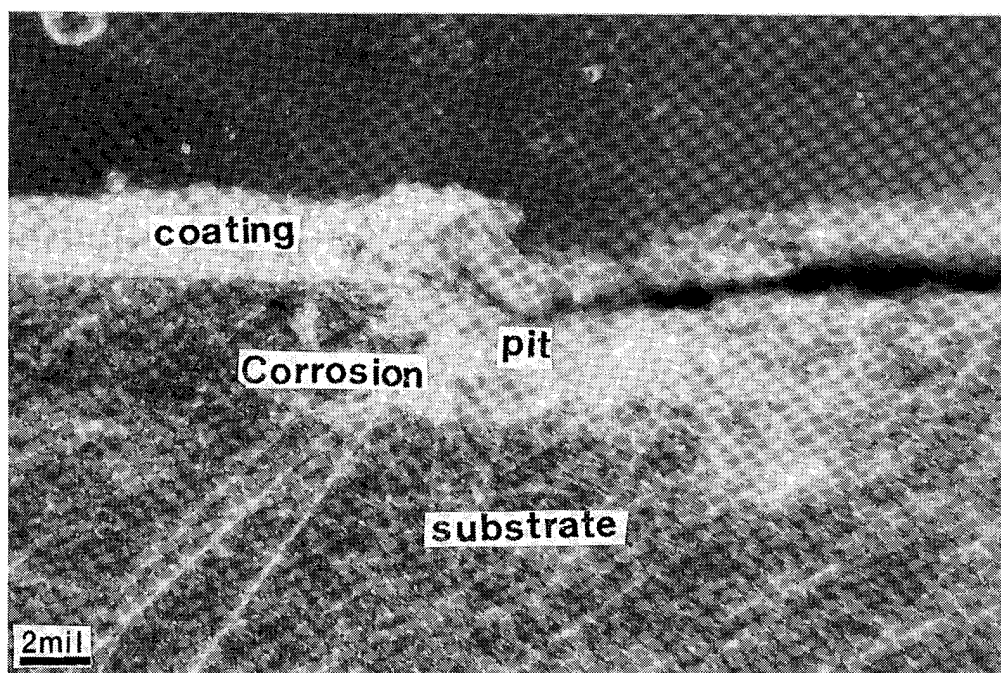
Figure 3.4. (c) Example of corrosion and salt product at defect (blister) on Sn plate and (d) same example with corrosion product removed.

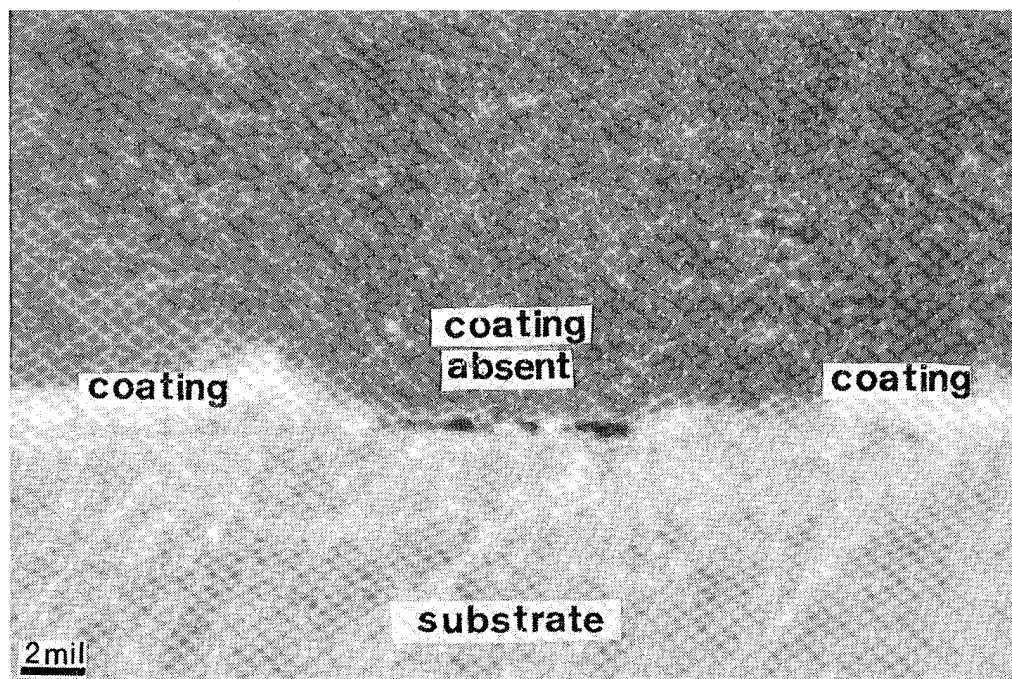
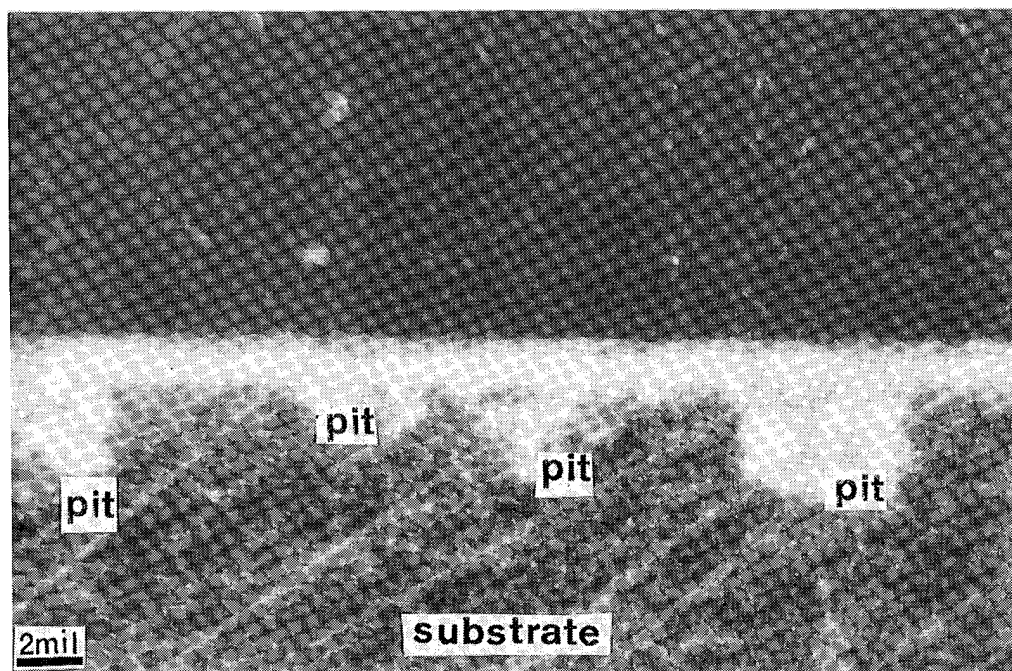
Figure 3.4. (e) Example of tin coating flaked away because of plating flaws that exaggerated corrosion of aluminum substrate and (f) pitting corrosion through tin coating and past nickel preplate.

Line A-B indicates depth of pitting into knife-edge.

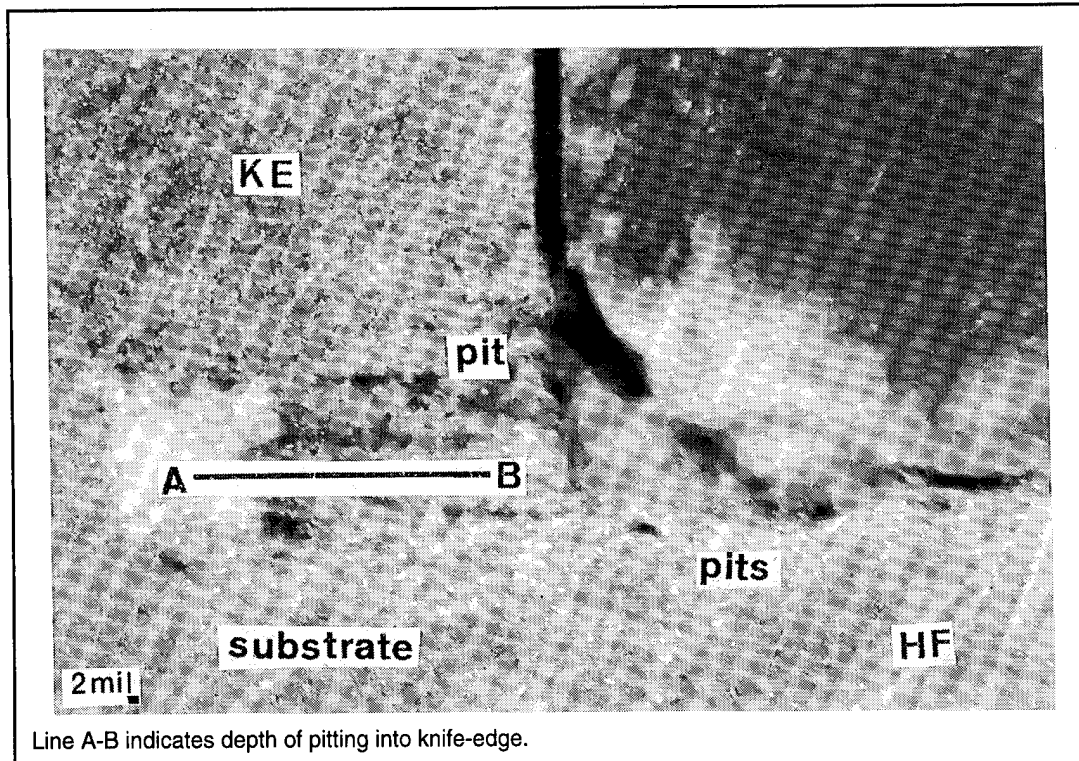
Figure 3.4. (g) Pitting corrosion in corner; cross-section shows knife-edge (KE) and half-face (HF) surfaces.

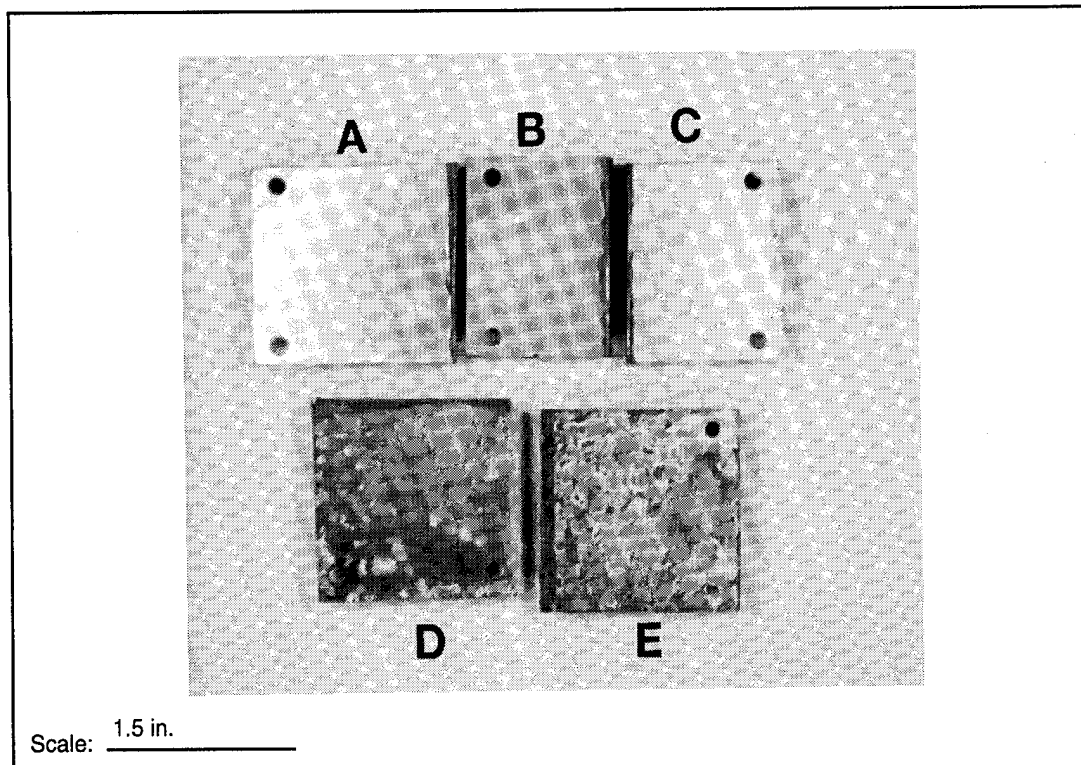
Figure 3.5. Post-salt fog test stylus electroplated samples of (A) tin coated; (B) uncoated; (C) tin coated; (D) nickel coated; and (E) copper coated.

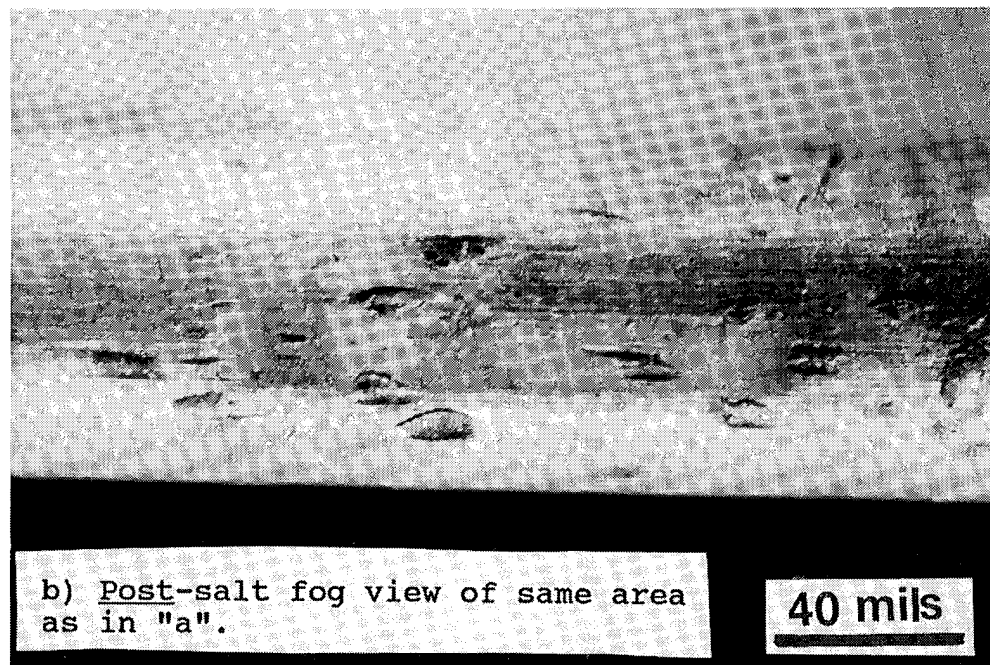
Figure 4.4. Micrograph of typical coated knife-edge samples showing the relative resistance of the coatings over intentionally gouged areas to salt fog degradation.
