Shop Talk

Some Production Plating Problems & How They Were Solved—Part 16

2. Decorative chromium plating on zinc die castings—Misplating.

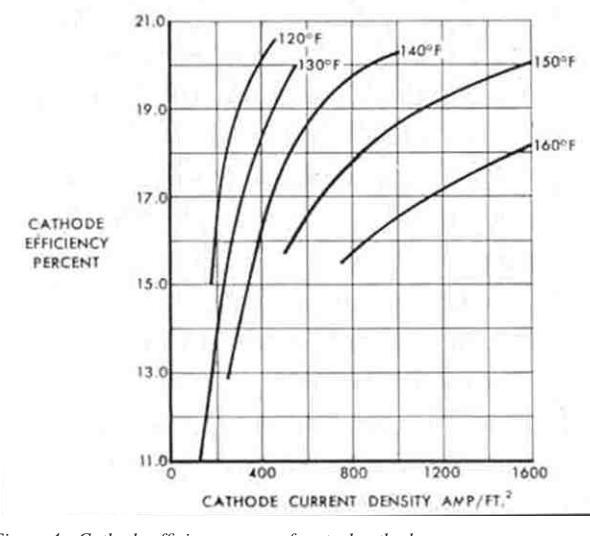
Figure 4—Cathode efficiency curves for steel cathodes.
 3.

Wednesday morning's load came out on Thursday afternoon. Thus, we started out running two loads a week. If we could have cut the plating time down from 28 to 23 hr, we would have been able to do five loads a week. However, since the motor-generator set was operating almost at full capacity, this would have had to be accomplished mainly by increasing the cathode current efficiency of the bath from the present 16.4% to 20.0%.*

According to the data, lowering the temperature from 54° C (130° F) to 49° C (120° F) would increase the efficiency from 16.4% to 18.2%. This, however, would also increase the bath resistance. Lowering the ratio from 100:1 to 75:1 would raise the efficiency to 17.7%. This would also decrease the throwing power. If both the above temperature and ratio changes were made simultaneously, the best that could be hoped for was an efficiency of 19.5%, 0.5% short of the requirement!
