Microcracks in Hard Chromium Electrodeposits

By A.R. Jones

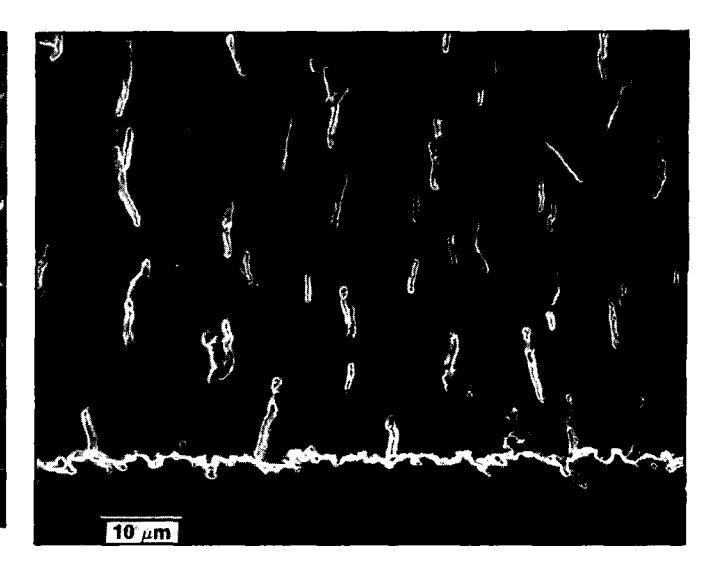
The pattern of interconnecting microcracks in Fig. 1 has about 900 cracks/cm (2200 cracks/in.). Before development by reverse-current etching, the cracks are filled with chromium or chromic oxide. Figure 2 shows an etched cross section of a microcracked chromium deposit. The formation of microcracks and how they are affected by the plating conditions are discussed in this paper, which also examines the correlation of the number of microcracks with the brightness and hardness of the deposits.

The depth of microcracks can be estimated from the gassing duration data in Table 1 and the etched cross section in Fig. 1. Table 1 data indicating that gassing persists for about 1 min while a microcrack is plated over would correspond to a chromium thickness of about 0.33 μ m (0.01 mil) at the deposition rate forth is sample. Figure 2 shows that microcracks range in depth from 5 to 10 μm (0.2 to 0.4 mil), however. The plating rate in a microcrack is greater than on the surface, therefore the microcracks are deeper than 0.33 µm. A shorter reverse etch will produce a microcrack that is shallower than 5 to 10 µm.

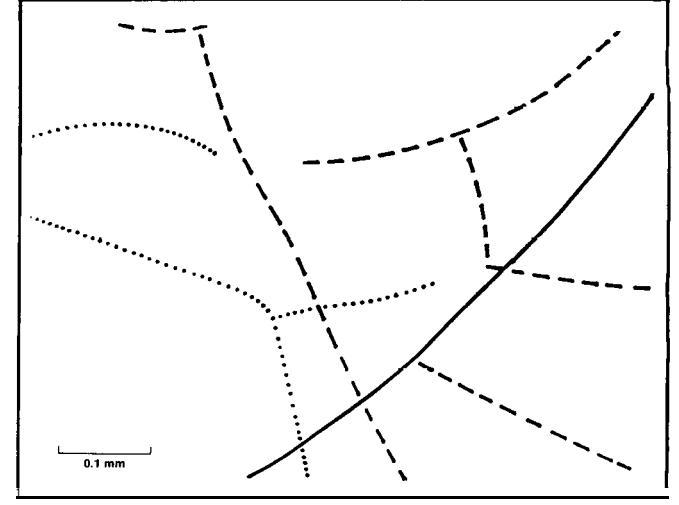
Fig. 3-Microcracks transferred from video tape; see Table 1, episodes 1 to 3.

In any single video tape frame, the microcracks that formed most recently were the most evident, but microcracks from previous episodes were visible as lighter lines. When the plating current was momentarily turned off during episode No. 4, gassing stopped and the microcracks disappeared. When the current was turned on, the same microcracks started gassing. Brittain and Smith' observed this same behavior when they interrupted the current for several hours.

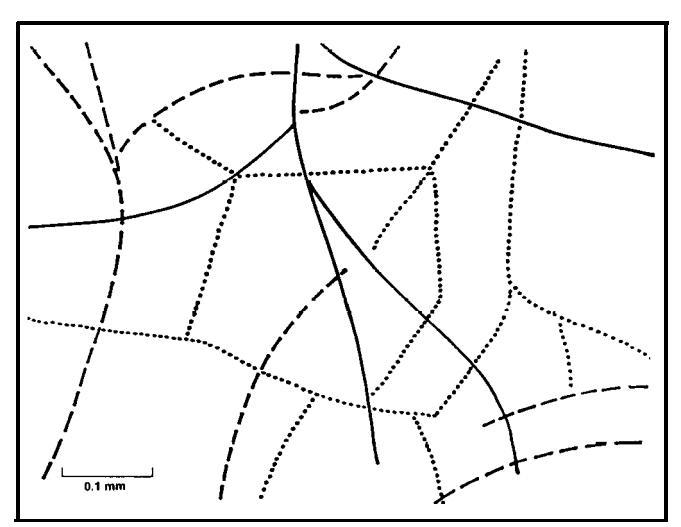
Fig. 5-Microcracks transferred from video tape; see Table 1, episodes 7 to 9.

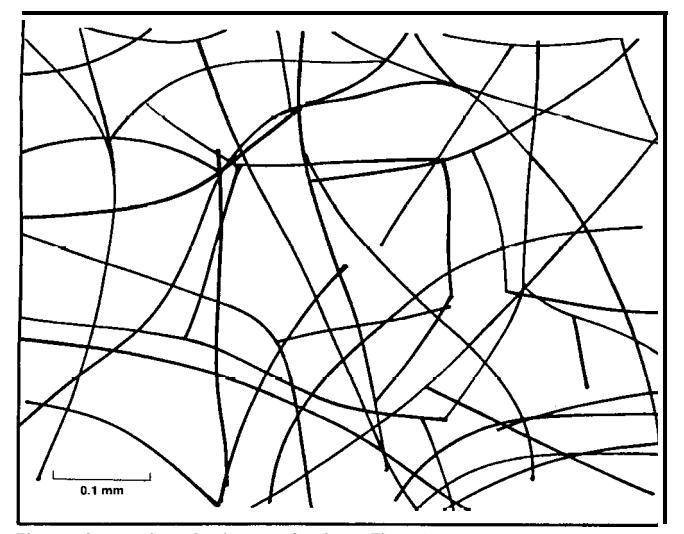
Fig. 6-Composite of microcracks from Figs. 3105.

The Fig. 6 composite obtained during a 44-min plating period shows a density of 200 microcracks/cm by comparison with a pattern of 170 microcracks/cm for this plated sample. These densities are considered to be statistically equivalent. Thus the reverse-current etch used evidently developed all of the microcracks formed during 44 min of plating. About 15 µm (0.6 mil) of chromium was deposited in 44 min of plating and about 10 µm (0.4 mil) was dissolved during the development of the microcracks. Microcrack patterns are imprinted downward as chromium is etched. Microcrack episode No. 7 covered the field of view in less than 33 msec. Thus the microcrack pattern was fully developed in this single video tape frame.

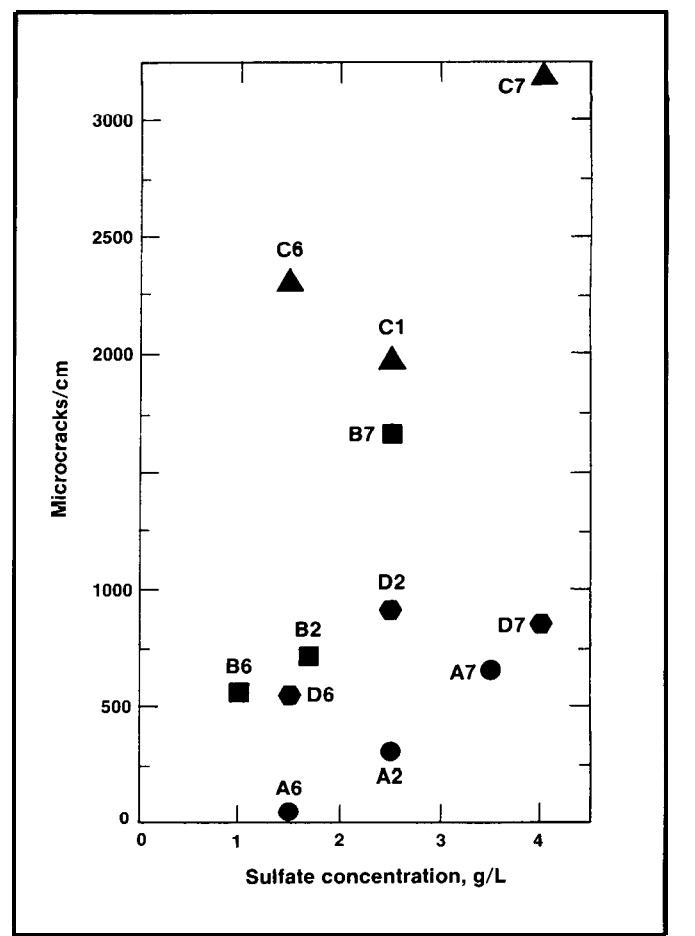
Fig. 7—Microcrack density as a function of sulfate concentration; al deposits are identified in Table 2.

data indicate that deposits from the conventional bath have the lowest number of cracks, whereas chromium deposited in the solution giving an efficiency of 25 percent[®] had the highest crack count—about twice as many as the deposits from any other bath. Figure 7 shows that increasing the sulfate concentration resulted in an increase in microcrack density, especially for the mixed catalyst and 25-percent baths.

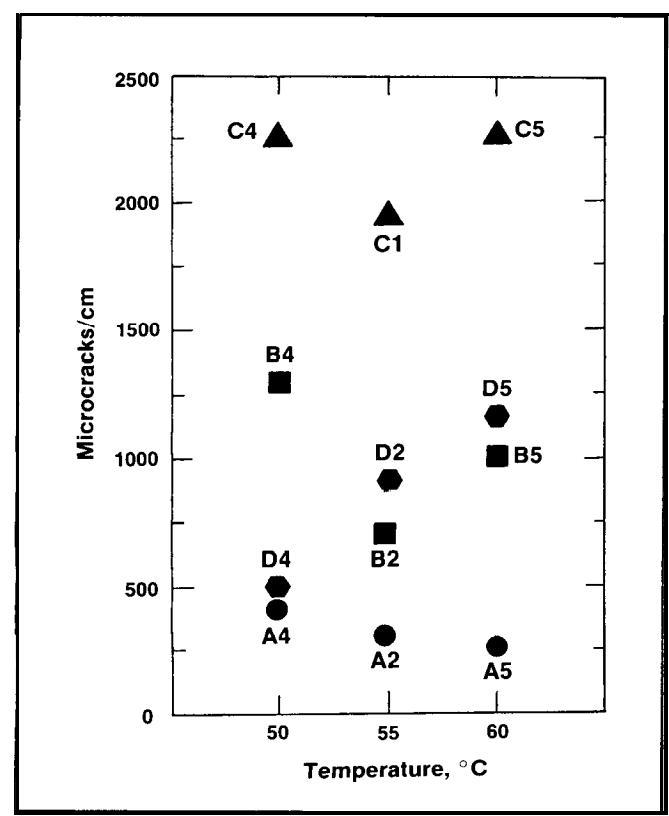
Fig. 8—Microcrack density as a function of bath temperature; deposits are identified in Table 2.

Figure 8 shows the effects of changing the temperature on the density of microcracks; Fig. 9 reports the results of increasing the current density. The microcrack density in deposits from the conventional bath increased from less than 4 to 300 microcracks/cm as the current density increased from 8 to 16 A/dm².

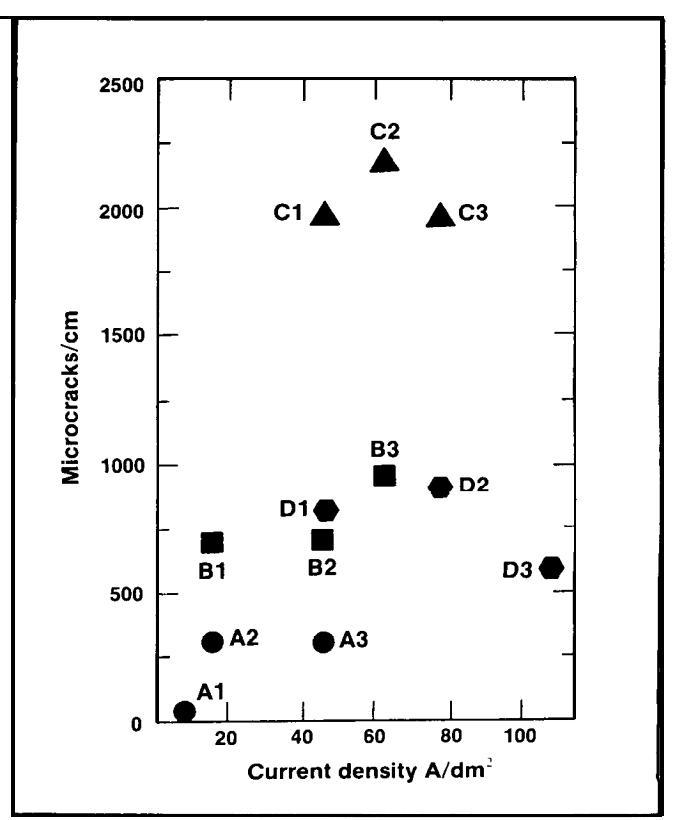
Fig. 9—Microcrack density as a function of current density; deposits are dentified in Table 2.

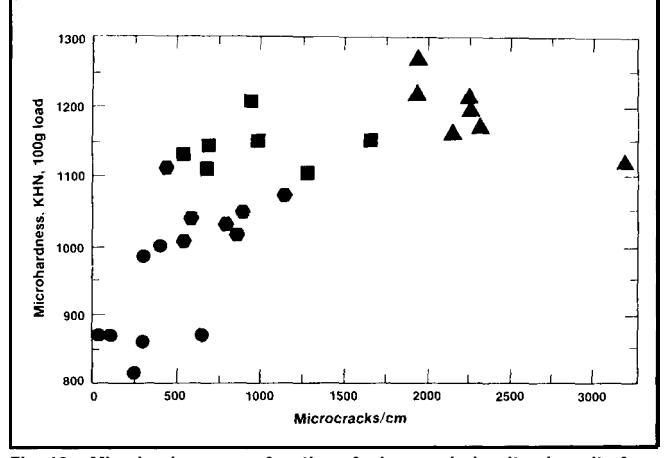
Fig. 10— Microhardness as a function of microcrack density; deposits from conventional bath shown by solid circles; squares show deposits from the mixed catalyst bath; triangles designate deposits from the 25 percent bath and hexagonals show deposits from the 40 percent bath.

The data in Fig. 10 shows a general trend of increasing microhardness with an increasing microcrack density. However, the increases in both microhardness and microcrack density relate to the chemistry of the solutions. Chromium deposited in the conventional bath was relatively low in both microcrack count and microhardness, whereas deposits from the 25-percent bath were high in both cases.

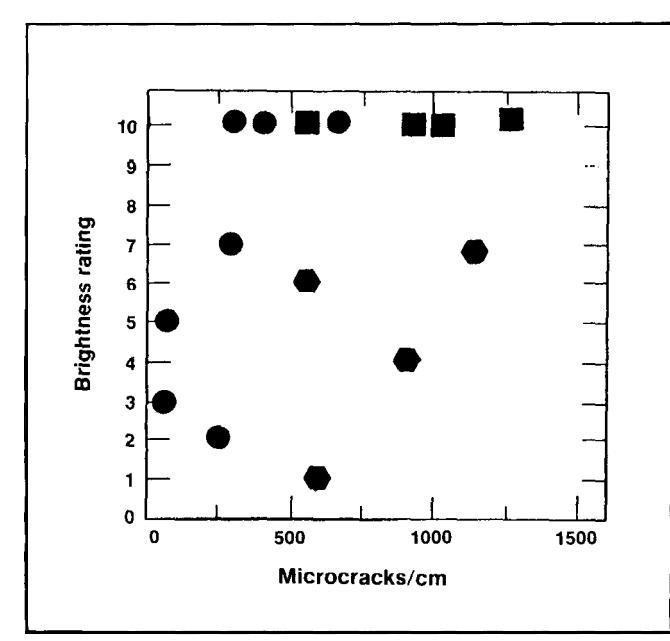
Fig. 11 —Data points for brightness and microcrack density; symbols are described in the Fig. 10 caption.

The scatter of points in Fig. 11 indicates that there was no correlation between microcrack density and brightness. Deposits from the mixed catalyst bath appeared consistently bright, whereas chromium deposited in the conventional and 40-percent baths had varied in appearance depending upon plating conditions.
