Improving Your — Chloride Zinc Plating Operation _

By Stephen Schneider

Learn to recognize problem areas, then swiftly institute corrective measures.

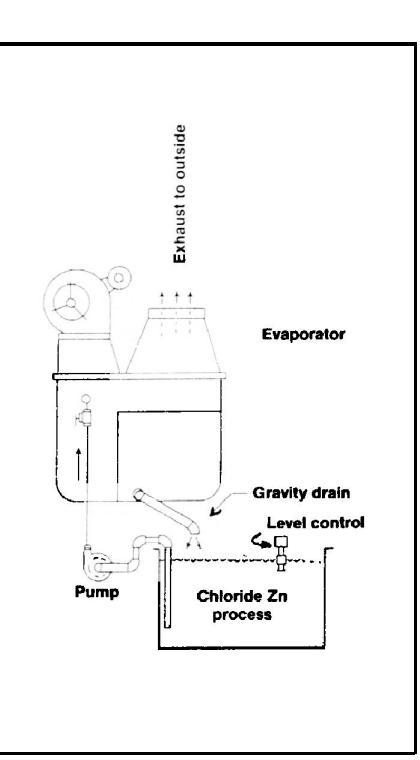
Fig. 1 —Atmospheric evaporator for controlling solution "growth." (Courtesy Poly Products Corp., Atwood, CA)

4. Use an atmospheric evaporator activated by a solution level control (Fig. 1). Depending on the prevailing humidity, at room temperature these units will evaporate 5 to 15 gal/hr, which will more than compensate for

solution growth. A low-foaming bath must be employed.

Two additional benefits of evaporators are that they treat iron through aeration and they cool the bath to reduce or eliminate the need for cooling water or chilling.

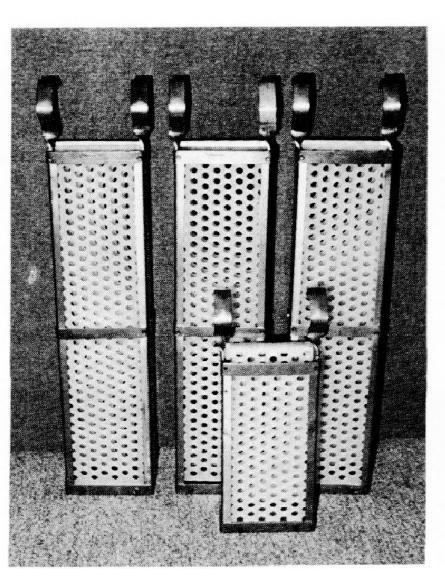
Fig. 2—Titanium anode baskets with perforated polypropylene panels combat deterioration problem.

Titanium anode baskets with perforated polypropylene panels in place of expanded titanium mesh are available (Fig. 2). These are becoming quite popular because they practically eliminate the deterioration problem, even at elevated voltage.

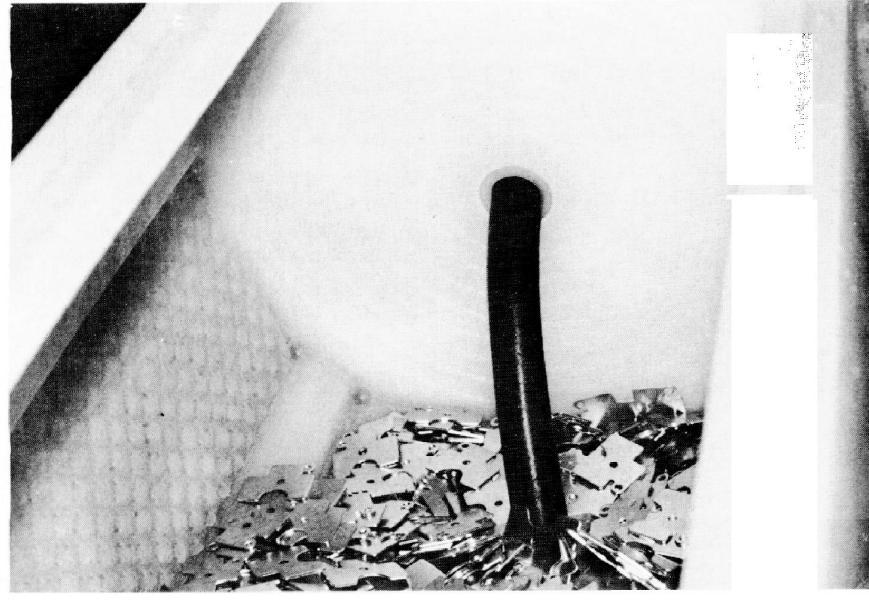
Fig. 3-Barrel welds should be checked for solution bleedout.

• Barrel Bleedout: This recently discovered cause of bare spots looks just like a chromate slough-off problem on barrel-plated parts, but it's not. Cracks or porosity in barrels can result from imperfect welds or equipment aging. Solution from cleaning, pickling, plating, and chromating can accumulate in the panel welds and slowly bleed out on the parts under the load stand. This will readily leach any chromate film. The phenomenon is immediately apparent on color chromated work, but only shows up in storage through white corrosion on clear chromated parts. Because the solution that bleeds out of the welds is dilute and clear, it is normally not apparent to the naked eye (Fig. 3).

To determine whether such a problem exists, leave the barrel rotating overnight in a rinse tank with 0.5 oz/gal black dye. Follow this with a rinse; trapped solution should show through the polypropylene. An alternative test is to spray methyl orange indicator on the barrel welds at the load stand and see if any red color change occurs. Bleedout solution is normally clear and acidic. Also, examine the barrels after weekend shutdowns for evidence of "salting" around the welds, indicative of the problem.
