Making Direct Contact

A plastic anode basket can help improve plating performance . . .

By VERN MEHLER Anode Systems South Bend, Indiana

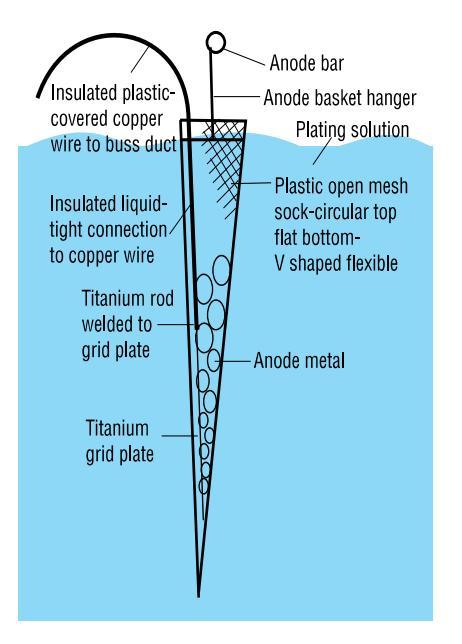
1. ANODE BASKET design for consistent conductivity during plating

So how do you eliminate these problems? You build a new type of anode basket. As an example, let's construct a simple ball-type anode basket. Start with a non-flattened expanded titanium grid plate about three-by-24 inches and weld a stub piece of titanium rod to the center. Connect a length of insulated copper wire to the titanium rod by means of a special submersible insulated connection.

Then fabricate a special open-mesh plastic sock with an open top and a flat, V-shaped closed bottom. The titanium grid plate is inserted into the sock and the sock is suspended above the plating tank with the grid plate under the solution level and the wire running outside the plating tank to the electrical bus. The wire is connected to the bus through a fusible link that operates as a safety device. Anodes are added to the sock in such a way to orient the titanium guide plate between the anode metal and the work to be plated. (Fig. 1.)

The wire is directed from the copper bus outside the plating tank to the center of the titanium grid plate, eliminating any electrical connection above the plating tank. This also eliminates cleaning the connection, hot spots, electrical connection resistance, intermittent contacts, electrical burning, and pitting. This also allows a much higher current-carrying capacity.

As anode metal (zinc balls) is added to the basket, the additional weight stretches the plastic sock, wedging the balls into the titanium grid. The sharp edges of the non-flattened titanium easily cut through any oxide or dirt accumulation, assuring good contact. As the anode metal dissolves and its size decreases, it continuously drops lower into the plastic "V" notch, where it is still pushed into the grid plate to assure good contact.
