## Advice & Counsel

Corroding Away-Part I

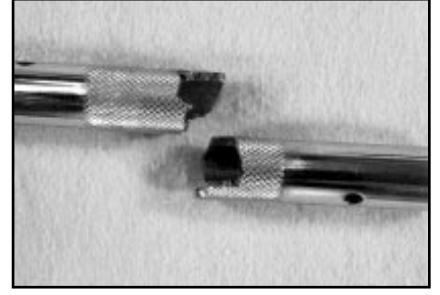
he last month seems to have ⊥ yielded a spate of corrosionrelated problems. The first problem came very close to home when I visited my boat and found a turnbuckle snapped (Fig. 1). It seems the boatyard installed a nickel-chromiumplated brass turnbuckle on my "baby stay" (a small cable that runs from about the middle of the mast of a sailboat to the deck). Brass is a poor choice of material for any application involving high tensile stress and a corrosive environment, because of its high sensitivity to stress corrosion failures. Sure enough, this brass turnbuckle evidenced intergranular brittle failure (Fig. 2) typical of stress corrosion. The correction is to replace the part with a material more suitable to the high seas (stainless steel).

Fig. 1-Snapped turnbuckle.

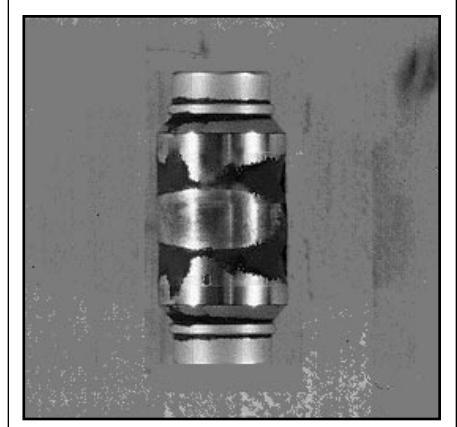
mium-plated areas. Etching of metal became evident only after several months of tooling processing and repeated cleaning. The "corrosion" appeared to be concentrated to areas that were cavities or recessed areas on the tooling, whether chromium-plated or not (Fig. 3). A definite line of demarcation was visible where the tooling was mounted into the molding plate, with no etching present on areas where the tooling was mounted into the plate, but severe etching immediately above the joint between the plate and the tooling.

Fig. 3-Concentrated corrosion

By Stray Currents? Stainless steel and chromium plating are soluble in alkaline solutions, when subjected to anodic DC current. Stray current could therefore cause attack of the metals. The attack, however, would be concentrated on sharp edges and ridges, which is the opposite of the observed attack (at crevices). Further, company efforts at measuring stray currents failed to detect significant levels.

Was this Chemical Attack? Stainless steels and chromium plating are not subject to chemical attack by alkaline cleaning solutions, in the absence of stray currents or dissimilar metals. Further, chemical attack would manifest itself uniformly, while the experienced attack was very localized. Was this Caused By the Ultrasonics? Stainless steels and chromium electroplate are resistant to corrosive attack by alkaline solutions, as long as a thin oxide film (which forms instantly when cleaned stainless steel or chromium is exposed to air) is present on the surface of these metals. It is possible to apply an excessive amount of cavitation intensity\* in an ultrasonic cleaning tank, resulting in the destruction of the protective oxide film. The resulting erosion of the metal will occur over a long period of time, and would be concentrated at cavities, where sonication is at a maximum concentration.

We suspect that the current operating practice of applying 40 watts/gal, for a 200-gal cleaning tank is producing an erosion of the metal in areas of maximum cavitation (recessed areas and cavities). The ultrasonic power applied to the tooling in this tank should be reduced to 20 watts/gal. *PasF*

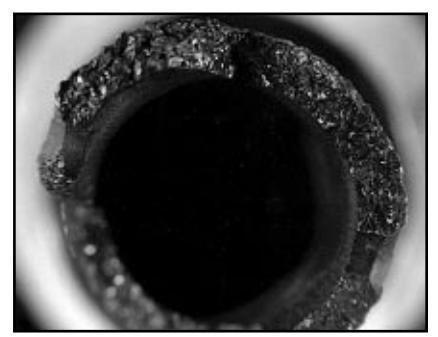
Fig. 2—Granular brittle failure.
