Can a Plating Shop Operate Without Vapor Degreasers-Even for Wax Coatings?

By Carol Eden

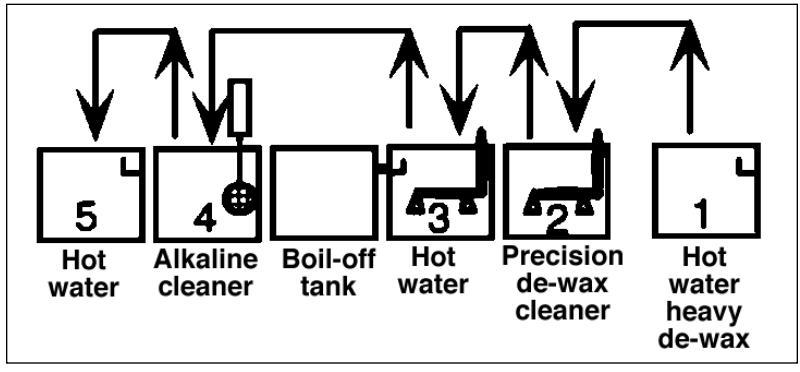
Fig. 1—Experimental de-wax line at United Airlines.

The first two methods were ruled out, but the third was chosen for a try. The process, however, was modified to fit United's needs. An experimental dewax line was built using the following steps (see Fig. 1):

- (1) Hot water heavy wax removal
- (2) Chemical de-wax tank
- (3) Hot water rinse
- (4) Alkaline cleaner
- (5) Hot water rinse

In all, six tanks were used, but one was a boil-off tank to prevent the dewax chemical from flowing into the waste treatment system.

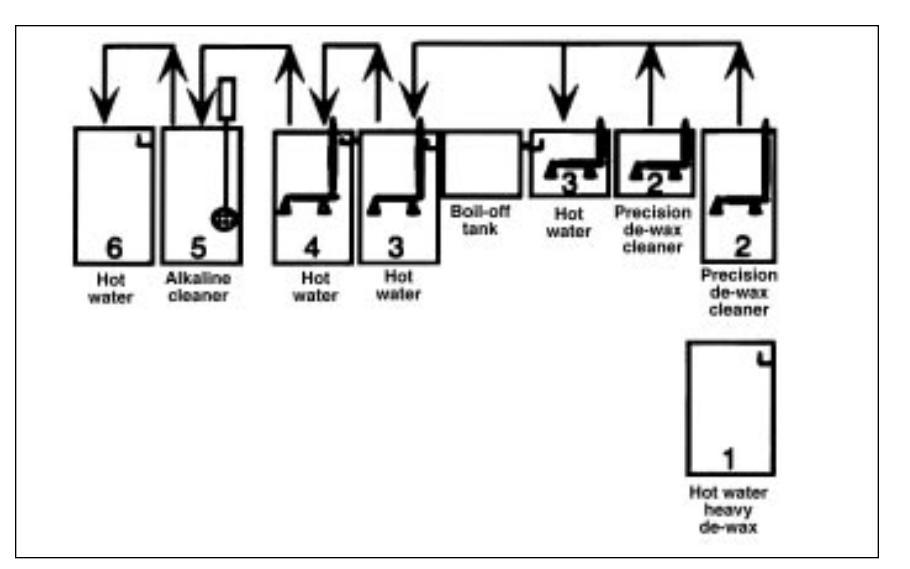
Fig 2—Current de-wax line at United Airlines.

The process flow of the current dewax line is (see Fig. 2):

- (1) Hot water wax removal
- (2) Chemical wax removal (two tanks)
- (3) First hot water rinse (two tanks)
- (4) Second hot water rinse
- (5) Non-etch alkaline cleaner
- (6) Hot water rinse

Figure 2 shows the experimental tanks and boil-off tank still on the line. There are also some tanks with spargers and one mixer included.
