The Effect of Electrolyte on the Anodized Finish Of a Magnesium Alloy

By T.F. Barton and C.B. Johnson

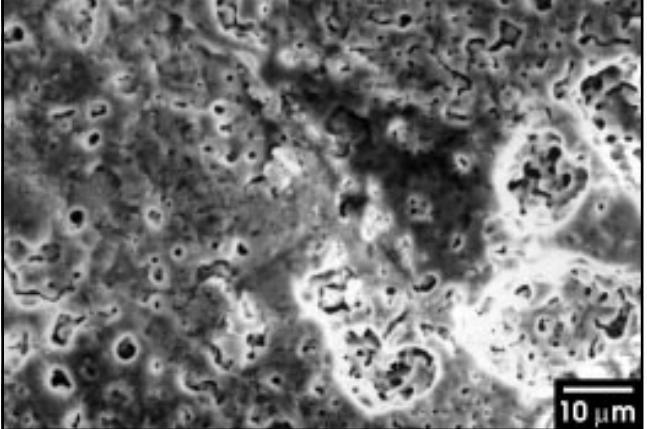
Fig. 1—SEM photomicrograph of the porous surface of magnesium anodized in 3 M sodium hydroxide solution containing 0.15 M sodium fluoride.

A visual examination of the surface of the anodized electrodes was conducted (Fig. 1, Table 1). The anodized coatings ranged from nearly transparent, colorless films to opaque gray. Some coatings were very smooth; others were patchy, although all were porous on a microscopic scale. In the more translucent coatings, non-uniformities in color on the surface because of poor surface pretreatment were visible. Properly abraded and cleaned surfaces generally gave uniformly colored coatings. Anodization in sodium hydroxide, with no other additional electrolyte, produced a nearly transparent coating. Fluoride and phosphate additions to the electrolyte resulted in the smoothest and most uniformly opaque coatings, gray in color. Aluminate and tetraborate additions produced whiter, but patchier, coatings. Pitting was evident on those anodes that had fixed sparks occur during anodization. The large extent of pitting that occurred during anodization in sodium iodide did not permit that experiment to be taken to completion.

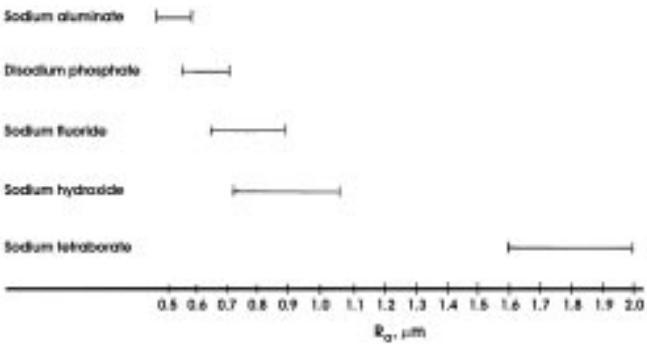
Fig. 2—The effect of electrolyte on the surface roughness of anodized magnesium.

Surface roughness measurements were conducted on representative anodized samples, using a diamond stylus technique. The results are shown in Fig. 2. The order of increasing roughness for samples was aluminate < phosphate < fluoride

< hydroxide << tetraborate, although there was considerable overlap in measurements among the first four samples. Local defects were noted on several of the samples that did not contribute to the roughness measurement value significantly, but did address sample uniformity.

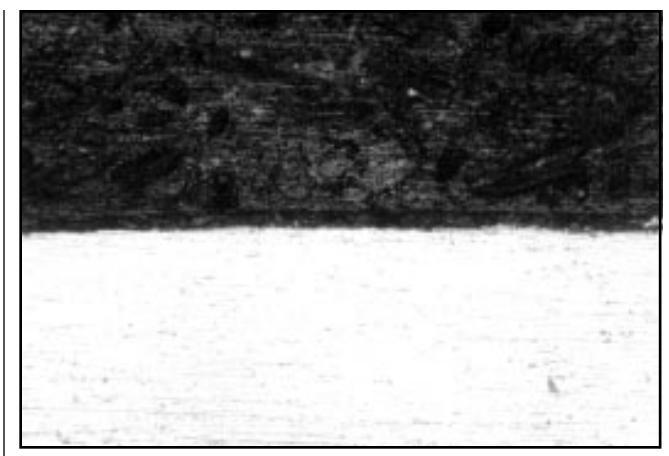
Fig. 3—Optical photomicrograph of a cross-section of magnesium anodized in 3 M sodium hydroxide solution containing 0.15 M sodium aluminate. 500X.

Coating thickness measurements were conducted on crosssectioned, mounted samples using optical photomicrographs and a calibration gauge. Photos of a representative sample are shown in Fig. 3. The thickness values are listed in Table 2. From these results, it is obvious that only some electrolytes contribute to layers of significant thickness. Aluminate and tetraborate produced measurable layers under these conditions, although the thickness of the tetraborate layer varied greatly over the surface of the anode. Other electrolytes, such as phosphate and fluoride, did not produce a layer of sufficient thickness to be measured optically, although all evidence pointed to a surface film of some type.

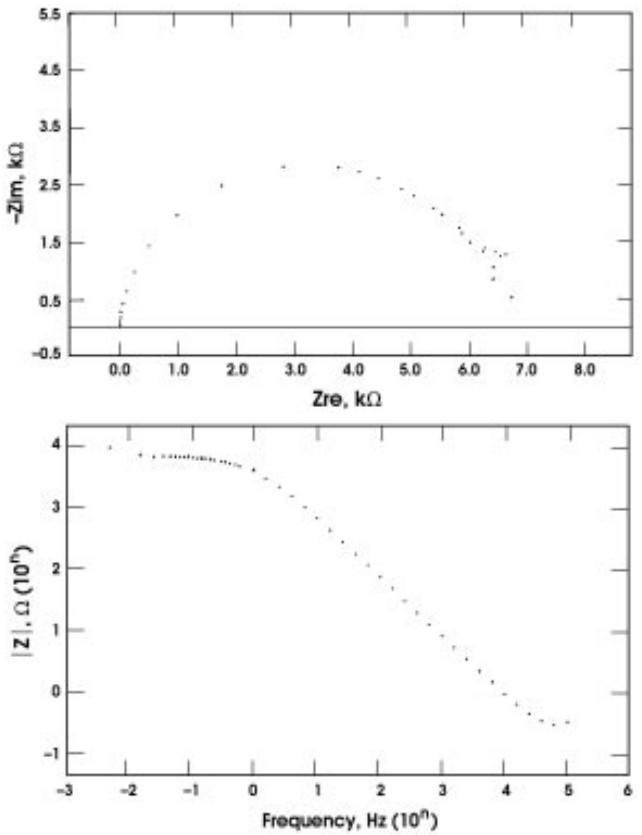
Fig. 4—(a) Nyquist and (b) Bode plots for electro-chemical impedance data generated for a non-anodized magnesium electrode in 0.1 M sodium perchlorate solution at -1.5 V vs. SCE.

The EIS data of the anodized samples could be fitted to a simple Randles circuit with reasonable accuracy.⁵ The data corresponded well to a planar capacitor as the sole frequency-dependent component (based on information in the shape of the Bode and Nyquist plots, Fig. 4). This was despite the fact that microscopic examination showed that the surface film on all the anodized samples was porous. The EIS response was probably not influenced by film porosity inasmuch as the pores were of large diameter compared to the thickness of the film.
