The Effect of Solution Age on Corrosion Resistance Of Electroless Nickel Deposits

By R.N. Duncan

This paper* describes the results of tests, conducted to quantify how the age of the plating solution affects the corrosion resistance and other properties of a high phosphorus, electroless nickel deposit. Specifically, the composition, internal stress, ductility, corrosion protection and chemical resistance of the coating were investigated, along with the bath's plating and contaminant buildup rates. The paper also describes tests conducted to establish the effect of orthophosphite and sulfate accumulation and suggests possible causes for the changes observed.

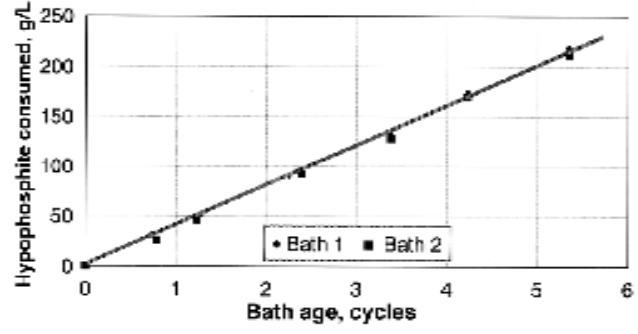
Fig. 1-Effect of bath age on hypophosphite consumption.

These tests showed a linear consumption of hypophosphite and production of orthophosphite over bath life. During each cycle of operation, 40.5 g of sodium hypophosphite were used, as shown in Fig. 1. This is equivalent to 5.6 g of hypophosphite per gram of nickel reduced, or about 3 moles per mole. The average efficiency of the baths, consequently, was 33 percent (based upon conventionally accepted deposition reactions), which is typical for most acid electroless nickel formulations.

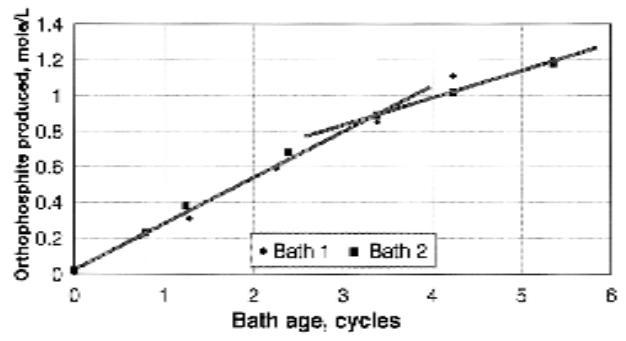
Fig. 2—Effect of bath age on orthophosphite production.

For the first three cycles of operation, the production of orthophosphite was linear at 0.26 mole per cycle. After that, however, the build-up rate declined and, between the fourth and fifth cycles, was only about 0.20 mole per cycle. This change is shown in Fig. 2. No other change in the bath chemistry was observed that would explain this reduction. The oxidation of hypophosphite did not slow, nor was there any evidence that the missing phosphite precipitated as an alkali or nickel salt. Although the rate of phosphorus deposition did increase during this period, the change was not large enough to account for all of the lower orthophosphite production.

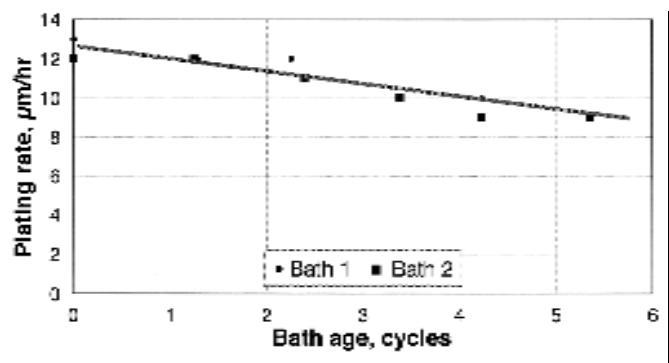
Fig. 3—Effect of bath age on plating rate.

As with most electroless nickel solutions, the plating rate of the baths declined as they were used. With the new baths, the plating rate was about 12 μ m/hr. After the first cycle, however, the rate began to fall, and by 5 cycles it had settled to 9 μ m/hr. This change is illustrated by Fig. 3. No attempt was made to maintain the rate at a higher level by increasing the pH or temperature, because this action might have also changed the properties of the deposits.

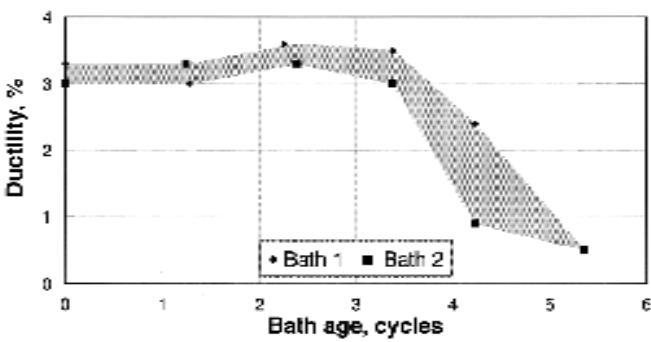
Fig. 6—Effect of bath age on deposit ductility.

The relationship of ductility and age of the coatings is illustrated by Fig. 6. It was observed to be the reverse of that of stress. Through the first three cycles, the bending ductility of the deposits was constant at about 3 percent as elongation. It then began to decline, reaching values of less than 0.5 percent by the fifth cycle of age.

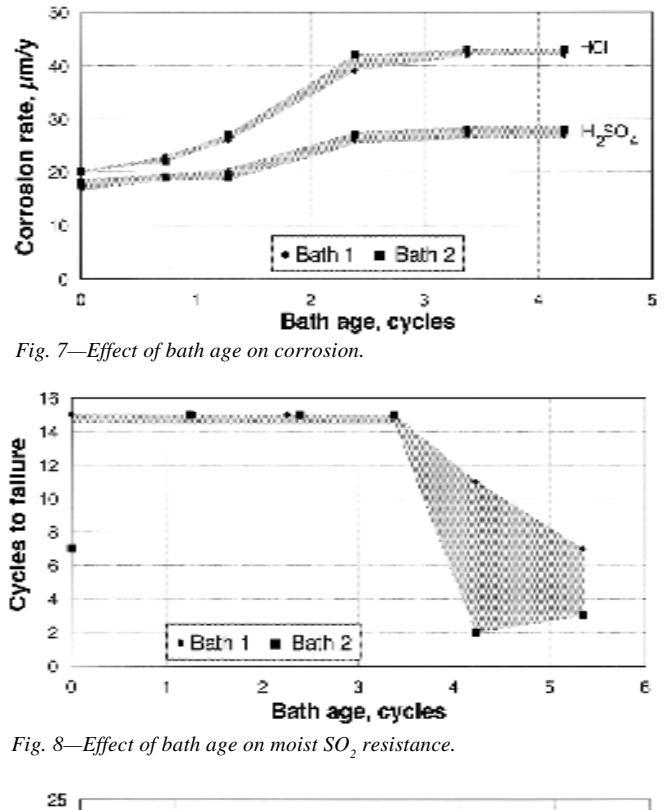
Chemical resistance and corrosion protection were found to be different properties, which are not directly related to each other. The chemical resistance of the coatings began to decline as soon as the baths were used and showed a distinct reduction between the first and second turnovers. During the latter part of bath life, the chemical corrosion of the deposits in both reducing and oxidizing acids appeared to stabilize. These changes are shown in Fig. 7.

Corrosion protection, on the other hand, followed the same transitional patterns as stress and ductility. During the first three turnovers, with one exception, the deposits consistently provided more than 15 cycles of Kesternich resistance, which is considered superior. As illustrated in Fig. 8, after the third turnover, the Kesternich resistance of the coatings began to decline, reaching values as low as 2 to 3 cycles. This pattern was also the reverse of that of the deposit stress.

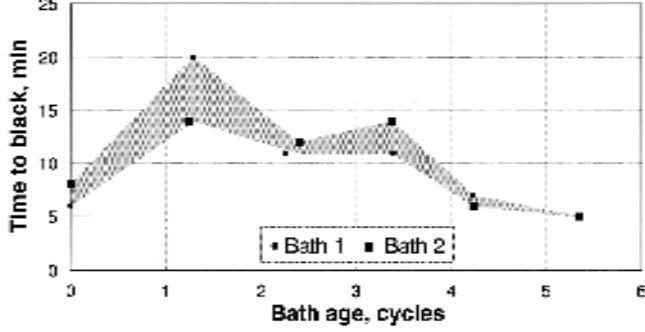
Fig. 9—Effect of bath age on nitric acid resistance.

The passivity of the electroless nickel deposits was found to be similar to their chemical resistance. All of the test specimens passed a one-min nitric acid exposure, showing no discoloration. As shown in Fig. 9, however, the time required for the deposits to blacken showed a steady decline after the first cycle, similar to the increased corrosion that the coatings experienced in hydrochloric and sulfuric acids.

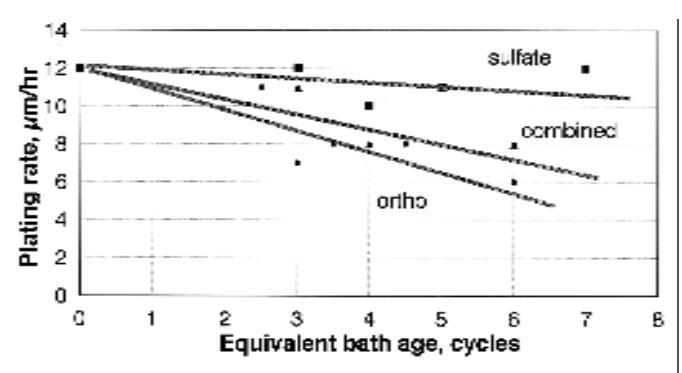
Fig. 10-Effect of salt additions on plating rate.

To provide a better understanding of some of these changes, another experiment was conducted. A series of plating solutions from the same formulation previously tested were made up in 2-L beakers, heated on hot plates and agitated with magnetic stirrers. To these solutions, measured amounts of orthophosphite [as $H_2(HPO_3)$ neutralized with sodium hydroxide] and sodium sulfate were added. The plating rate of the solutions and the internal stress of their deposits were then measured. The concentrations of the salts added and the results of these tests are summarized in the table. Also shown in this table are the results of a similar experiment reported by Linka and Riedel using the same electroless nickel formulation.⁸ The results of both tests are also shown in Figs. 10 and 11.

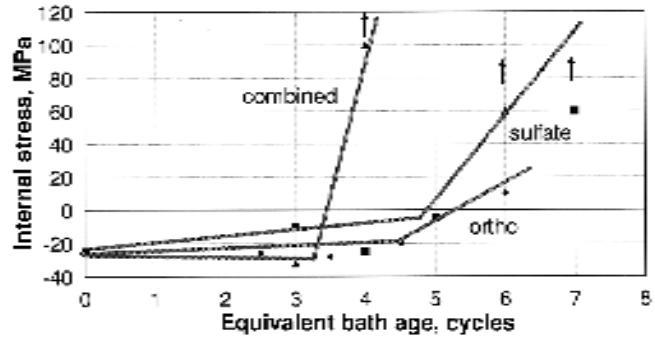
Fig. 11—Effect of salt additions on deposit stress.

Both groups of experiments showed the same rapid shift from compressive to tensile stress observed with baths aged naturally. Tensile stresses were produced, but only after the equivalent of about six cycles of either orthophosphite or sulfate was added to the test solutions. Based upon this result, it appears likely that neither salt by itself is the cause of this phenomenon.

When a combination of the two salts was added to the solution, however, much smaller amounts were needed to cause the loss of compressive stress. The shift occurred at the equivalent of between 3 and 4 cycles of operation, which was similar to that observed with the naturally aged solution.
