The Use of Synthetic Hydrotalcite as a Chloride Ion Getter for a Barrier Aluminum Anodization Process

By J.K.G. Panitz, D.J. Sharp and Brian Melody

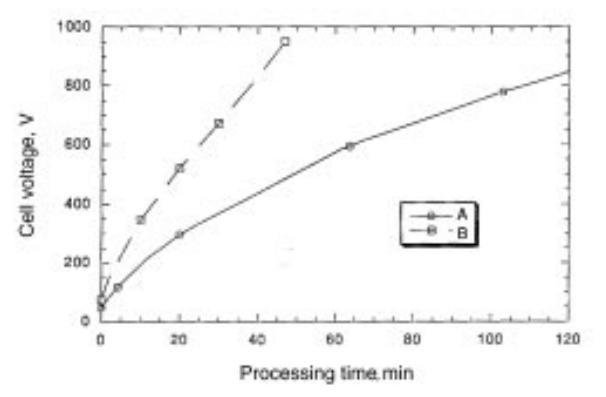
Fig. 1—Representative processing times for a solution of ammonium tartrate and water with 6061-T6 aluminum alloy coupons: Curve A, first run; curve B, fourth run in this bath.

During the first phase of this study, the baseline performance of the ammonium tartrate and water electrolyte was observed.⁴ Figure 1 shows typical run times which become shorter and approach a reproducible value as the bath is reused. Figure 2 shows flaws that frequently form on substrates anodized in freshly prepared baths.

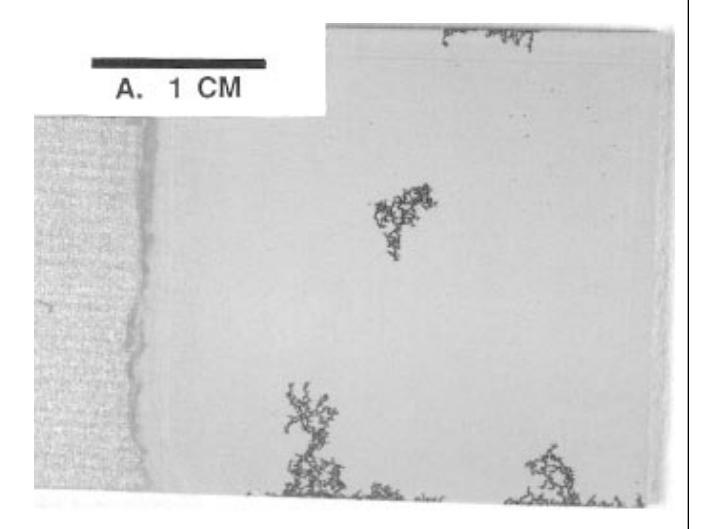
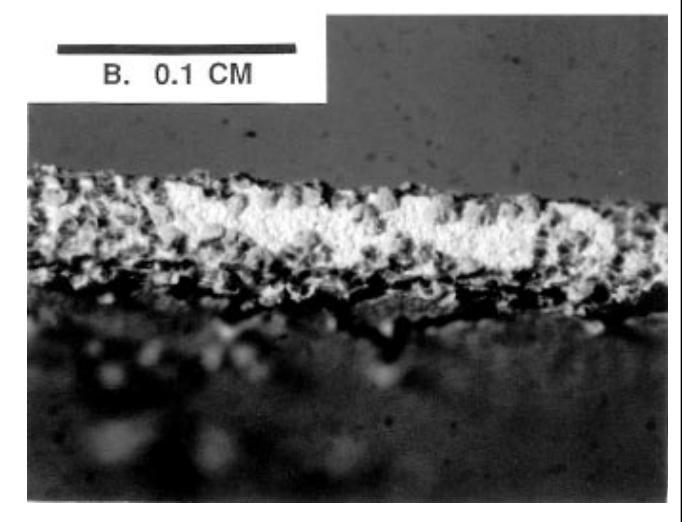
Fig. 2—A massively flawed coating formed in freshly mixed electrolyte: A, surface; B, area along an edge at one of the three sites where macroscopic trails of defects appear to have originated from a high electric field site at an exterior corner.

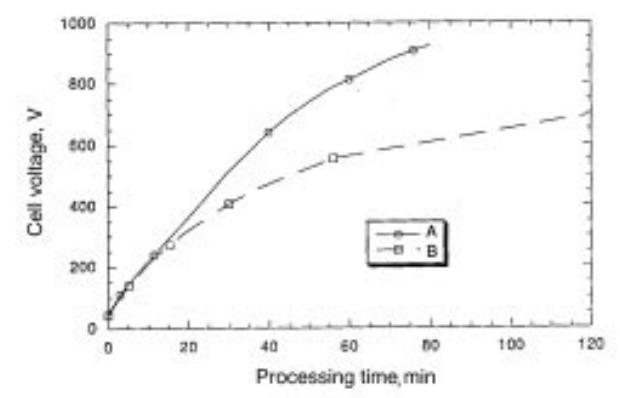
Fig. 3—Representative processing times for a bath containing synthetic hydrotalcite. Here a powder plus isopropanol paste was prepared and stirred directly into a freshly mixed bath; rectangular coupons were used as substrates. Curve A, first run in a relatively short processing time for a freshly mixed bath; curve B, second run, where the powder has formed a thick scum on the surface of the bath.

After observing the performance of a baseline aqueous ammonium tartrate bath, a new 450 cc, 50 Kohm-cm bath was prepared and stirred in a paste with 1 g synthetic hydrotalcite powder and 2 g isopropanol. Bath resistivity did not change as a result of this addition. Some powder sank to the bottom, some went into suspension, especially when the bath was agitated. A trace amount floated to the top of the bath. The first anodization run in a fresh bath with synthetic hydrotalcite was substantially faster than the first run in a fresh bath without synthetic hydrotalcite. (Compare Fig. 3, curve A, to Fig. 1, curve A.) The second anodization run in the bath with

synthetic hydrotalcite (Fig. 3, curve B) required substantially more time to reach a cell voltage of 950 V. The problem was apparent: Substantial amounts of synthetic hydrotalcite powder had floated to the top of the bath. A thick paste formed that extended the meniscus region on the substrate and impeded acceptable coating growth. The coating in the meniscus region was visibly flawed.

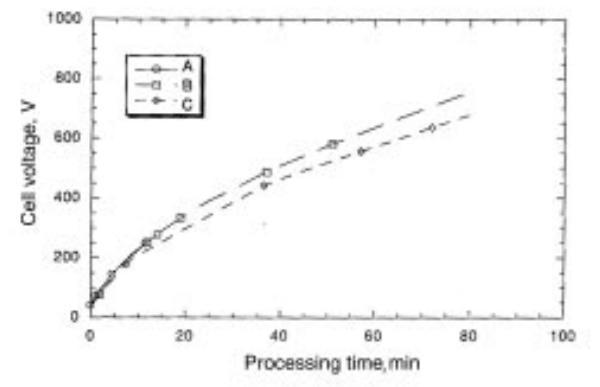
Fig. 4—Processing times for the second series of experiments in a control bath with no synthetic hydrotalcite. Substrates with non-filed edges and tails extended out of the electrolyte. Processing times were long, in part, because of metal burrs on the non-filed substrate edges. Curve A, first run; curve B, second run; curve C, third run.

These problems suggested two opportunities for process improvement: (1) change the shape of the substrate to reduce substrate area in the meniscus region and (2) restrain the synthetic hydrotalcite powder in a filter bag. Figures 4 and 5 show the results of making these two modifications. Figure 4 shows three voltage ramp rates typical of processes performed in a bath containing no chloride ion getter with 2 x 2 cm substrates with a 0.25-wide tail for electrical contact. Figure 5 shows three voltage ramp rates typical of processes performed in a bath containing 1 g of dry powder in a nylon filter bag and using tailed substrates.

average process time is longer here than for similar runs performed with rectangular coupons (compare Fig. 4 and Fig. 1). The substrates were cut from sheet stock, using hand shears, then ground to remove a ragged edge along the interior curve leading into the tail. The grinding process left a sharp burr along the edge that was difficult to anodize. The tailed substrates prepared for the remainder of this study were hand-filed to remove the troublesome burr.

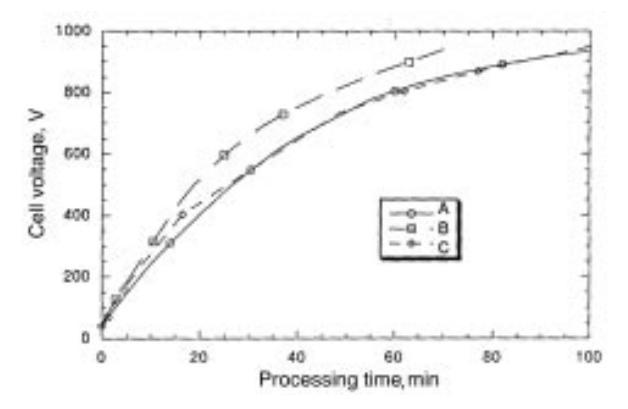
Fig. 5—Processing times for the second series of experiments in a bath with synthetic hydrotalcite powder in a nylon filter bag. Substrates with non-filed edges and tails extended out of the electrolyte. Shorter processing times are shown to occur consistently when the bagged chloride getter is added to the bath. Curve A, first run; curve B, second run; curve C, third run.

Three comments can be made regarding the process modifications. First, the run times for the bath with the chloride getter are shorter than the run times for the bath with no getter. Second, the nylon filter bag was able to keep gross amounts of synthetic hydrotalcite powder from escaping to the surface of the bath, forming a surface suspension and lengthening process times as the bath was stored and reused. Third, the

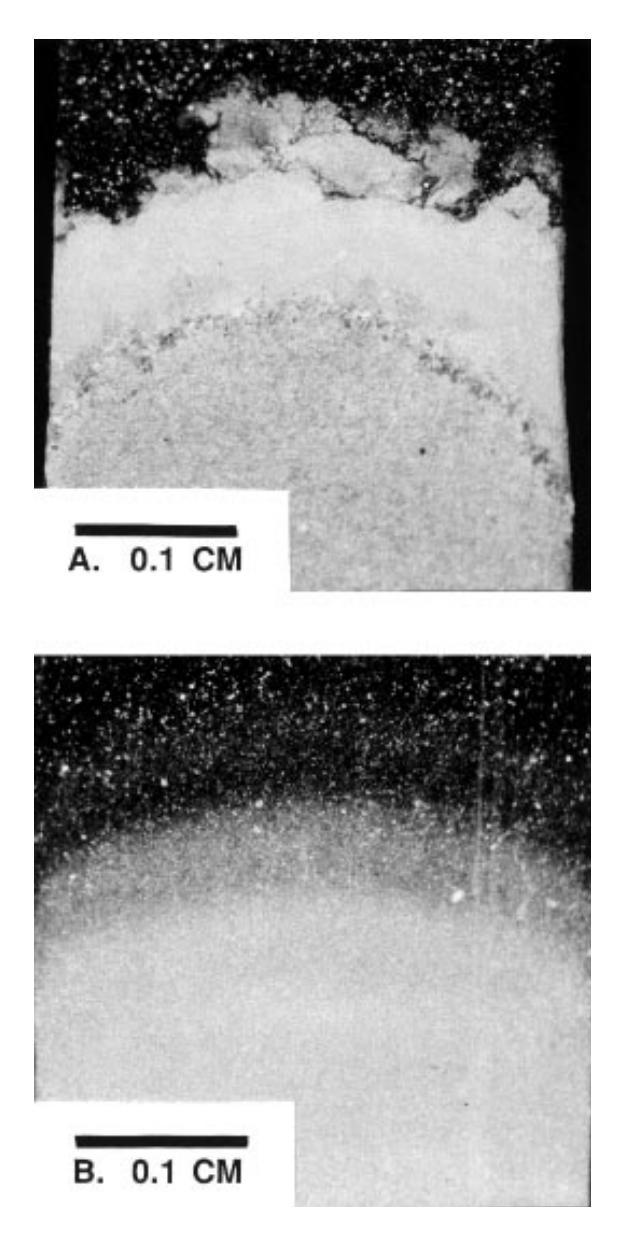
Fig. 7—Micrograph showing the meniscus region on two anodized samples: A, flawed coating formed in a bath without a filter paper skimming the surface; B, good quality coating formed in the same bath after wiper installation.

prepared. A nylon bag with 1 g synthetic hydrotalcite powder was added to the other portion. The first anodization run with the gettered bath was slow (Fig. 6), requiring 39 min to reach a cell voltage of 628 V. The appearance of flaws and craters in the meniscus area (Fig. 7), accompanied by visible arcing and audible whistling, caused us to stop processing at this point. We consider this localized arcing a result of small amounts of submicrometer-sized synthetic hydrotalcite powder escaping through the nylon filter, capturing chloride ions, and forming positively charged micelles that agglomerate on the substrate in the meniscus area where the electric field is high and agitation is weak. No craters or flaws were visible on submerged areas exposed to strong agitation from the magnetic stirrer. These experiments suggested an additional process refinement. A piece of a porous cellulosic #42 Whatman® filter paper was rinsed in a succession of 80 °C deionized

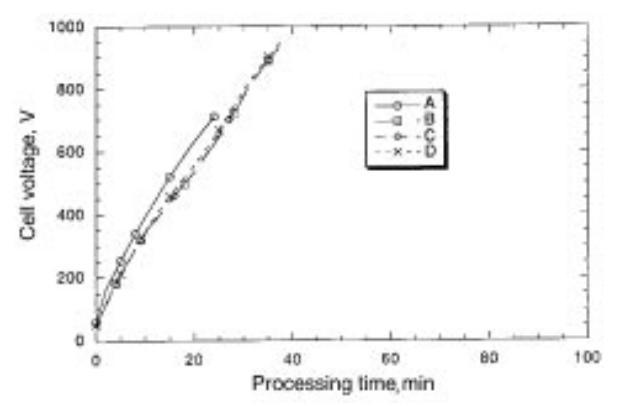
Fig. 8—Run times for the third series of experiments in a bath with a trace of HCl, bagged chloride getter and a surface skimmer (filed substrates). Curve A, first run-of-the-day. Cell voltage rose rapidly to 725 V in 30.5 min, then black defects appeared and the cell voltage fell to 695 V in 1 min. The run was then terminated. Curves B, C and D show subsequent anodization runs produced good quality coatings at 950 V in a short time.

water baths for three days to remove trace amounts of chlorides and fluorides characteristically present in "ashless" filter paper. The paper was positioned to skim the surface of the bath and scavenge getter agglomerates that escaped from the filter bag and floated to the top of the bath. The improvement in processing time obtained by using this wiper was sufficiently dramatic (Fig. 8, curve A, compared to Fig. 6) that we proceeded to the final stage of the study.

The final problem encountered with the HCl-contaminated bath with synthetic hydrotalcite occurred after storage. If the bath was used after being stored for two or more days, the cell voltage would readily rise to 770 to 800 V in 30 to 40 min. Then, a few barely visible dark spots appeared on submerged substrate surfaces and rapidly (in 1 to 2 min) grew into halfmm-dia. grains. Cell voltage decreased catastrophically by 50 to 100 V as the spots grew. Under an optical microscope, the spots appeared as raised and cratered rosettes (Fig. 9). The chloride-contaminated, chloride-gettered bath performed well after an initial run following extended storage. These results suggest that, during extended storage, particles of synthetic hydrotalcite escape through the filter, capture chloride ions and form large, charged micelles that, at sufficiently strong fields, migrate to the surface of the substrate and initiate damage. These micelles seem to adhere to the substrate and are removed from the bath when the first-run-of-the-day is concluded. After the first run-of-the-day was completed, processing times to 950 V were rapid and reproducible (Fig. 8, curves B, C and D). Coatings formed that appeared to be flawless.

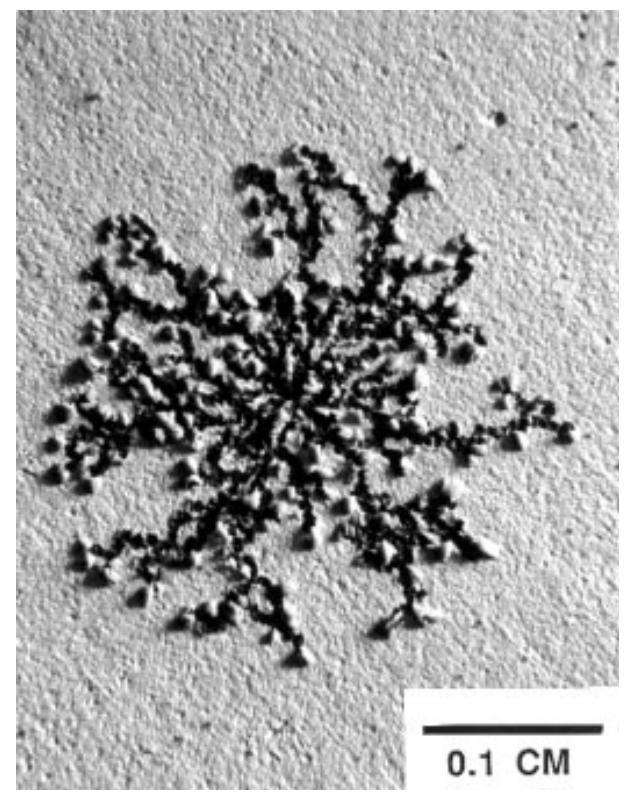
Fig. 9—Micrograph showing a rosette-like defect on the first-run-of-theday sample logged in Fig. 8, curve A.

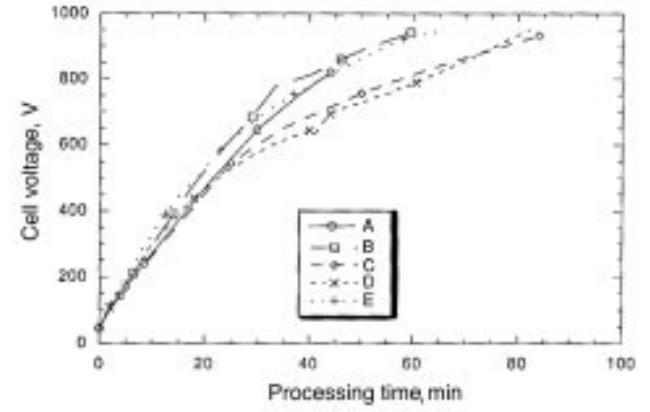
Fig. 10—Run times for the third series of experiments in a control bath with HCl and no chloride getter (filed substrates). Curves A-E represent the first five runs. Processing times with this amount of Cl⁻ contamination are long without improvement. These process times can be compared with the relatively short processing times illustrated in Fig. 8, curves B, C, and D for the gettered bath.

This behavior can be compared to the control bath with the same amount of added chloride contamination and no synthetic hydrotalcite (Fig. 10). Processing times to 950 V for the control bath are more than twice as long as processing times for the chloride-gettered bath. At this level of chloride ion contamination, there was no steady decrease in processing time with continued use. The coatings produced by this bath were not visibly flawed. The defects that robbed current from anodic film growth and exhibited extended processing time, were microscopic. As in earlier chloride ion contamination studies,¹ there was frequently a characteristic slowing or reversal in the voltage ramp rate that occurred over a period of a few minutes as the cell voltage approached 650 to 750 V.
