Technical Article

Hydrogen Embrittlement in Coating Technology – Measurement & Testing

by Dr. W. Paatsch* & V.-D. Hodoroaba

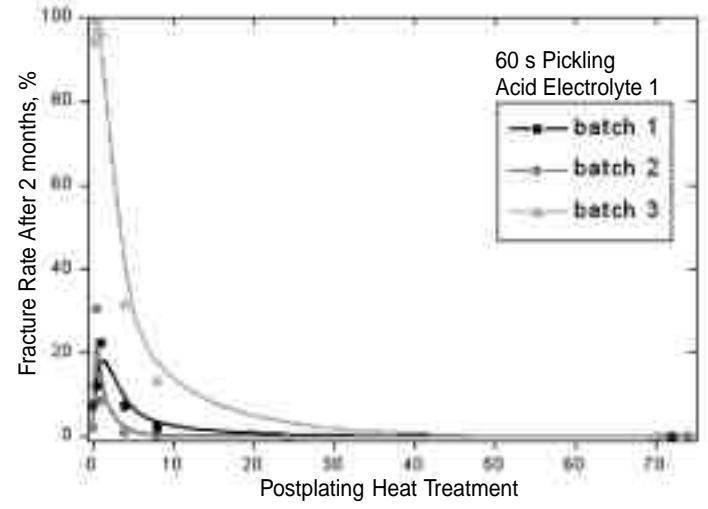
Fig. 1—Fracture rate of Zn-plated fuse holder rings with respect to annealing time at $220^{\circ}C$ ($428^{\circ}F$).

In recent investigations,² high strength fuse holder rings were conventionally semi-bright zinc plated, heat treated and mounted on a cylindrical pin such that the stress was close to the yield point but below any plastic deformation. The fracture behavior as a function of the post-plating heat treatment after a two-month testing time is shown in Fig. 1.

Each point in the diagram represents the behavior of 100 samples and therefore fulfills statistical demands. The fracture rate first increases with bake-out time, up to a maximum and finally approaches zero with further time. The reason for this behavior is said to be an absorption-diffusion mechanism of hydrogen in the case of bright or semi-bright zinc coatings.3 According to electrochemical hydrogen permeation measurements and hydrogen concentration measurements using the hot extraction technique, a large amount of hydrogen is trapped in the zinc coating. It is thought however that the distribution is not uniform, and the highest concentration should be close to the zinc-basis metal interface. As the increased temperature exceeds the trapping energy, hydrogen diffuses primarily into the basis metal as the zinc itself forms an efficient diffusion barrier. As expected this is followed by a dramatic increase in the fracture rate up to unity. With increasing bake-out time, however, a new equilibrium is reached where, because of effusion and diffusion effects, the hydrogen content in the basis metal falls below the local critical concentration and no further embrittlement occurs. Up to now however, no analytical proof for this reasonable interpretation of the tensile test experiments has been given. Now, as efficient Glow Discharge Optical Emission Spectroscopy (GD-OES) has become available, hydrogen distribution profiles in metals can be measured.

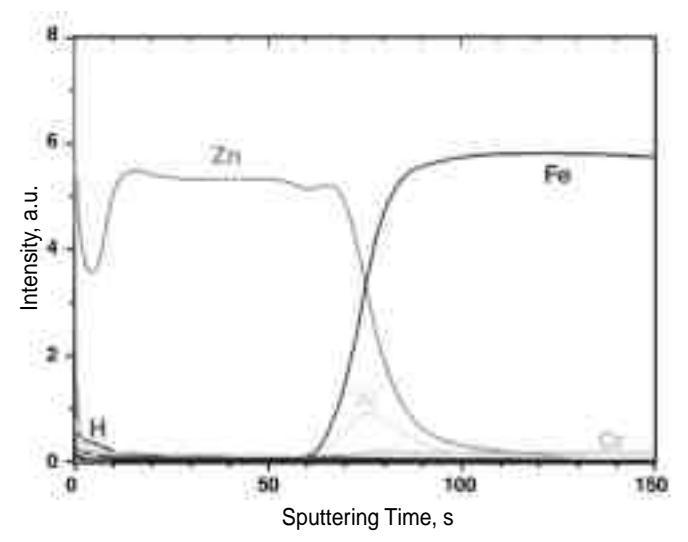
Fig. 3—Depth profile of a zinc layer deposited by hot dip galvanizing.

The following two examples will illustrate how powerful a tool GD-OES is in analyzing hydrogen in plated samples not necessarily related to the embrittlement problem. Figure 3 shows the depth profiling for a zinc layer on steel formed by hot dip galvanizing. As expected no hydrogen is found. Any hydrogen originating from the pickling pretreatment and penetrating the basis metal effuses during the high temperature galvanization. The minimal hydrogen signal detected at the surface of the sample is caused by contamination and is an indication of the sensitivity of GD-OES. The aluminum at the zinc-steel interface originates in the molten bath where it is added to avoid the formation of brittle alloy phases.

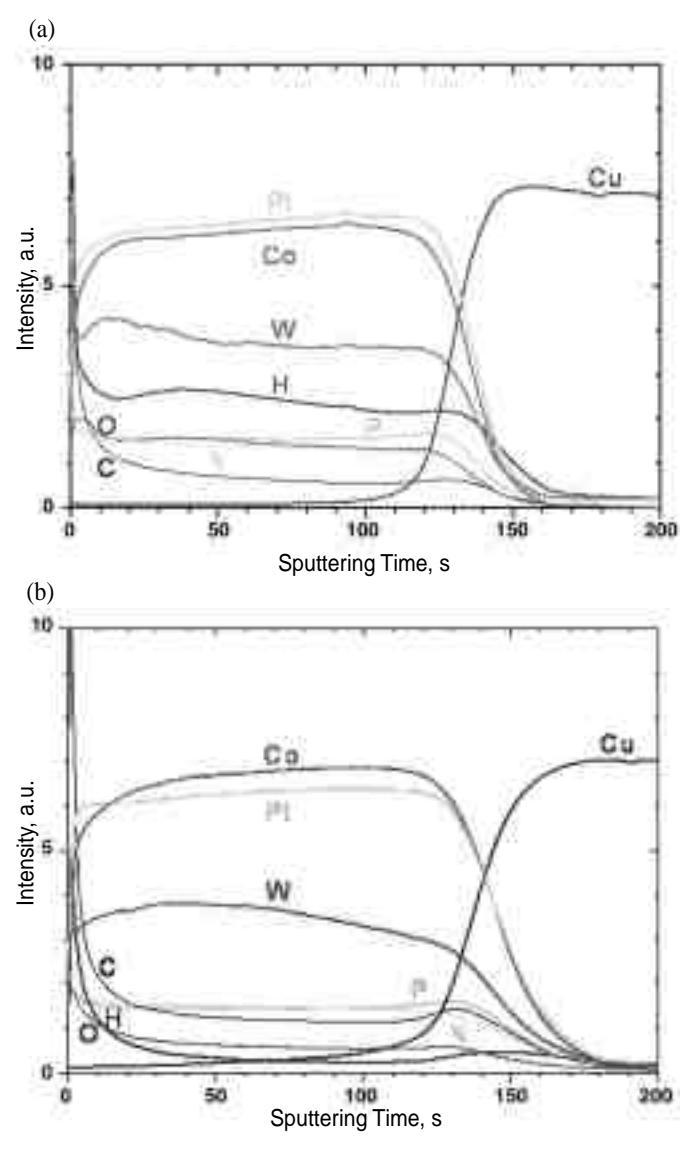
Fig. 4—Depth profiles of an electrolytically deposited Co-Pt-W layer: (a) as plated and (b) after annealing.

The second example involves a Co-Pt-W layer electrodeposited on a copper substrate. Figure 4a shows that GD-OES depth profiling shows significant hydrogen content in the coating. No hydrogen is found in the copper basis metal, which is known to form a very efficient diffusion barrier to hydrogen. After annealing the sample at 400°C (750°F) for 24 hours (Fig. 4b) hydrogen can no longer be detected.

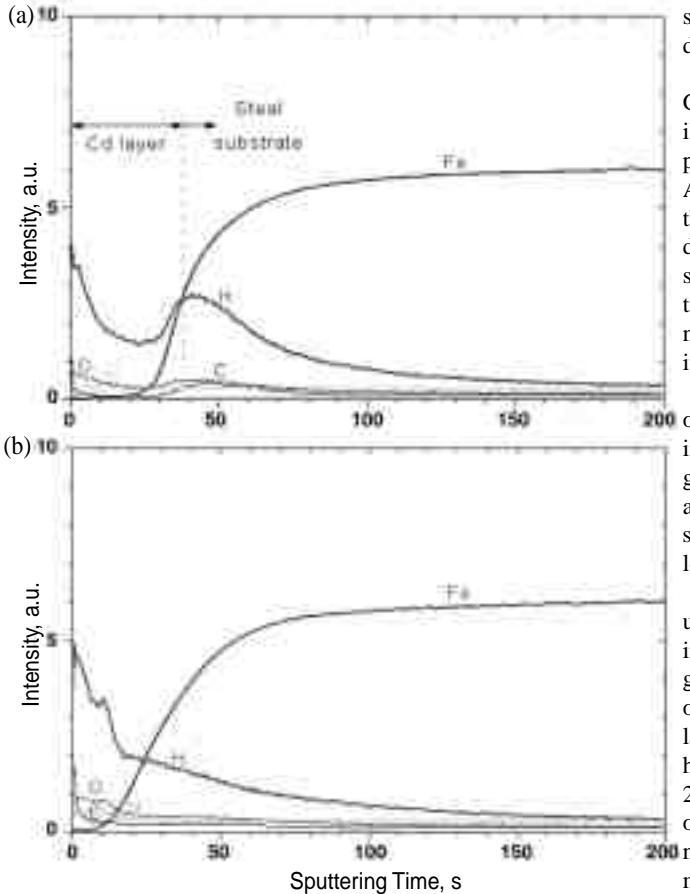
Fig. 5—Depth profiles of an electrolytically deposited cadmium-layer: (a) as plated and (b) after heat treatment. The cadmium signal is not shown.

The hydrogen distribution of a porous plated cadmium layer used in the aircraft industry (a low embrittlement coating) is shown in Fig. 5. Although the cadmium signal is not shown in the diagram, the interface can be clearly delineated from the iron signal of the basis metal. While hydrogen is incorporated in the cadmium layer the following maximum indicates that a significant amount of hydrogen is stored in the interface (Fig. 5a). After heat treatment at 220°C (428°F) for 8 hours, the hydrogen content in the layer is more or less unchanged showing that it is chemically bound and therefore not diffusible. In agreement with the model given above the maxi-

Sputtering Time, s mum at the interface disappears and the level within the basis metal is reduced. Hydrogen is now able to effuse and diffuse.

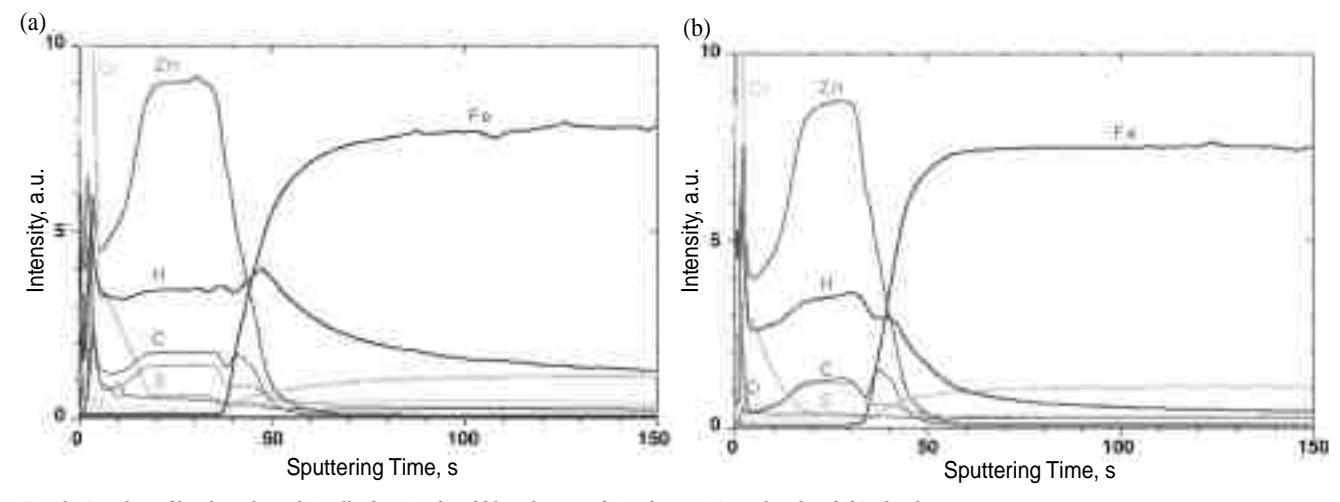
Fig. 6—Depth profile of an electrolytically deposited and blue chromated zinc layer: (a) as plated and (b) after heat treatment.

Figure 6 shows the profiles for a zinc-plated and blue-chromated sample in the as plated condition (Fig. 6a) and after heat treatment (Fig. 6b). Again chemically bound hydrogen is found in the semibright plated zinc layer. The carbon and sulfur comes from codeposited brighteners. In order to get information on the quantity of hydrogen in the zinc layer, additional NRA measurements were carried out.⁶ Because of the unavailability of certified standards containing hydrogen, the GD-OES quantification of hydrogen calibration curve can be derived by adding hydrogen in gaseous form in controlled quantities. For specially prepared samples, *i.e.*, electrolytic zinc coatings of 1 µm depth, NRA yields hydrogen concentration values of about 10 atomic %, homogeneously distributed in the zinc layer. Unfortunately, the zinc-steel interface could not be

evaluated, because the uncertainty of the localization of the reaction involving hydrogen at $\sim 1~\mu m$ depth was too high.

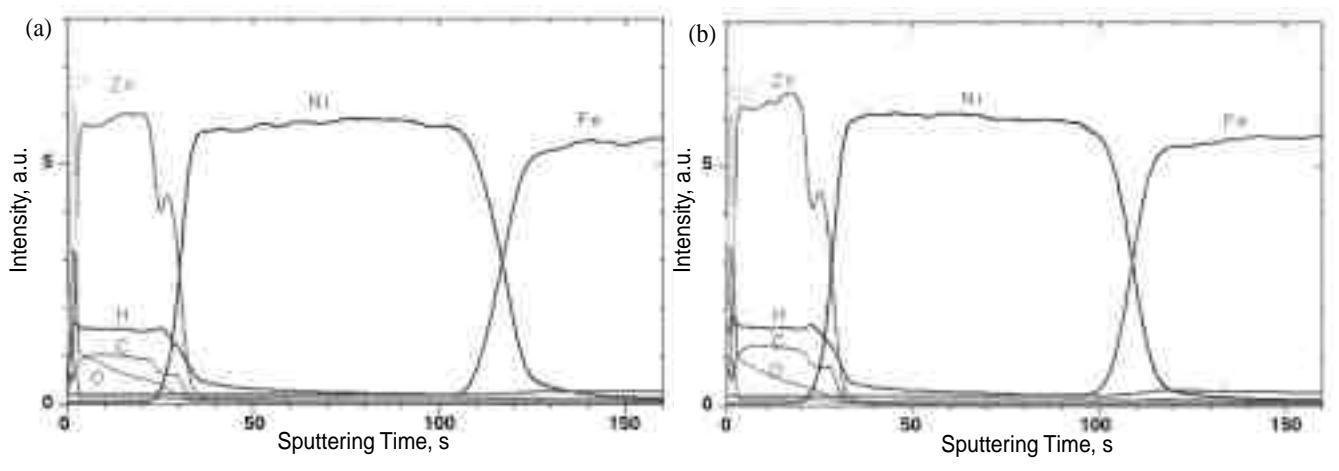
Fig. 7—Depth profiles of an electrolytically deposited and blue chromated zinc layer with an intermediate nickel layer: (a) as plated and (b) after heat treatment.

An innovative zinc-plating process of high interest has been developed, where a thin nickel layer is plated prior to zinc plating to avoid the post heat-treatment.⁷⁻⁹ For electrochemical reasons, related to the nickel plating process and the nickel surface itself, the process of hydrogen recombination to molecular hydrogen is preferred. As a result, the partial pressure of hydrogen at the surface is less and therefore hydrogen penetration into the basis metal is reduced. The hydrogen profile in Fig. 7a shows no significant hydrogen at the basis metal-nickel interface and similar results are noted at the nickel-zinc interface. As expected no change is found after heat treatment at 220°C (428°F) for 2 hours (Fig. 7b). Of course this result has to be confirmed by sustained load tests as hydrogen embrittlement is a complex system property where the local hydrogen concentration in the area of critical tensile stress within a component is the deciding factor.
