Shop Talk

Some Production Plating Problems & How They Were Solved—Part 5

Collected and edited by Dr. Samuel Heiman Updated by Dr. James H. Lindsay, AESF Fellow

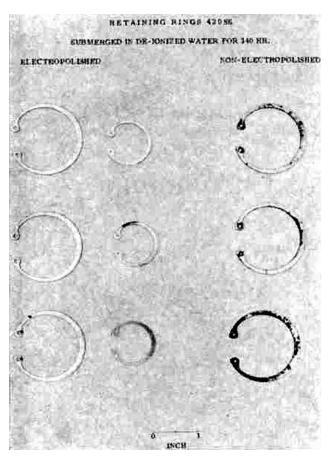
The merit of electropolishing is shown by the fact that the unpolished retaining rings had general pitting and corrosion after the corrosion test, whereas the electropolished parts had only a few isolated pits. This is shown in the accompanying figure.

Call the AESF Bookstore or Go On-line 1-800/334-2052 www.aesf.org (secure site) desired results. The electropolishing bath used was the citric acid-sulfuric acid type, but there is no reason to believe that any other standard electropolishing bath for stainless steel could not have been used. This solved the problem.

We did not investigate the corrosion mechanism. However, other ways by which electropolishing improves the corrosion resistance are likely to involve (1) the formation of a heavier oxide film on the surface than the "natural" oxide and (2) the removal of the surface layer which originally had stresses and inclusions (insoluble in dilute nitric acid) from previous forming operations.
