# Technical Article

# The Corrosion Behavior of Cadmium, Zinc, Zinc-Nickel & Nickel-Phosphorus/Zinc Commercial Coatings in Chloride Solutions

by L.A.S. Silva & L. Sathler

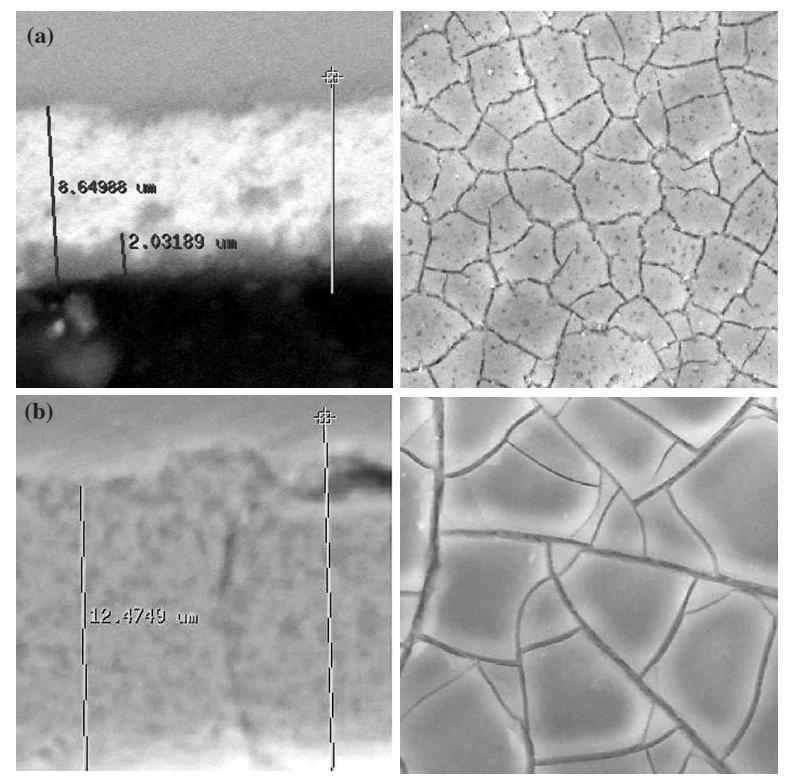
Fig. 1-Electron micrographs of the surface deposits: a) Cd, b) Zn.

Figure 1 shows the cross section of the cadmium deposit at a magnification of 4000X (left photo). The substrate is at the top, the deposit is in the middle and the resin is on the bottom. The SEM surface view of the cadmium (right photo) is shown at a magnification of 2000X. The cadmium deposit (Fig. 1a) (8.6  $\mu$ m) was continuous, fine-grained, smooth and well-chromated (2.0  $\mu$ m), as identified by EDS. The zinc deposit (Fig. 1b) (12.4 µm) exhibited larger grains, but the surface was smooth and well chromated (1.9  $\mu$ m). In cross section, thin cracks were observed across the zinc deposit. Figure 2 shows (at the same magnification) that the Zn-16.3% Ni alloy deposit (Fig. 2a) was irregular, fine-grained and no cracks were seen in the cross section. The electroless Ni-6%P/Zn deposit (Fig. 2b) exhibited an irregular surface, rough grains and microcracks. Energy dispersive x-ray spectroscopy (EDS) of the electroless Ni-6%P/Zn samples heat treated at 320°C (608°F) for 1 hr showed the presence of 6% Ni on the surface.

The SEM results revealed that the cadmium and Zn-16.3% Ni alloy coatings were fine-grained and free of defects. By contrast, the zinc coatings showed microcracks across the deposit, while the electroless Ni-6%P/Zn coatings showed microcracks and micropres

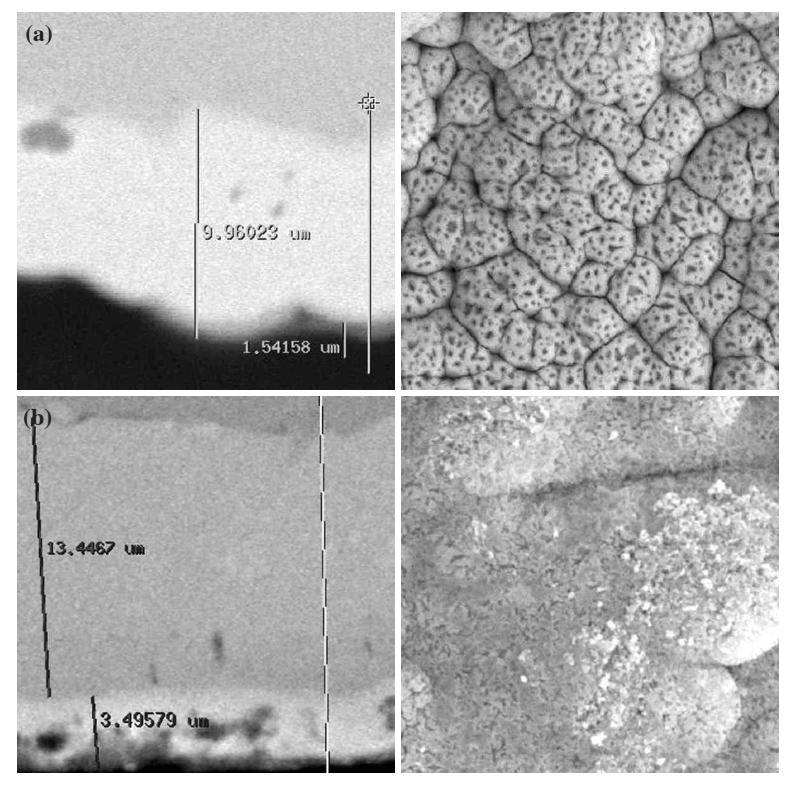
Fig. 2–Electron micrographs of the surface of the deposits: a) Zn-16.3% Ni; b) Ni-6%P/Zn [320°C (608°F), 1 hr].

on the surface. It is likely that hydrogen under the surface, produced during the electrodeposition and electroless deposition processes, produced the defects. The hydrogen can provoke internal stress, cracks and microfissures in the deposit structure. In the case of the electroless Ni-6%P/Zn coatings, hydrogen relief at 190°C (374°F) for 1 hr and heat treatment at 320°C (608°F) for 1 hr could have easily led to the formation of the many cracks in the deposit surface.

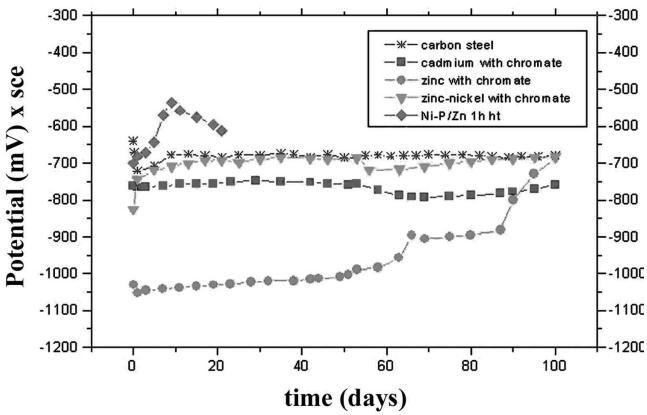
Fig. 3-Potential variation with time in total immersion tests.

Figure 3 shows the potential variation with time in the total immersion tests. The zinc coatings exhibited a potential below –1000 mV during 50 days without corrosion. After that, the potential started to increase reaching –690 mV at the end of 100 days. The samples exhibited a heavy red rust. The cadmium samples did not corrode and the potential remained constant, at about –755

mV. At the beginning of the test the Zn-16.3% Ni alloy samples exhibited a potential below -800 mV. After 20 days, the potential remained constant, near -680 mV. The electroless Ni-6%P/Zn coating showed red rust after 8 days. The corrosion increased and the samples were removed after 21 days. The steel substrate exhibited corrosion and the potential stabilized at about -680 mV.

Corrosion potential measurement by the total immersion method is a simple procedure for evaluating corrosion resistance. In this work, the zinc coating potential remained below -1000 mV over the first 50 days. However, it reached -690 mV after 90 days (Fig. 3) and the specimen showed red rust. At the beginning of the zinc test, the corrosion was primarily found close to the microcracks because of the large potential difference between the coating and substrate (~300 mV). When the substrate started to corrode, the potential increased, trending toward the substrate potential value. Cadmium plated samples did not corrode and the potential remained constant and below that of the substrate potential. According to Gavrila,<sup>16</sup> the potential increase at the beginning of the test for Zn-16.3% Ni alloy coating was associated with dezincification of the alloy. Zaky, et al.,19 studied the microstructure and the corrosion behavior of Zn-5% Ni alloy coatings. They identified a stable  $\gamma$  and a metastable  $\eta$  phase which dissolved rapidly in the corrosive medium. Similar results were found by Krishniyer, et al.,9 who studied Zn-Ni and Zn-Ni-P alloys with a nickel content less than 15%. In our work, the Zn-16.3% Ni alloy coating studied did not corrode and its potential stabilized at -680 mV. The behavior of electroless Ni-6%P/Zn samples was different from the other coatings. The lower potential can be attributed to the enrichment of the surface in the form of a Ni-rich phase by the strong corrosion of zinc promoted by the microcracks. Substrate corrosion appeared on the eighth day when the potential started to decrease.

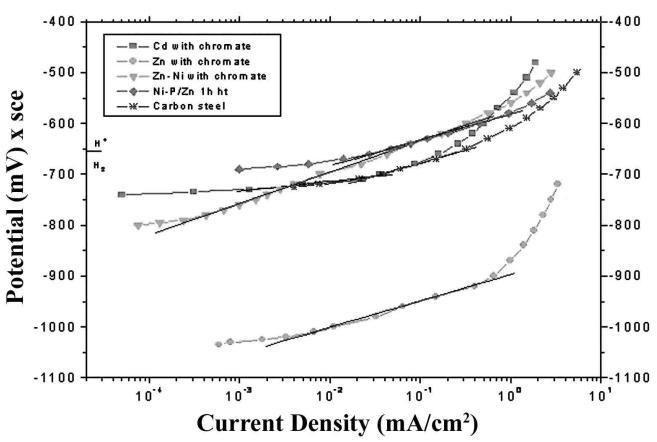
Fig. 4-Anodic polarization curves of the coatings studied.

Figures 4 and 5 show the anodic and cathodic polarization curves. These deposits showed active dissolution in chloride solution. The linear interval shown in the curves was obtained by linear regression which allowed us to determine the corrosion current by straight-line extrapolation to the corrosion potential. The Tafel constants were determined from the slopes. Table 2 shows the results for  $E_{corr}$ ,  $i_{corr}$ ,  $b_a$  and  $b_c$ .

Anodic polarization tests showed that the coatings studied actively dissolved in chloride solution. The corrosion rate (i\_\_\_) was remarkably low for cadmium (0.43 µA/cm<sup>2</sup>) and Zn-16.3% Ni (0.14  $\mu$ A/cm<sup>2</sup>) but was high for chromated zinc (2.2  $\mu$ A/cm<sup>2</sup>) and electroless Ni-6%P/Zn (7.9  $\mu$ A/cm<sup>2</sup>) coatings. It is known that cadmium coatings show better corrosion behavior than zinc in sea water.5,20,21 It has also been observed that Zn-Ni coatings present a higher corrosion resistance than chromated zinc.6-9,22

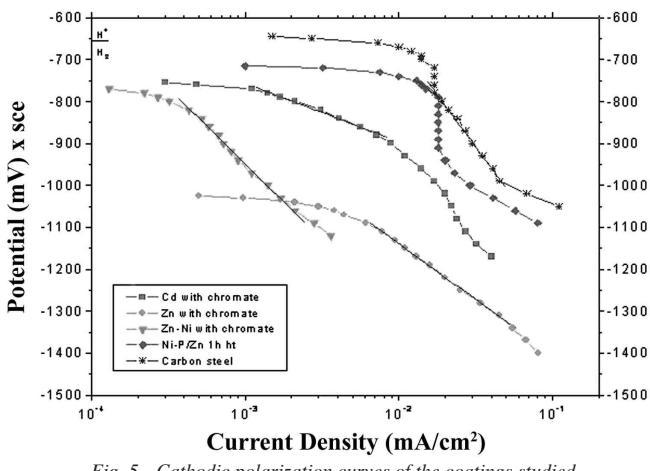
Fig. 5-Cathodic polarization curves of the coatings studied.

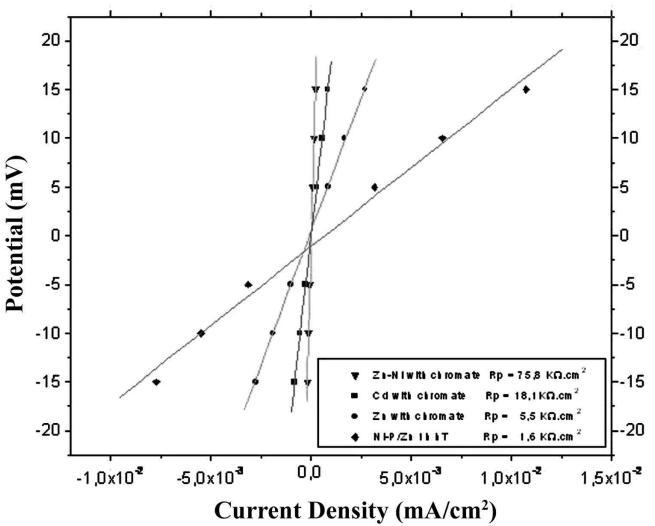
Fig. 6-Linear polarization curves of the coatings studied.

The results of the linear polarization tests are shown in Fig. 6 and Table 3. The coatings, presented in decreasing order of resistance, were: Zn-16.3% Ni alloy (75.8 K $\Omega$ ·cm<sup>2</sup>), cadmium (18.1 K $\Omega$ ·cm<sup>2</sup>), zinc (5.5 K $\Omega$ ·cm<sup>2</sup>) and electroless Ni-6%P/Zn (1.6 K $\Omega$ ·cm<sup>2</sup>). The *B* values calculated from b<sub>a</sub> and b<sub>c</sub> varied between 18.9 and 27.0 mV except for cadmium which was 7.3 mV. The I<sub>corr</sub> values determined from the polarization resistance measurements were close to those found with the anodic polarization tests.

The results of the linear polarization tests confirmed that Zn-16.3% Ni alloy showed the best corrosion resistance in 3% NaCl solution, in accordance with the anodic polarization test results. The Zn-Ni coating polarization resistance was about three times better than that of the cadmium coating.
