Advice & Counsel

Interpreting CASS Results

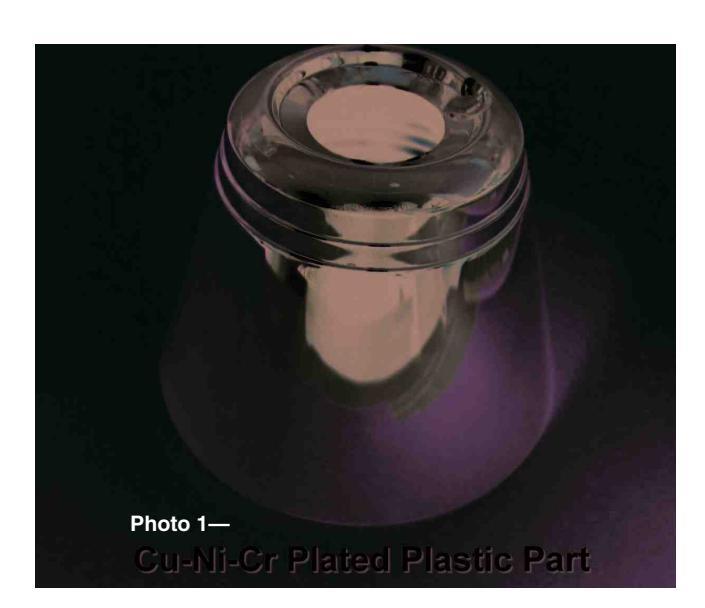
Please settle a disagreement between our customer and our lab personnel. We are conducting an eight hour CASS (Copper Accelerated Salt Spray) test in accordance with ASTM B368. Our parts a plated plastic, with a copper- (duplex) nickelchromium finish (photo 1). After the test, the parts may have extremely fine pitting which is almost impossible to see without magnification. However, our client considers the appearance of these pits a failure of the test. Enclosed are the parts for your independent analysis of the test results.

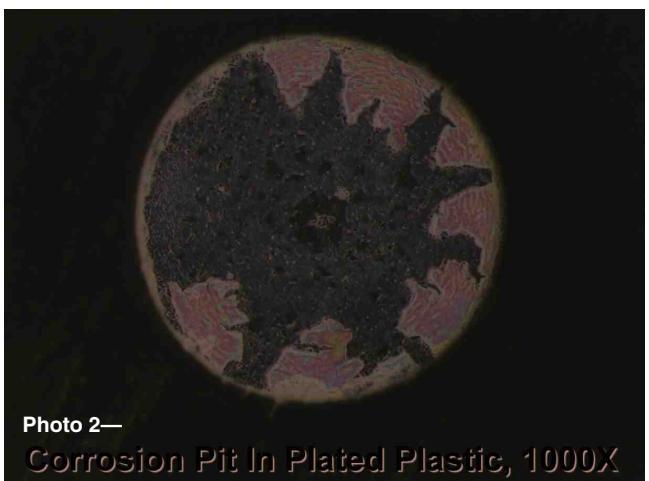
There was no evidence of corrosion penetrating to the substrate (plastic), as there was no plastic visible in the surface pores we found, even at high magnification (photo 2). Also, there was no evidence of copper corrosion products (crystals which typically are a blue green color), and there was no evidence of blistering of the coating.

We found microscopic porosity in the surface, which is normal for a porous chromium deposit over bright nickel. In fact the production of numerous corrosion cells over a large surface area is the exact mechanism by which this type of plated coating provides corrosion protection.

In a nutshell, Mr. Wright, you are right. These parts pass the eight hour ASTM B368 CASS test. Now all you have to do is convince your customer.
