The Electrochemical Deposition of Tin-Nickel Alloys and the Corrosion Properties of the Coating

by Morten S. Jellesen^{*} & Per Møller

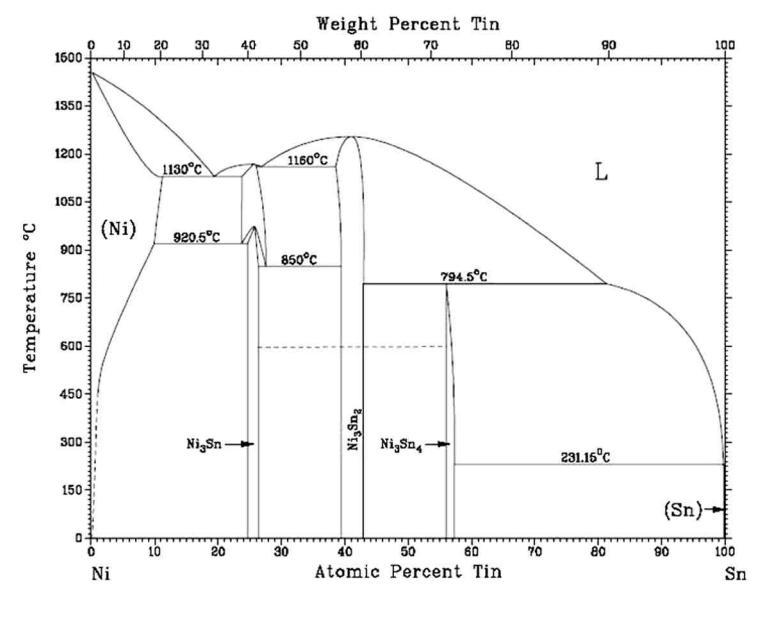
Figure 1-NiSn phase diagram.²

More than 50 years ago, Parkinson¹ published details describing a process to electroplate a deposit of nickel and tin with the composition of approximately 65/35 wt% (1:1 atom ratio) referred to as NiSn. This intermetallic phase of nickel and tin cannot be formed by any pyrometallurgical process and is not to be found in the phase diagram shown in Fig. 1.²

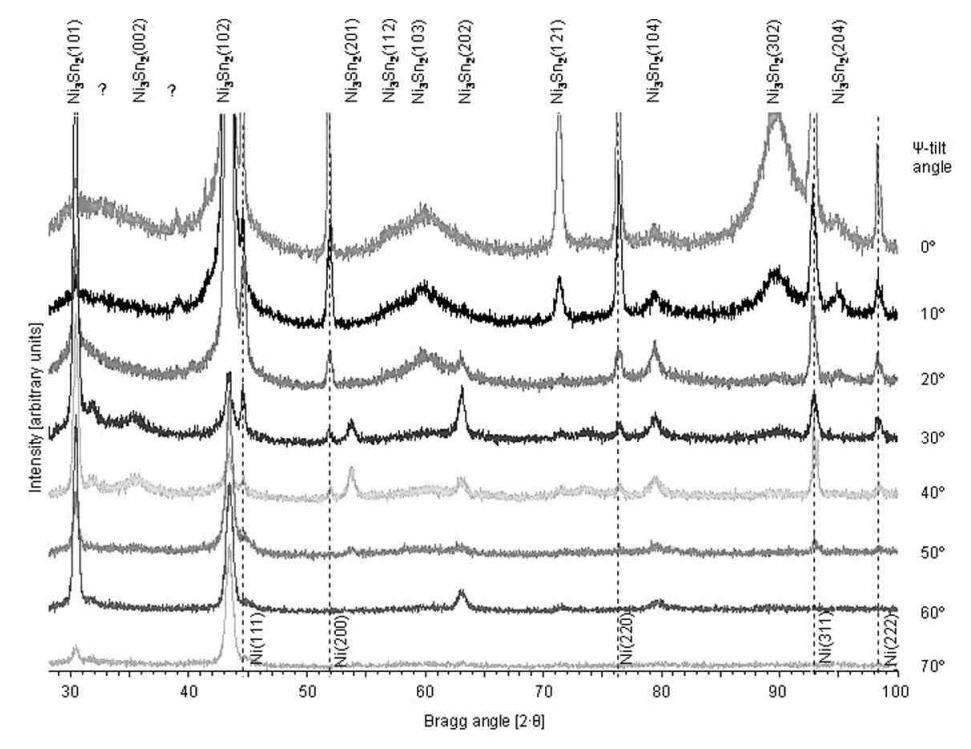
Figure 2—X-ray diffraction patterns (CuK α) of electrodeposited NiSn on a nickel substrate. The scan is repeated for eight different tilt angles. Nickel peaks from the substrate are marked with dotted lines.

X-ray diffraction patterns of the as-electrodeposited NiSn layer are shown in Fig. 2. Because of crystallographic texture effects, the scan was repeated at different ψ -tilt angles to obtain as many identifiable {hkl} line profiles as possible. The various diffractograms are shown with offset on the intensity axis. A total of 11 peaks were identified as being consistent with the crystal structure proposed for Ni₃Sn₂. The *a* and *c* lattice parameters determined from the peak positions of the{HK2} and {10L} line profiles, respectively were *a* = 4.173 Å and c = 5.123 Å and resembled those found by Lo⁴ for electroplated NiSn with lattice parameters *a* = 4.15 Å and *c* = 5.10 Å (See the peak positions indicated in Table 1.). A few diffraction peaks could not be identified as Ni₃Sn₂, indicated by a question mark in Fig. 2. The results indicated that as-electrodeposited NiSn mainly consisted of Ni₃Sn₂ with a hexagonal structure of the NiAs type.

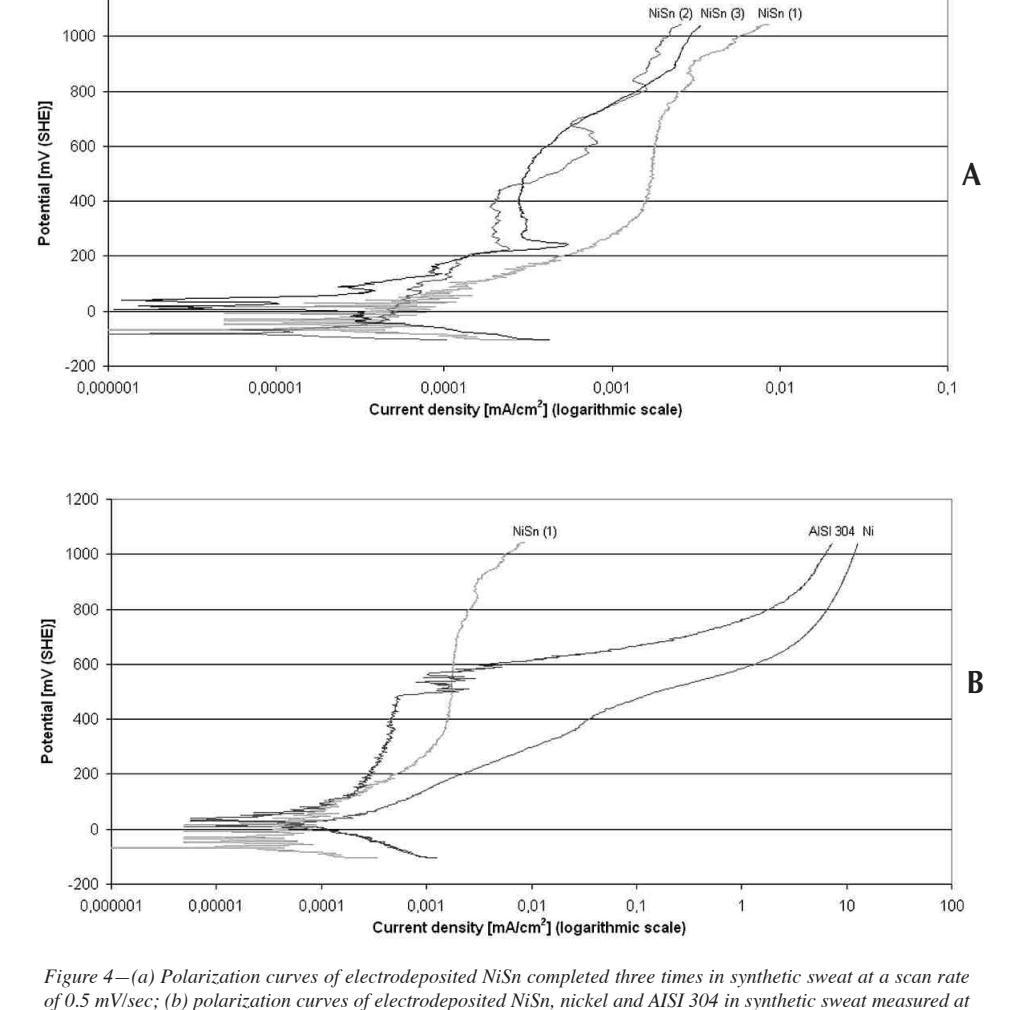
Figure 4(a) shows the repeatability of polarization curves of NiSn

and how the deposit decreased its passive current after the first scan, suggesting a passivation after this initial scan. The curves of the second and third scans were similar. Figure 4(b) shows that the current density of the passive layer on AISI 304 and NiSn was comparable. However, the pitting potential of AISI 304 was approximately 520 mV_{SHE}, whereas the pitting potential for NiSn was still not reached at 1000 mV_{SHE}.

As shown in Fig. 4, the passivation behavior of NiSn exceeded that of AISI 304 when polarized from -150 mV_{SHE} to 1050 mV_{SHE} at a scan rate of 0.5 mV/sec. It is important to note that the deposit must be free of pores. A simple test to evaluate the existence of pores involved immersion of the plated substrate in concentrated nitric acid. Pores will reveal themselves after a few minutes through excessive bubbling.

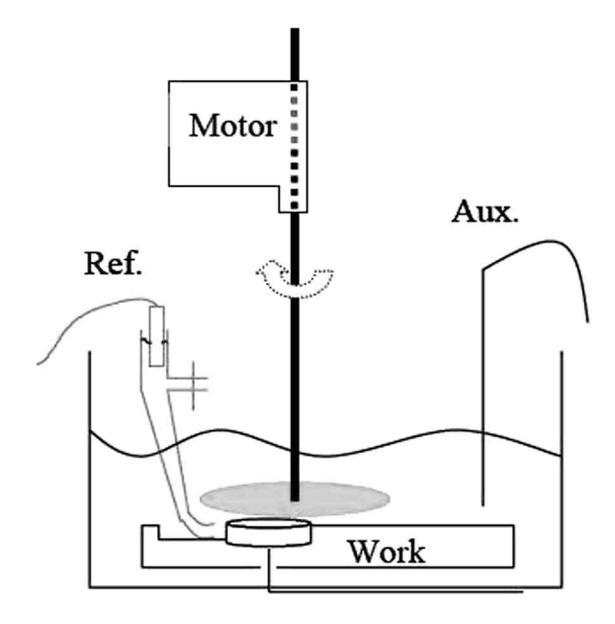
Figure 5—Tribocorrosion setup with motor, washable leather, auxiliary and reference electrode. The mounted sample acts as the working electrode.

Tribocorrosion studies were performed using the setup illustrated in Fig. 5. The apparatus consisted of a motor that rotated a polymer disk with a radius of 10 cm (3.9 in.). The disc was covered with synthetic washable leather. The motor rotated at a fixed speed of 150 rpm and the applied load was approximately 2.0 kg (4.4 lb.).

Washable leather was chosen as the wearing material, because it was comparable to the situation where human skin is in contact with the substrate. Electrochemical measurements could be made with the three-electrode setup, allowing potential and chronoamperometric studies of the substrate to be made with and without the influence of wear.

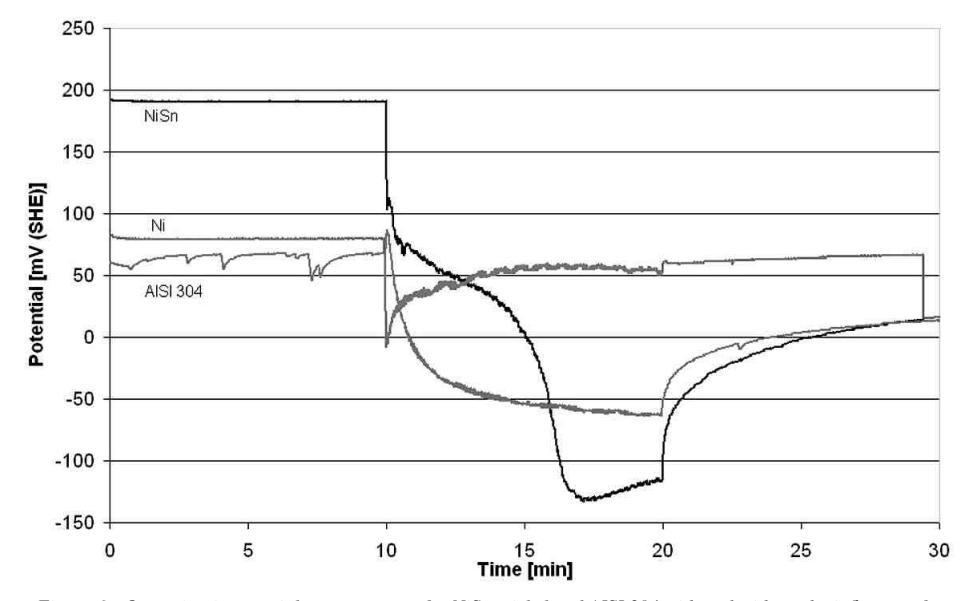
Figure 6-Open circuit potential measurements for NiSn, nickel and AISI 304 with and without the influence of wear. The open circuit potential was measured for 10 min and then the washable leather rotation was started. The rotation was stopped after 20 min.

Prior to the tribocorrosion tests, the samples were briefly immersed in the solution until a steady open circuit potential was reached. The monitoring of the open circuit potential continued and after 10 min, the rotation of the washable leather was started. An abrupt decrease of the open circuit potential was observed (Fig. 6). When the motor was stopped (after 20 min), the open circuit potential increased, indicating a re-establishment of a passive film Table 2Galvanic couplings in synthetic sweat solution

on the NiSn and stainless steel. Based on the open circuit potential monitoring, nickel seemed to be the metal least affected by wear.

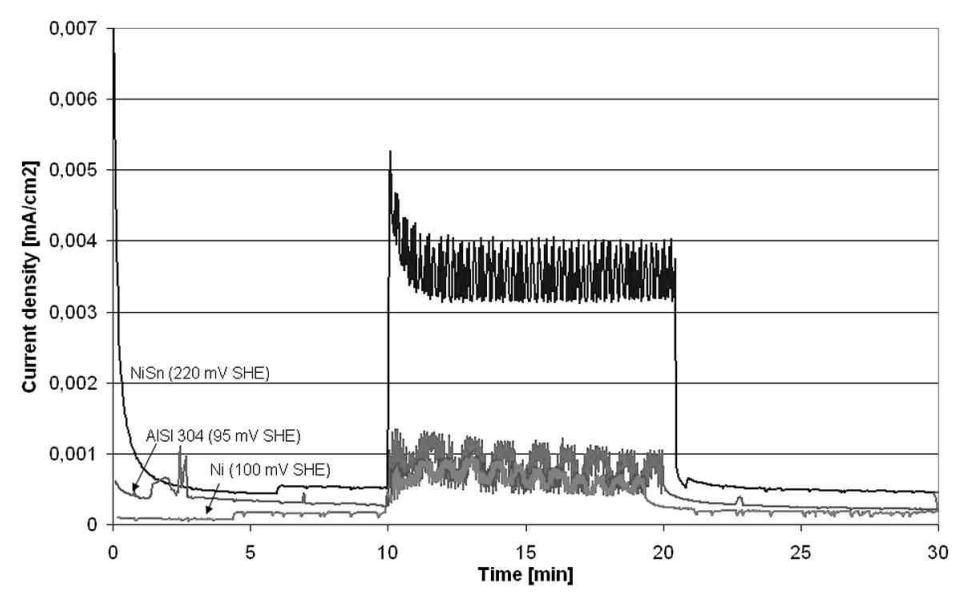
Figure 7—Chronoamperometric studies of nickel, AISI 304 and NiSn at a constant potential 25 mV above the corresponding individual open circuit potential.

In the chronoamperometic studies, a constant potential with respect to the reference electrode was applied and the anodic current was measured. The results are shown in Fig. 7. The constant potentials applied were 220 mV_{SHE} for NiSn, 95 mV_{SHE} for stainless steel and 100 mV_{SHE} for nickel. It is important to note that the current densities were measured at different applied potentials for each sample. The potentials were fixed at approximately 25 mV above the individual open circuit potential for each sample to simulate minor oxidation. The individual potential was applied

at time zero. For NiSn, there was a rapid decrease in current after time zero due to passivation at this applied potential. After 10 min, there was a rapid increase in current density due to the start of the rotation of the washable leather. The increase in current was strongest in the case of NiSn at the applied potential 220 mV_{SHE}. As soon as the rotation stopped, the surface repassivated and the current decreased to a level similar to that before wear was introduced.

A comparison of the results indicates that NiSn was most susceptible to tribocorrosion at a constant potential of 220 mV_{SHE} when compared to austenitic stainless steel at 100 mV_{SHE} and nickel at 95 mV_{SHE}. Austenitic stainless steel seemed to be more susceptible to tribocorrosion than nickel. These findings are in accordance with the assumption that passive materials are more susceptible to altering corrosion behavior when exposed to wear, because of the destruction of the protective properties of the passive film.

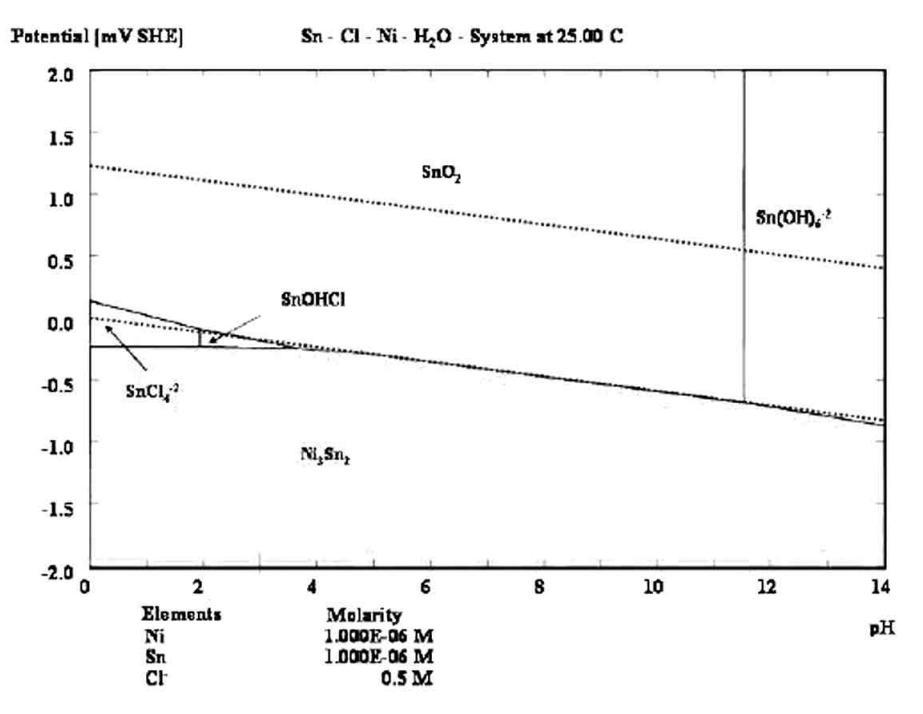
Figure 8-Simplified Pourbaix diagram for the Sn-Cl-Ni-H₂O system at 25°C (77°F).

The Pourbaix diagram shown in Fig. 8 is derived for a pressure of 1 bar (100 kPa; 14.5 lb/in²) and a temperature of 25°C (77°F). The diagram is derived for selected concentrations of ionic species (10⁻⁶M for nickel ions as well as tin, and 0.05M for chloride ions). Since X-ray investigations showed Ni₃Sn₂ to be dominant, Ni₃Sn₄, Ni₃Sn and nickel hydrides have been excluded from calculations, resulting in the diagram shown in Fig. 8.

The Pourbaix diagram shows stannic oxide (SnO_2) to be thermodynamically the most stable oxide. This does not necessarily mean that the oxide is of a protective (passivating) nature. Some kind

of passivating film is present on NiSn, accounting for its stability when exposed to concentrated nitric acid. At low pH values, Ni₃Sn₂ can transform into soluble tetrachlorostannate(II)⁻² ions (SnCl₄⁻²) or tin(II) chloride hydroxide (SnOHCl). At high pH values, tin(IV) hexahydroxide⁻² ion (Sn(OH)₆⁻²) is thermodynamically the most stable form. It should be emphasized that no information on corrosion kinetics is provided by this thermodynamically-derived diagram.
