# Shop Talk

## Plating & Surface Finishing Retrospective

#### Tin plate appearance problem

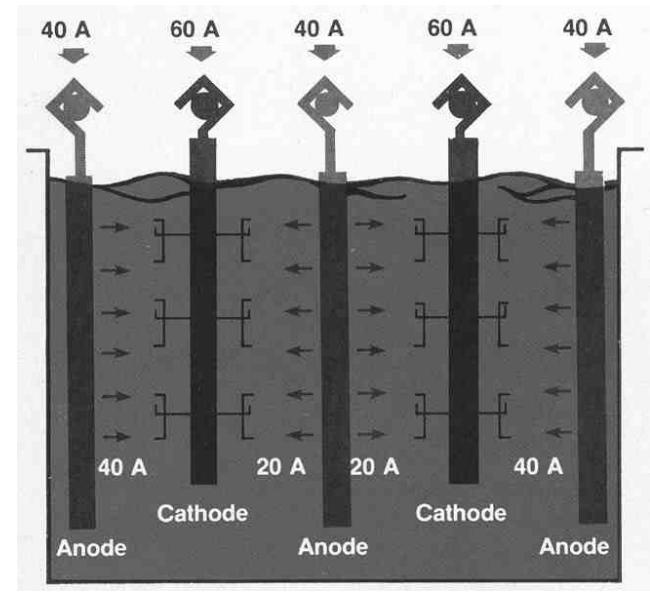
Fig. 1-Current distribution.

In your situation, you are drawing 120 A of total current, or 60 A per cathode bar. The current flow in the anode circuit is probably 40 A per anode bar. Figure 1 shows the current distribution for this case. The work on the left cathode bar draws 40 A from the anodes on the left and 20 A from the center anodes. The cathode on the right draws 40 A from the anode in the center. The problem here is the work surfaces that "see" the center anodes are drawing only half the current as are the surfaces facing the outside anodes. The result is uneven plating.

Although I cannot be certain, I would guess that the reason for the obvious difference in current density is due to the double cathode bar and the third anode bar between them. While this is a common arrangement used by many platers, it often results in the uneven plating similar to your situation. In order to plate uniformly, the center anode bar must carry twice as much current because it must supply current to two cathode bars, whereas each side anode bar supplies current to only one anode bar. The example that follows will illustrate this point.

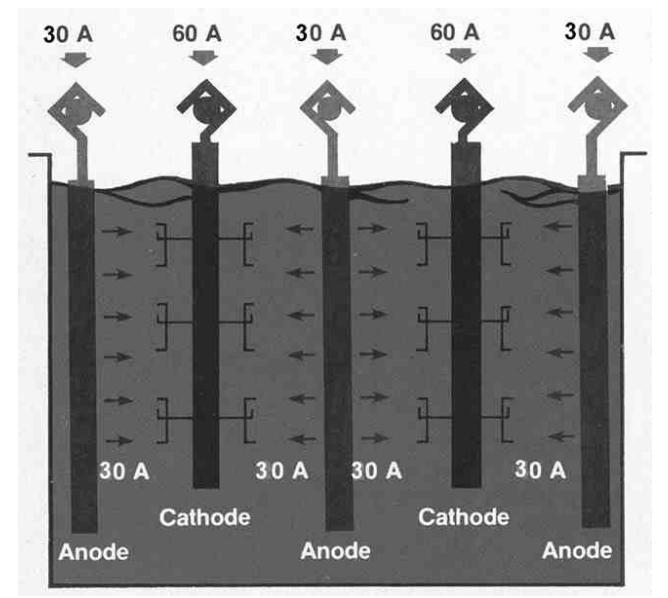
Fig. 2-Desirable current flow.

Figure 2 shows the desirable current flow to achieve a uniform current distribution. The center anodes now carry twice the current as either of the outside anodes. Each cathode now draws 30 A from the outside anodes and the inside anodes, resulting in uniform current density. Work surfaces facing either inside or outside anodes will "see" the same amount of current.

To get more current going to the center anodes, you can do one of several things:

- 1. Add more anodes to the center bar.
- 2. Move the cathode bar closer to the center anode bar and further from the outside anode bar.
- 3. Add rheostats to the anode circuit to control and adjust the current going to each anode bar.
