# The Nature of Plating Solution Turbidity and its Effects on Plated Parts

# Aleli L. Tumibay, Sally V. Barrinuevo and Baby M. Regalado, Analog Devices General Trias, Cavite, Philippines

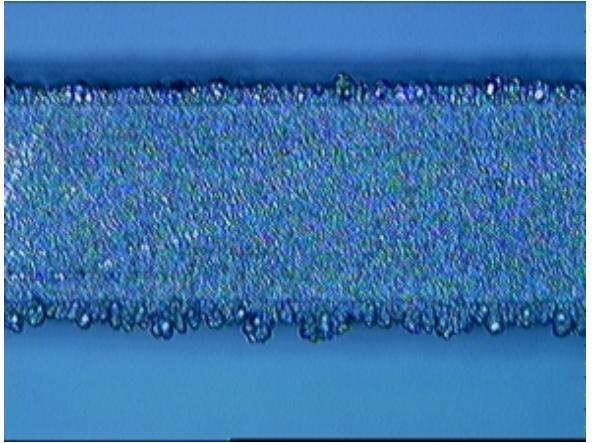
Figure 1. Rough plating

A high-speed magazine to magazine equipment is used to solder-plate components in strip form. Fresh preparations of methyl sulfonic acid (MSA)-based plating solutions yield almost problemfree plating process. However, through extended use, solution becomes turbid. Rough plating, which seem to be more pronounced at the edges, was observed in packages having high current densities. Figure 1 shows an optically magnified photo of a 28ld SSOP (Small Shrink Outline Package) termination processed when the plating solution was turbid (absorbance=3.3).

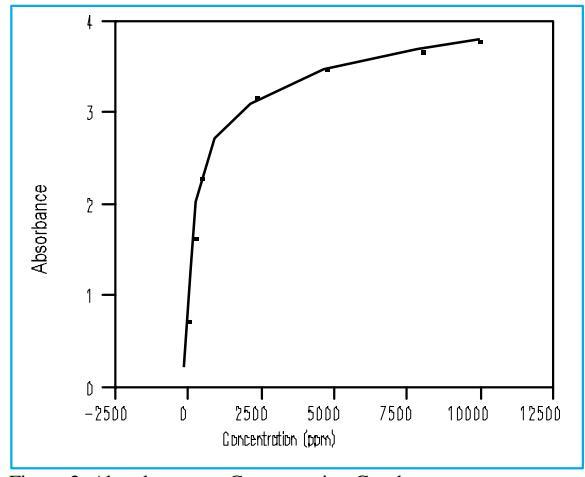
Figure 2. Absorbance vs. Concentration Graph

A chart was constructed by plotting the known amount of particulate solids (in mg/l or PPM) against the absorbance read at 380nm. Absorbance readings were observed to be exponential when plotted versus the concentration (Figure 2). The readings were noted to be asymptotic to the absorbance value of 4.0.

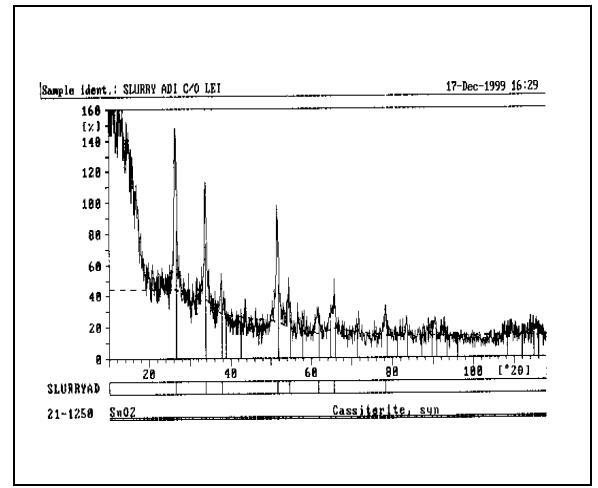
Figure 3. XRD readout of the sample

The XRD result shown in Figure 3 reported the particles to be made up of tin oxide. It was observed that during the drying process of the sample (in preparation for the XRD analysis) the tan or bonecolored sludge turned to greenish black. It is possible, though not proven in this paper, that the meta-stannic acid species exist when in solution<sup>5</sup>. These were reduced to tin-oxide when water was allowed to evaporate as shown by the following reaction:

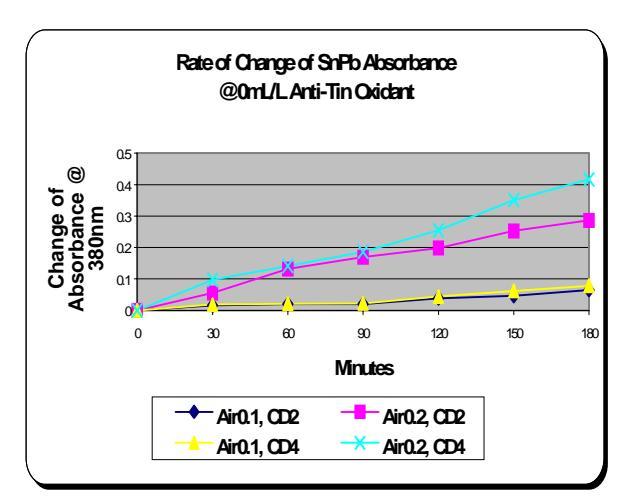
Figure 4. Rate of Change in Absorbance at 0mL/L Oxidant Concentration.

The different combinations were compared in terms of change in absorbance. As seen from the graph at Figure 4, without anti-oxidant, air is the most significant factor in inducing turbidity in the solution.

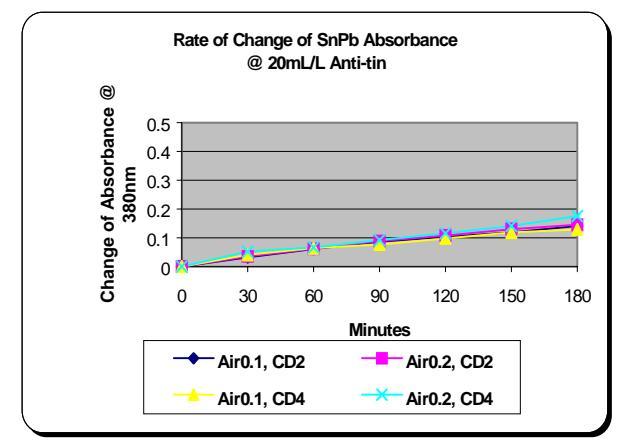
Figure 5. Rate of Change in Absorbance at increased oxidant Concentration.

The addition of anti-tin oxidant impeded the generation of the tin oxide particles, effectively suppressing the solution's turbidity. Figure 5 shows how it was able to maintain the solution clarity by keeping the change in absorbance very low at all times. Note that at lower air contact, addition of anti-Tin oxidant may not be necessary.

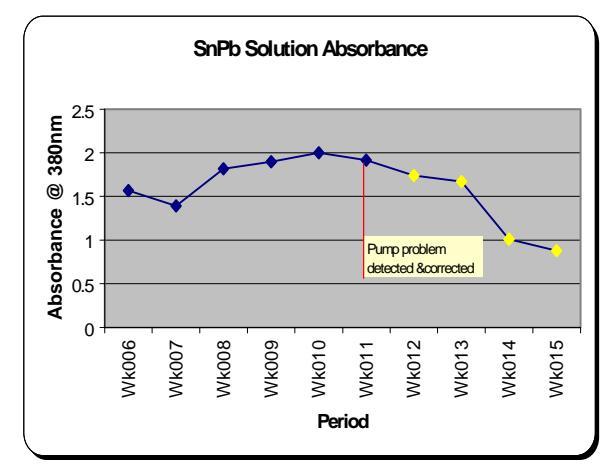
Figure 6. Absorbance trend of the plating solution

Reflecting on the implications of these experiments prompted the investigation of possible causes of abnormal air contact with the plating solution. One of the pumps used to deliver plating solution to the cell was found defective, taking in some air, instead of just the solution, with every turn of its impeller.

Figure 6 shows the improvement in the average weekly absorbance of the plating solution after the problem in the pump was detected and corrected.

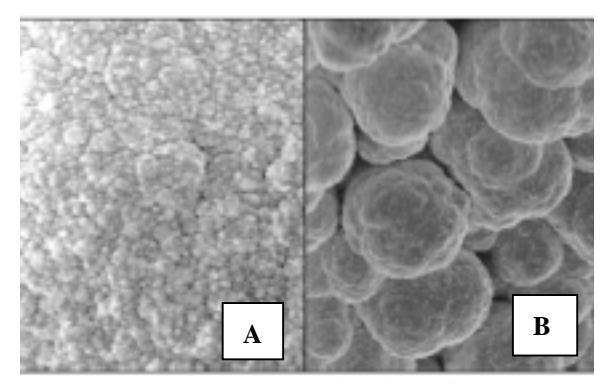
Figure 7. Surface morphology of SSOP units taken at lead edge @ 2000x magnification (A) when plating solution is clear, absorbance = 1.5 (B) when plating solution is turbid at absorbance = 3.3.

b) Unplated Tin-oxide. EDX was used to determine the composition of the surface and cross section of both units in Figure 7. EDX readings detected only Sn and Pb in both good and bad plating. The absence of oxygen peaks implies that tin oxide did not codeposit with the metal ions.

The tin oxide suspended in the solution acted as a barrier and induced a localized deposition of Sn metal in the electrode. The resulting layer is uneven and developed miniature protrusions. Since protrusions have more concentrated electric field, metal deposition is higher in that area resulting in rough surface morphology similar to that seen in Figure 7B.

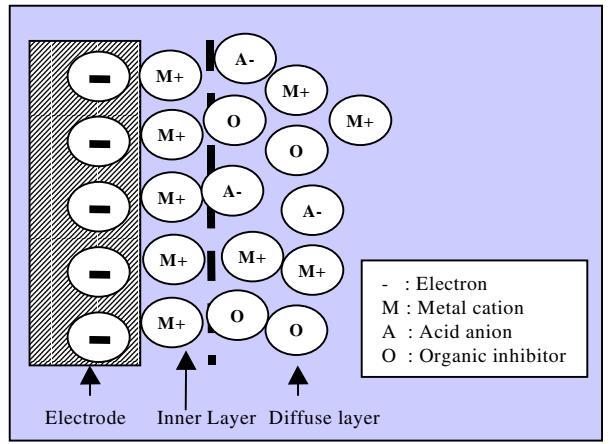
Figure 8. Helmholtz model. Source: Electrodeposition of Tin and its Alloys, M Jordan 1995.

The proposed mechanism is best explained by using the Helmholtz model, an idealized and simplified approach used by Jordan<sup>6</sup> to illustrate how metal ions are plated (Figure 8). This time, however, the presence of tin-oxide particles should be considered (Figure 9).

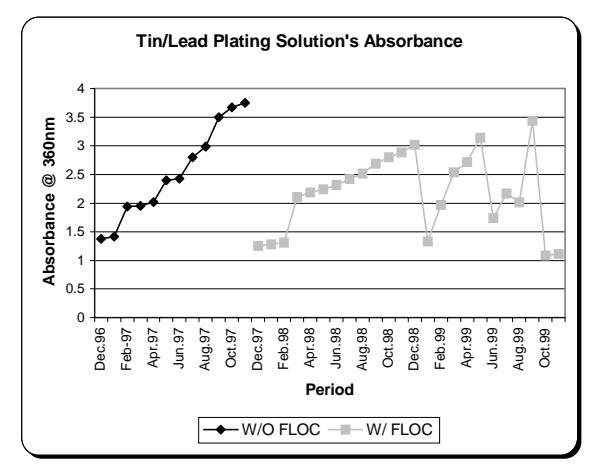
Figure 10. Absorbance of Plating Solution in the Line

Figure 10 shows how flocculation treatments enabled the extension of plating bath life. Since rough plating started to manifest when absorbance is 3.2 and higher, flocculation was implemented when absorbance reaches 3.0. Without flocculation treatments, plating solution lasted for about a year or less. With flocculation, the present plating solution (which has undergone three flocculation treatments already) was being used for two years now.

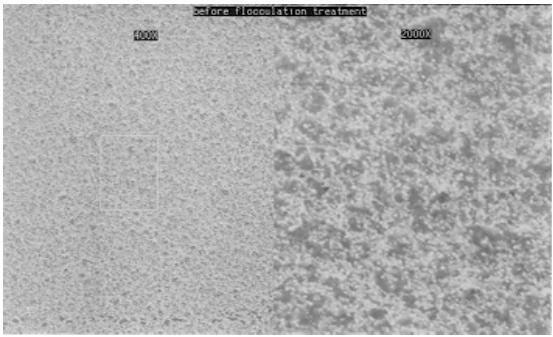
Figure 11. Surface morphology before flocculation (400 and 1000x)

An improvement was noted in the surface morphology as shown in the hull cell panel plating after the solution underwent flocculation treatment. Figure 12 (after flocculation) shows finer grain structure than Figure 11 (before flocculation).
