## **Troubleshooting Decorative Chromium Baths**

Jeff Guernsey, CEF-2, Electroplating Consultants International, Broken Arrow, OK

This paper will discuss common problems associated with decorative chromium plating baths and processes. It will focus on how to go about sectionalizing, localizing and isolating problems and how to resolve them once they can be correctly identified.

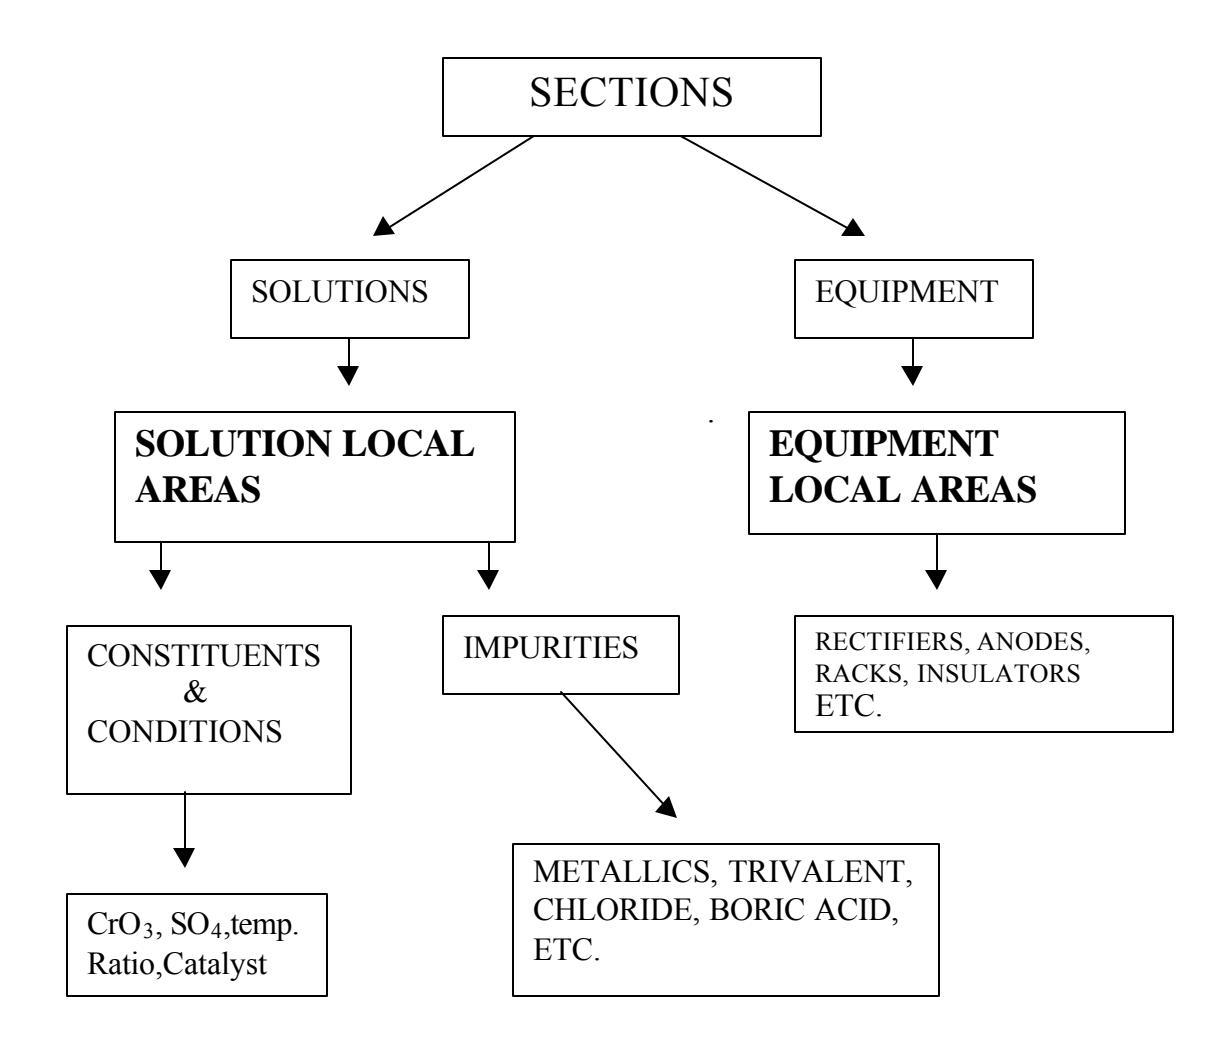
Jeff Guernsey Electroplating Consultants International 12940 South 198th Ave. Broken Arrow, OK 74014 918-455-4411 FAX 918-455-0465 eciato@aol.com Trouble shooting decorative chromium plating systems can be difficult to say the least. A technician needs information to guide him in the correct direction i.e. nickel, chrome, related processes or equipment. Sectionalizing, localizing and isolating is a systematic approach to narrowing down problems and eliminating them. Plating systems are complex and each system is different from the next. The decisions about what defines a section and what defines a local area will vary from shop to shop but for the purposes of this paper sections and local areas will be defined as follows:
