Quantitative & Localized Hydrogen Analysis of Electroplated Material

Paatsch W. & Hodoroaba V.-D. Federal Institute for Materials Research & Testing (BAM) Berlin, Germany

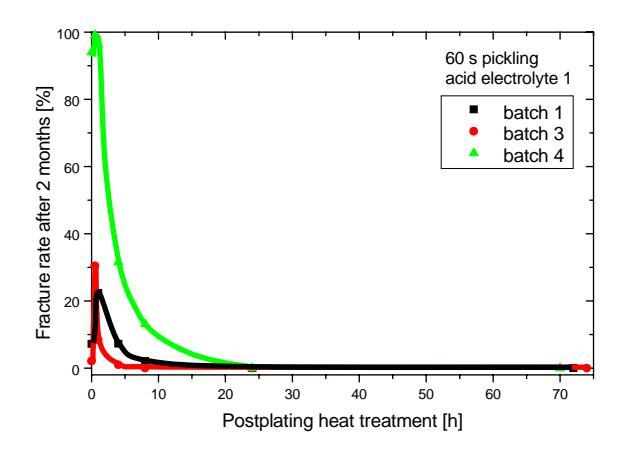
Fig. 1- Fracture rate of Zn-plated fuse holder rings with respect to the annealing time at 220°C

Each point in the diagram represents the behaviour of 100 samples and therefore fulfils statistical demands. The fracture rate first increases with bake-out time, up to a maximum and finally approaches zero with further increasing time. The reason for that behaviour is supposed to be an absorption-diffusion mechanism of hydrogen for bright or semi-bright zinc coatings⁽³⁾. According to electrochemical hydrogen permeation measurements and hydrogen concentration measurements using the hot extraction technique, a large amount of hydrogen is trapped in the zinc coating area. It is supposed that the distribution is not uniform however, and the highest concentration should be close to the zinc-base metal interface. With increasing temperature exceeding the trap energy, hydrogen diffuses mainly into the base metal as the zinc itself forms an efficient diffusion barrier. As expected this follows in a dramatical increasing of the fracture rate up to unity. With increasing bake-out time, however, a new equilibrium is read where, due to effusion and diffusion effects the hydrogen content in the base metal falls below the local critical concentration and no embrittlement occurs further on. Up to now however no analytical proof for this reasonable interpretation of the tensile test experiments has been given. Glow Discharge Optical Emission Spectrometry (GD-OES) - an already well-established analytical technique routinely used for the in-depth elemental analysis of metallic coatings of thickness in the range of some μm – has been systematically applied for measuring of the hydrogen distribution in metals. One should note that the GD-OES depth profiles can be routinely quantified by means of calibration via certified reference materials (CRM) for almost all the elements of the periodic table. However, the quantification of hydrogen is not possible yet, due to the lack of reference materials with certified amounts of hydrogen. The basic problem in the certification process is the long-term stability of the hydrogen concentration, which is very poor according to the wellknown high diffusion coefficient of hydrogen even at room temperature. We have recently carried out a survey from which three classes of coatings have been selected as being suitable as (layered) CRM for hydrogen. One should also note that on the other hand, even the qualitative hydrogen depth profiles are often useful for individual applications.

In recent investigations⁽²⁾ high strength fuse holder rings where conventionally semi-bright zinc plated, heat treated and mounted on a cylindrical pin that way, that the stress was close to the yield point but below any plastic deformation. The fracture behaviour, depending on the post-plating heat treatment after a two-month testing time is shown in Figure 1.

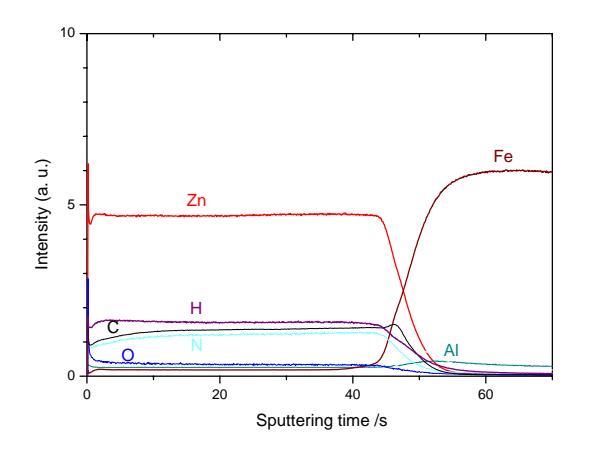
Fig. 2 - Depth profiling of an electrolytically deposited Zn-layer

Following the profile of Zn and Fe it can be concluded that a high and constant hydrogen content is detected within the Zn layer and no significant hydrogen is present in the base metal. Obviously hydrogen is incorporated into the layer, probably as $Zn(OH)_2$ and organic additive derivates respectively. Analysis with Raman spectroscopy in order to identify the compounds containing hydrogen are in progress. For comparison Fig. 3 show the depth profile of a Zn layer produced by hot dip galvanizing , which obviously does not contain a remarkable hydrogen concentration.

The hydrogen depth profile of a Zn-plated sample using a commercial semi-bright low acid electrolyte is represented in Figure 2.

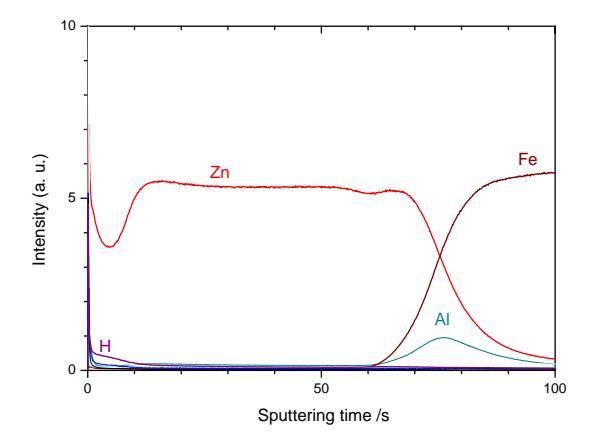
Fig. 3 - Depth profiling of a Zinc layer deposited by hot dip galvanising

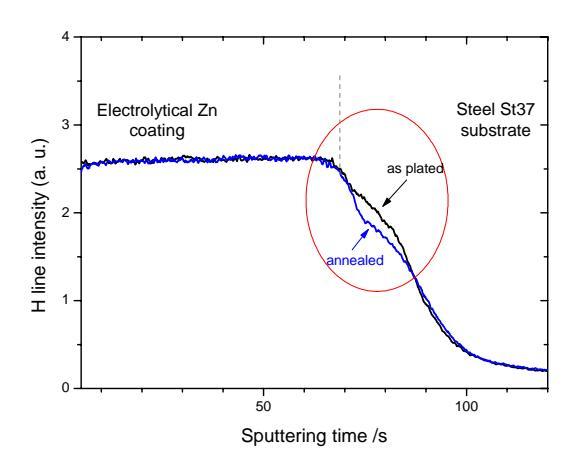
Coming back to the case of Zn coating *electrolytically* deposited, GD-OES depth profiling of samples being annealed for 24 hours in an argon atmosphere at 220°C (Figure 4) gives evidence that the hydrogen chemically bound in the layer itself is not influenced. Further on hydrogen being trapped in the layer–base metal interface diffuses and effuses resulting in a lower concentration and more homogeneous distribution in the base metal. Thus following the interpretation of the results of sustained load test experiments.

Fig. 4 – Depth profiles of H only in an electrolytically deposited Zn layer: (i) unannealed (black curve) and (ii) annealed (blue curve) 24 h, 220^oC in Argon.

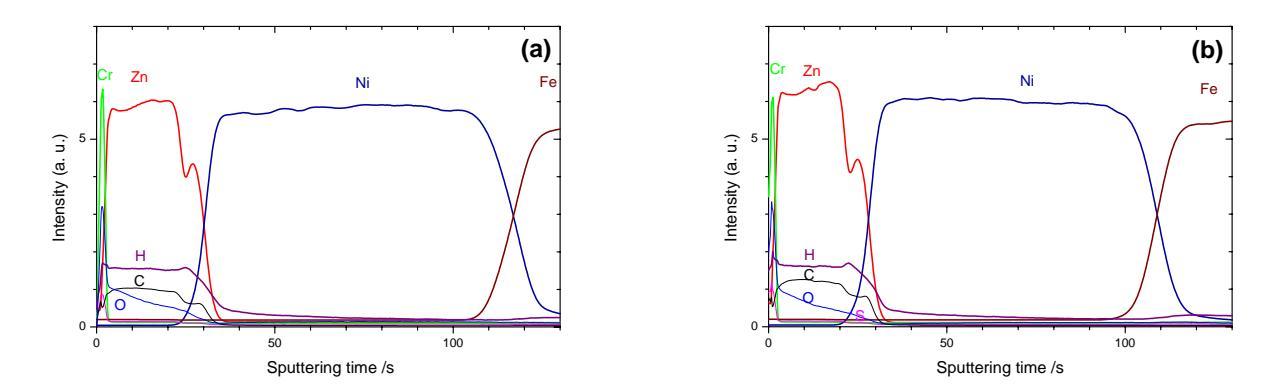
An innovative Zn-plating process of high interest has been recently developed, where a thin Ni layer is plated preceding the Zn plating in order to avoid the heat post-treatment ⁽⁷⁻⁹⁾. For electrochemical reasons during the Ni plating process as well as at the Ni surface itself the hydrogen recombination process to molecular hydrogen is preferred. As a result the partial pressure of hydrogen at the surface is less and therefore hydrogen penetration into the base metal is reduced. The hydrogen profile in Figure 5a shows no significant hydrogen at the base metal-Ni interface and about the same at the Ni-Zn interface. As expected no change is found after a conventional heat treatment at 220°C for 2 hours (Figure 5b). Of course this result has to be

Fig. 5 - Depth profiles of an electrolytically deposited and blue chromated Zn-layer with a Ni intermediate layer (a) as plated and (b) after heat treatment.

confirmed by sustained load tests as hydrogen embrittlement is a complex system property where the local hydrogen concentration in the area of critical tensile stresses within a component is deciding.

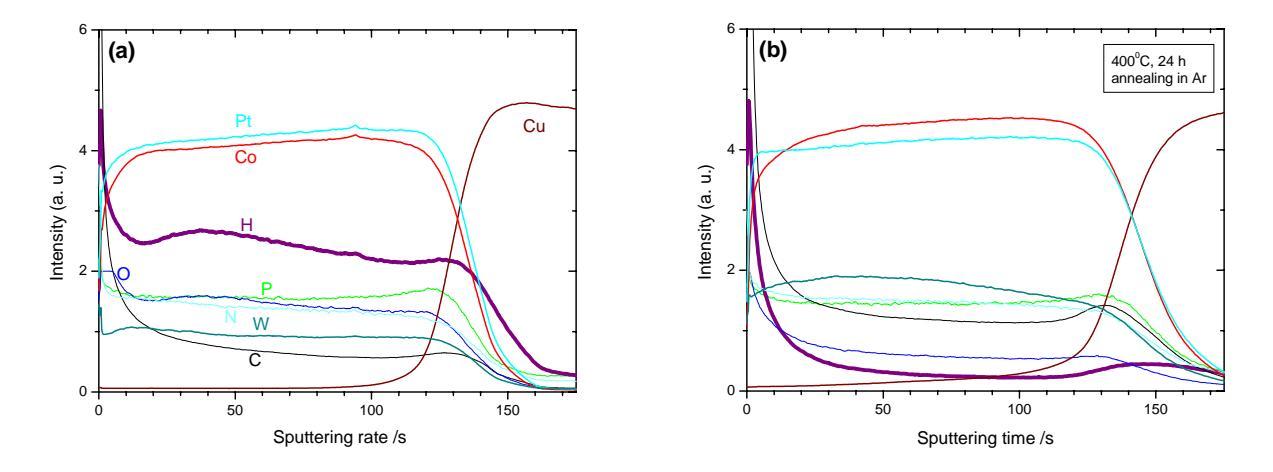
A further example is given for a magnetic CoPtW-layer electrolytically deposited on a copper substrate. Figure 6a shows that GD-OES depth profiling results in a remarkable hydrogen content within the coating. No hydrogen can be found in the copper base metal, which is known to form a very efficient diffusion barrier for hydrogen. After annealing the sample at 400°C for 24 h (Figure 6b) no hydrogen can be detected any more, indicating its vanishing due to an effusion process.

Fig. 6 - Depth profiling of an electrolytically deposited CoPtW-layer as plated (a) and after annealing (b)

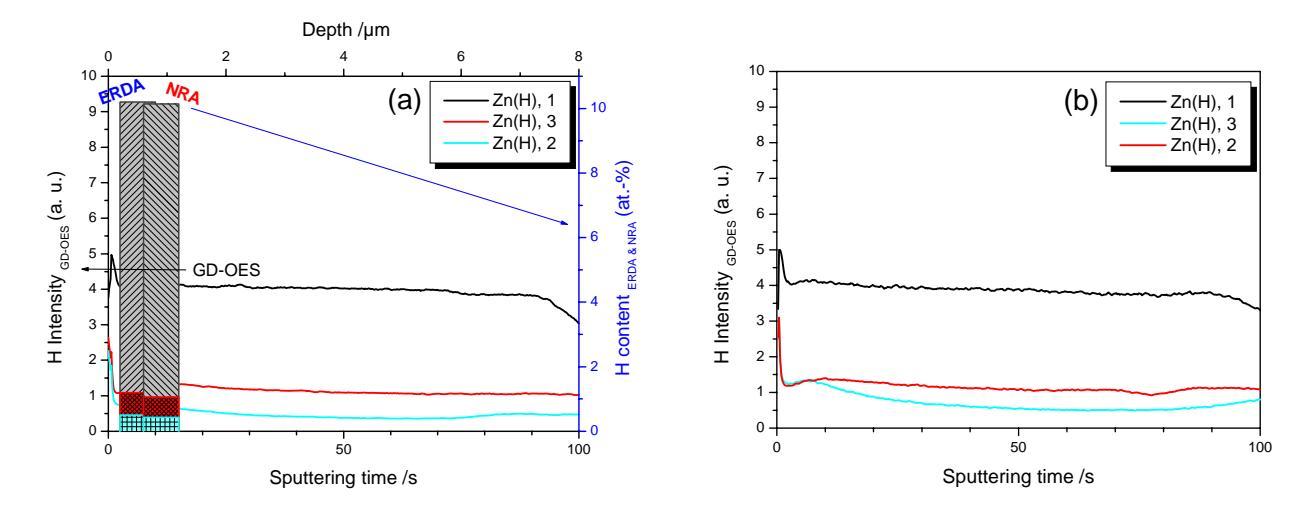
Fig. 7 – GD-OES depth profiling of H of three various concentrations in electrolytically Zn coatings together with the absolute H concentrations as measured in the first ~1.5 μ m depth by ERDA and NRA, respectively (a); stability test after 5 months (b).

As one can see in Figure 7a, both ERDA and NRA quantitative results are in a good agreement each other and the correlation of the H concentrations with the H signals found in GD-OES is not linear. Further investigations related to this point are necessary, nevertheless matrix effects were expected. Exact determination of the sputter rates (necessary to be known for new CRMs) are planned, however they are difficult to be performed with high accuracy (by weighing). First stability measurements for this type of coatings have been performed by GD-OES after 5 month and show a quite good stability of the hydrogen concentrations (Figure 7b). Measurements of both in-depth and lateral homogeneity of the hydrogen concentration in the microscopic range by Secondary Ion Mass Spectrometry (SIMS) are in progress. An extension of the range of application of H-CRM for other analytical methods is obviously welcome.

there is no CRM suitable for GD-OES calibration of H (www.comar.bam.de). Various trials in the past of production of bulk materials (charged with H) or hydride pellets have failed, as the H concentration was not stable over longer periods of time (even at room temperature). The reliable alternative has been proven to be some thick *coatings* containing H in *bound* form and hence unable to diffuse easily even at higher temperatures. An immediate example of such a potential reference coating is just offered by electrolytical Zn (see Figure 4). First test samples with various hydrogen concentrations in the Zn coating have been produced and supposed to homogeneity and stability investigations. The in-depth and lateral homogeneity of the H concentrations in the macroscopic range is tested by GD-OES (qualitatively only); the first ~1.5 μ m from the top surface are quantitatively analysed by ERDA and NRA, respectively. The results of the H concentrations for three different electrolytical Zn coatings can be put together as follows in Figure 7a.

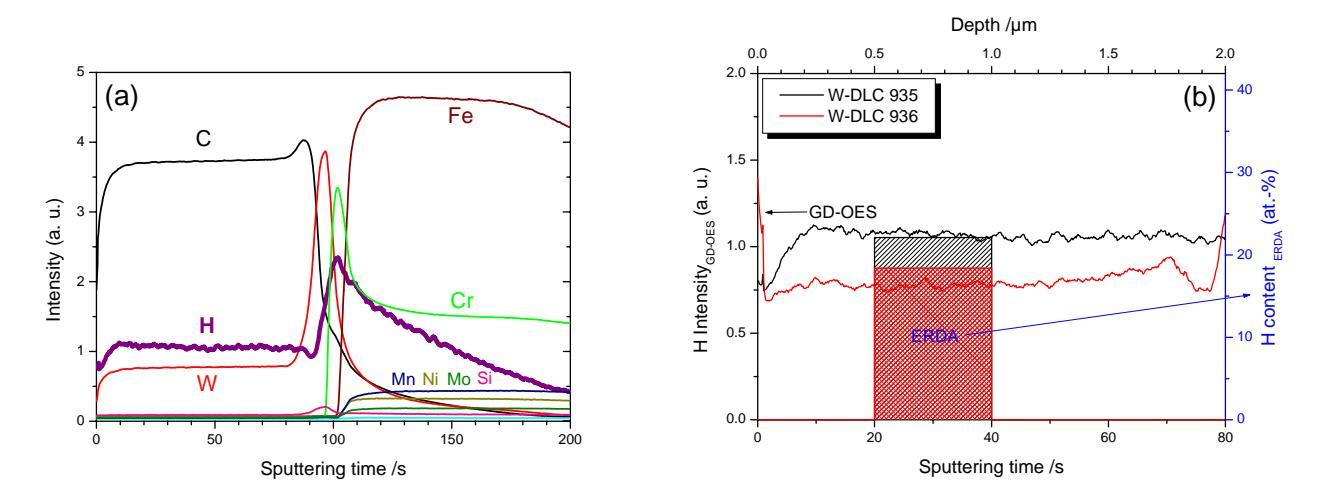
Fig. 8 – GD-OES depth profile of a W-DLC(H) coating deposited on steel (a); GD-OES depth profiles of H only for two different H concentrations determined by ERDA (b).

W-DLC hard coatings containing hydrogen, see Figure 8, have been established as a second class of coatings where the homogeneous concentration of H keeps stable.

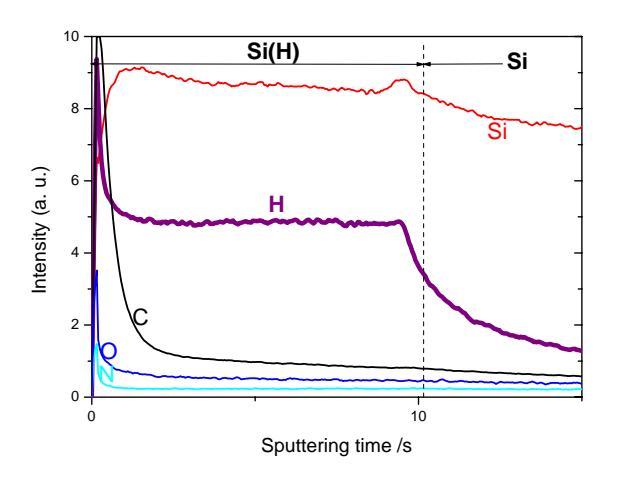
Another suitable candidate of H-CRM can be Si(H), see Figure 9. The existent Si(H) layers are thin layers (having a thickness in the range of ~100-200 nm) destined for NRA; production of thicker layers is under discussion.

Fig. 9 – *GD-OES depth profile of a Si(H) layer on Si wafer.*
