# Microribbons in Hard Chromium Electrodeposits

#### Allen R. Jones and Craig V. Bishop, Atotech WW R&D

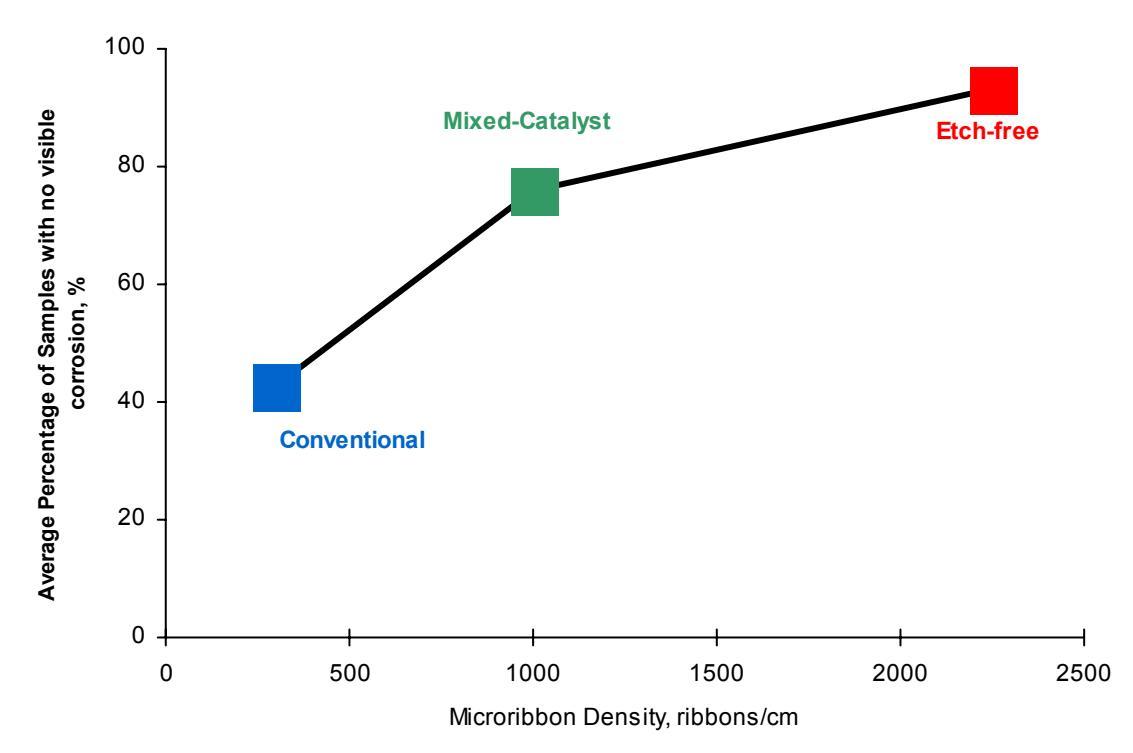
Figure 1. Corrosion resistance of 25-µm thick deposits without post finishing after 200 hrs. vs. Microribbon Density.

A corrosion study was conducted to determine the effect of temperature and microribbons (mrb) on corrosion resistance. Ten samples were plated from an etch-free bath under identical conditions at both 60 and 70°C and then tested in a neutral salt spray test (NSST) according to the specification ASTM B117. The samples had a chromium thickness of 25  $\mu$ m and were not post finished. Table 1 shows that for deposits plated in an etch-free bath, as the microribbon density increases, the deposits corrosion resistance increases significantly. The anodic etch method used to develop microribbons is described on page 9. It is normal for the microribbon density and the conditions move to a regime that is out side of the bright plating range. Figure 1 shows that in different plating chemistries, as the microribbon density increases the deposits corrosion data used in this plot is from prior studies by Newby<sup>6</sup> and the microribbon density data was estimated from the plating conditions using data from Jones<sup>4</sup>. This data shows that microribbon density is an important factor in determining a plated products corrosion resistance.

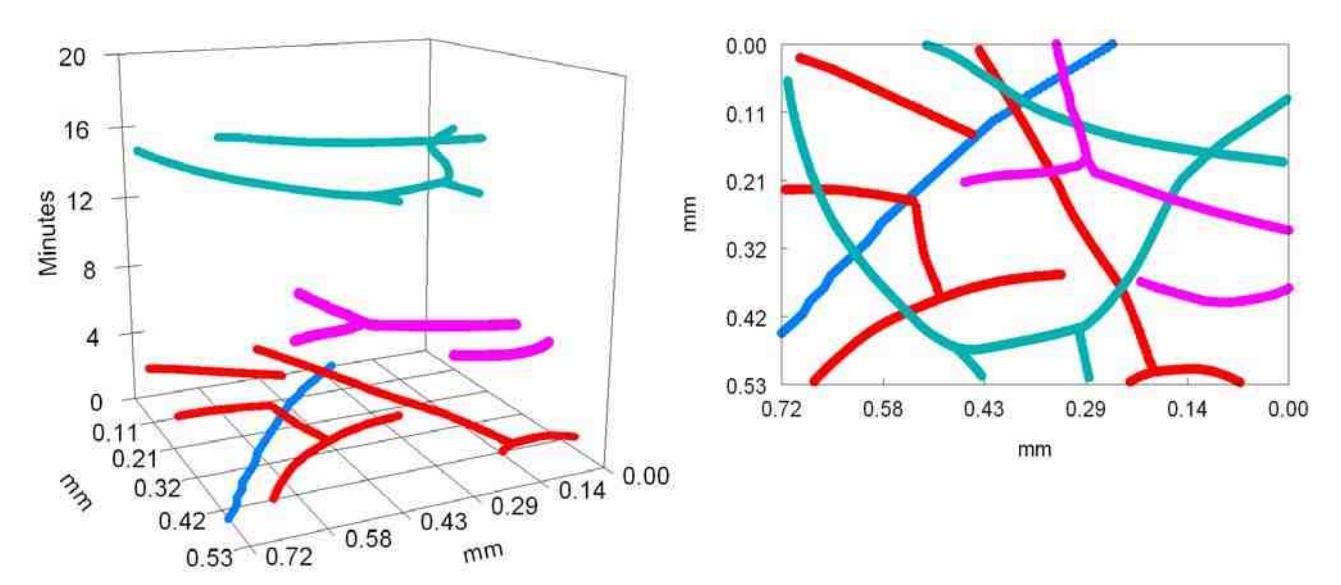
Figure 2. 3-D and 2-D representations of spatial and temporal distributions of microribbons from a film recorded during electrodeposition in a conventional solution. The microribbon at time 0 was at the start of recording, microribbons are shown at 2, 5 and 15 minutes.

Jones<sup>4</sup> filmed microribbons in a conventional solution. This data was used to generate the 2-D and 3-D representations of microribbons shown in Figure 2. These graphs show the spatial and temporal distributions of microribbons in a conventional chromium deposit. Four microribbon episodes are represented. The deposit contained 170 microribbons/cm based upon anodic etching of the sample. The films showed copious quantities of hydrogen gas emanating from or coalescing at the microribbons. At a magnification of 650x when the current was monetarily turned off, the gassing ceased and the microribbons were not visible. Prior microribbons were visible in the chromium surface.

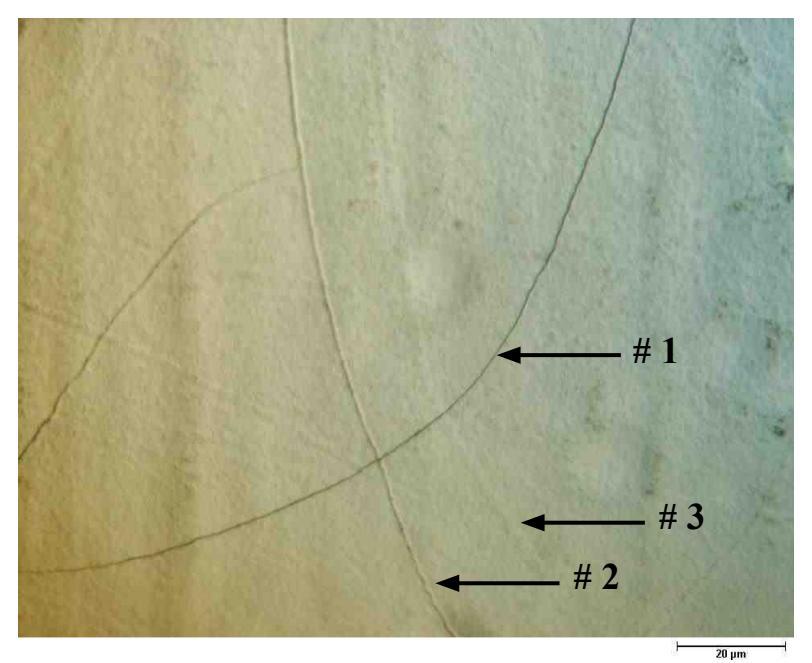
Figure 3. As-plated chromium samples from an etch-free bath. At least three microribbon layers are visible; #1 is the outer most, #2 is deeper, and #3 is the deepest. (0410a00137)

As-plated deposits exhibit many microribbon episodes on the chromium surface. Figure 3 shows at least three layers of microribbons. The outer most microribbon (#1) may contain a crack and the deepest (#3) is filled in and plated over and leaves a faint "foot print" in the chromium deposit.

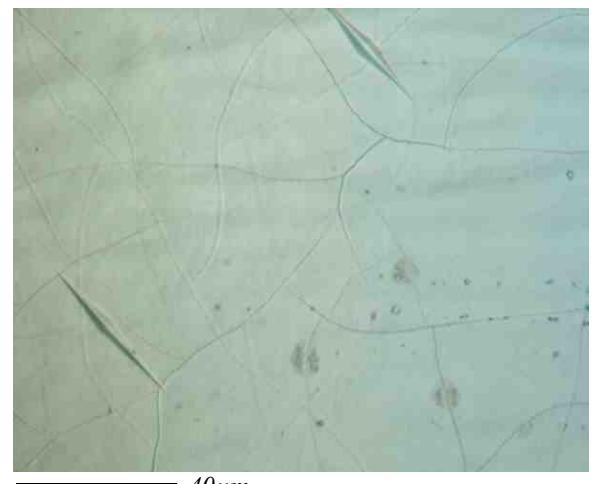
Figure 4 As-plated etch-free deposit.

A study was completed to determine if the most visible microribbons are the first to be etched and widest after anodic etching is used to develop the microribbons. Microhardness indents were used as landmarks so that photographs could be taken after the etching process. The sample used for this testing was a 25-µm thick etch-free deposit plated from a solution containing 250 g/l of chromic acid, 3.2 g/l sulfate, and catalyst at 60°C and 30 A/dm<sup>2</sup>. The substrate used was AISI 1018 hexagonal bar. The anodic etch was performed in a 100 g/l sodium hydroxide solution at 31 A/dm<sup>2</sup> for 1, 2, and 3 minutes. The results are shown in Figures 4-7. The most visible microribbons in the as-plated sample are the first to be developed by the anodic etching and become more pronounced with increased etching. As the etching is continued more microribbons are developed.

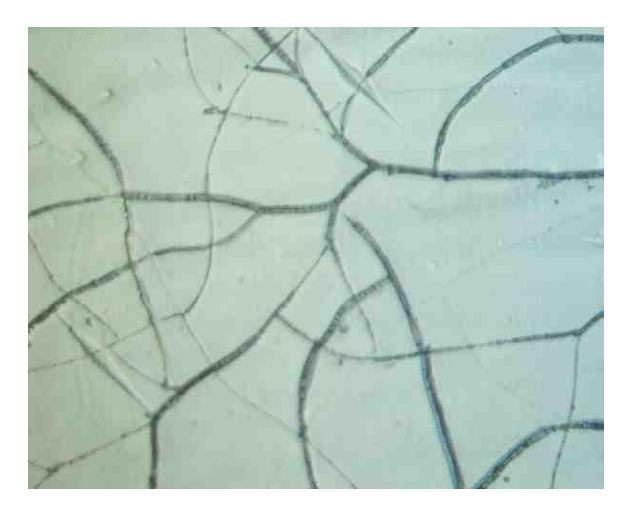
Figure 5. After anodic etching for 1 minute at 31 A/dm<sup>2</sup>.

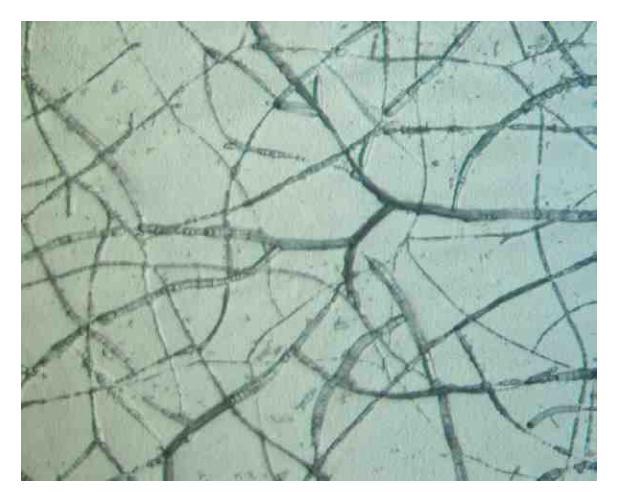
Figure 6. After anodic etching for 2 min at 31 A/dm<sup>2</sup>.

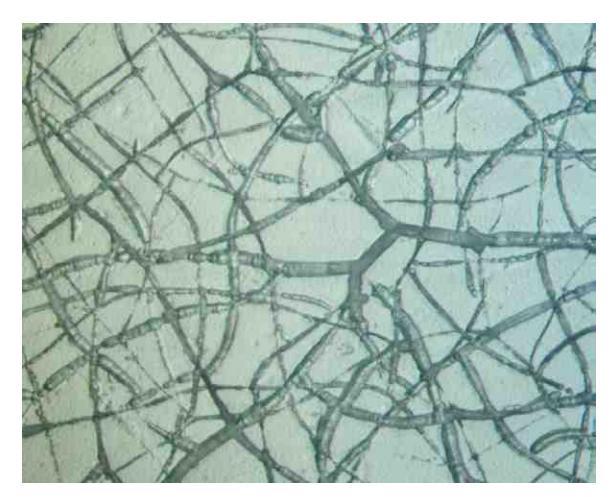
Figure 7. After anodic etching for 3 min at 31 A/dm<sup>2</sup>.

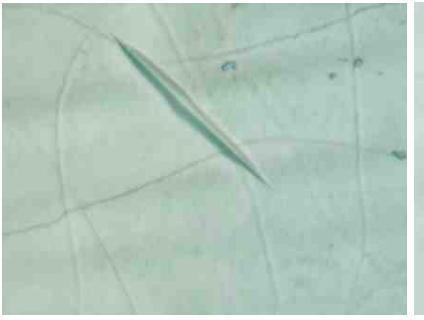
Figure 8. As-plated sample

Kobayshi, et al<sup>14</sup> reported that microribbons could be removed or cloaked with post finishing and that this was accomplished more readily with etch-free deposits, which contain more microribbons. This was confirmed using a manual post finishing method. The chromium deposit used for these tests was taken from a different area of the sample used in the above-mentioned anodic etching tests. Microhardness indents were used as landmarks so that photographs could be taken after the buffing process. The sample was buffed using green compound on a hard muslin wheel for 5 and 10 seconds. As shown in Figures 8-10 the microribbons are diminished after 5 seconds of buffing and not visible after 10 seconds. Ultrasonic treatment after buffing did not make the microribbons more visible. This indicates that the microribbons were not just filled with compound but that metal was possibly smeared over the microribbons. The length of the indents decreases with buffing; indicating that metal was removed during the buffing process or chromium metal was moved into the indent.

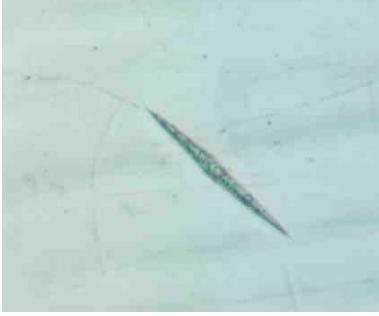
Figure 9. After 5 sec of buffing.

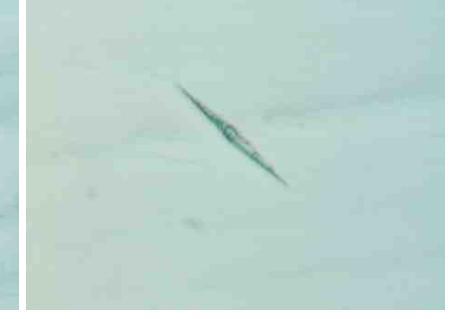
Figure 10. After 10 sec of buffing & 2 min ultrasonic.

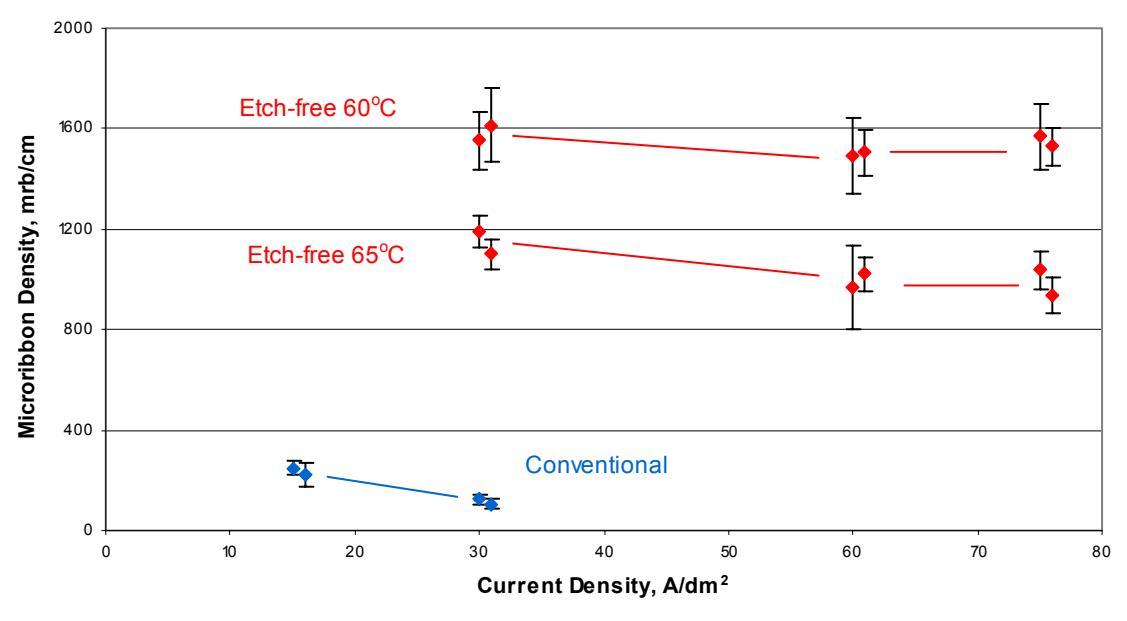
Figure 11. Microribbon density vs. current density for conventional and etch-free deposits. The error bars are based on 90% confidence intervals.

The microribbon densities were developed and determined using an anodic etch process. After cleaning, the sample was anodically etched in a solution that contained 100 g/l of sodium hydroxide for two minutes at 46.5 A/dm<sup>2</sup>, rinsed and dried. The part was examined under sufficient magnification so that between 10 and 20 microribbons intersect a reference line on a grid. All of the microribbons intersecting several lines were counted in three different areas on the same part. The microribbon densities are calculated based upon their number per unit length and the magnification. The microribbon densities are shown in Table 2 and Figure 11, each value is the average of nine measurements. The microribbon densities of the conventional deposits are much lower than the densities for the etch-free deposits and as the current density increases the microribbon densities of the conventional deposits decreases. The microribbon densities of the etch-free deposits plated at 60°C are more than 10 times higher than the microribbon densities of the conventional deposits. The microribbon densities of the etch-free chromium deposits do not vary with changes in current density, but higher plating temperatures decrease the microribbon density. As indicated by the 90% confidence interval error bars in Figure 11, there is considerable uncertainty in microribbon densities. This means that microribbon densities of 1400 and 1600 mrb/cm may not be statistically different values.

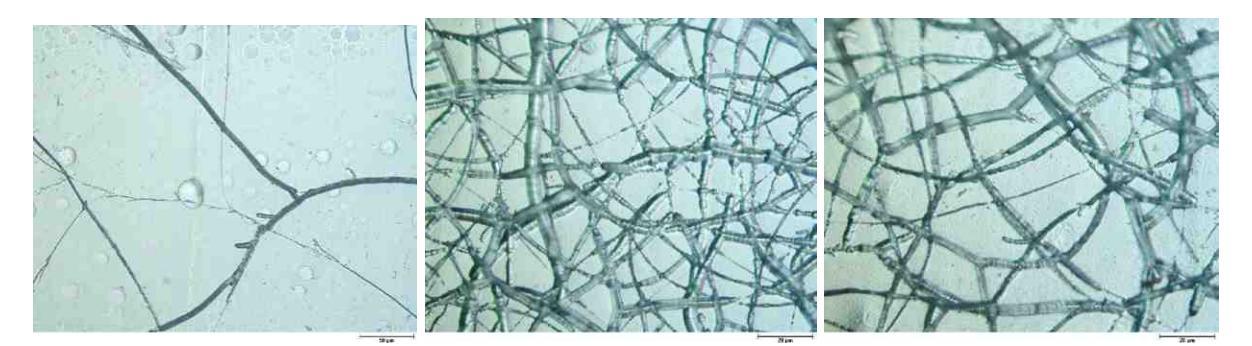
Figure 12. Etched surface of conventional deposit M5 at 400x.

Figure 13. Etched surface of etchfree deposit M7 at 1000x.

Figure 14. Etched surface of etchfree deposit M16 at 1000x.

Figures 12, 13, and 14 show the etched surface of conventional sample M5 and etch-free samples M7 and M16, plating conditions are shown in Table 2. The conventional deposit has very few microribbons and they are wide. The etch-free deposits have many microribbons after etching and many of these microribbons are very narrow.

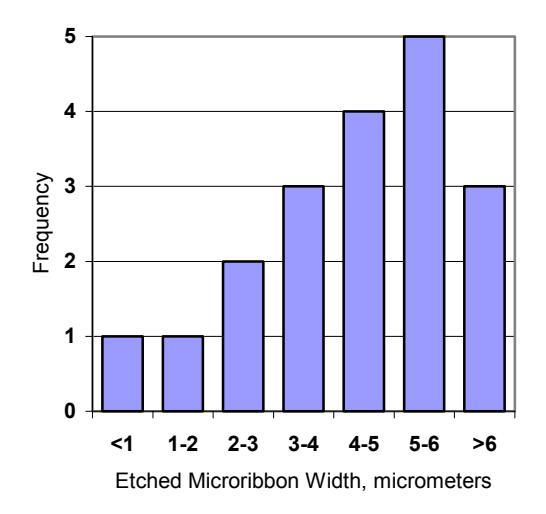
Figure 15. Etched microribbon width data for conventional deposits M4 and M5.

To better understand microribbons, the width of the etched microribbons were measured. The distributions of the widths for several samples are shown in Figures 15-19. These figures show the frequency or number of microribbons in a specific width range; for example, between 1 and  $2\mu m$ , or 3 and  $4\mu m$ , etc.

Since the conventional deposits contain so few microribbons, the data from samples M4 and M5 were combined to produce a larger microribbon sample size. The frequency axis and values for the conventional deposits are much smaller than the axis and values for the etch-free deposits. The software used to measure the etched microribbon widths is limited to values greater than  $0.8\mu m$ . Microribbons widths of less than  $0.8\mu m$  were assigned values of  $0.5\mu m$ .

There is a significant difference in the distributions between conventional chromium deposits and etch-free chromium deposits. The conventional deposits have a majority of microribbon widths of >4  $\mu$ m where as etch-free deposits have a majority of widths <3  $\mu$ m. The microribbon width distributions for etch-free deposits plated at 30 A/dm<sup>2</sup> and 60 A/dm<sup>2</sup> are very similar, however the distribution of the deposit plated a 75 A/dm<sup>2</sup> has a slight shift to intermediated microribbon widths.

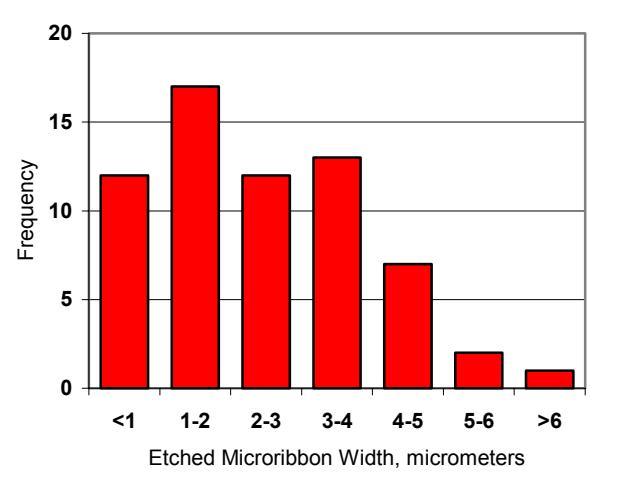
*Figure 16. Etched microribbon width data for etchfree deposit M7.*

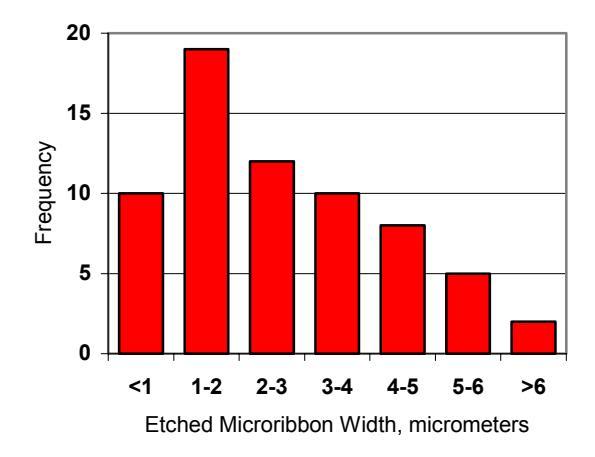
*Figure 17. Etched microribbon width data for etch-free deposit M10.*

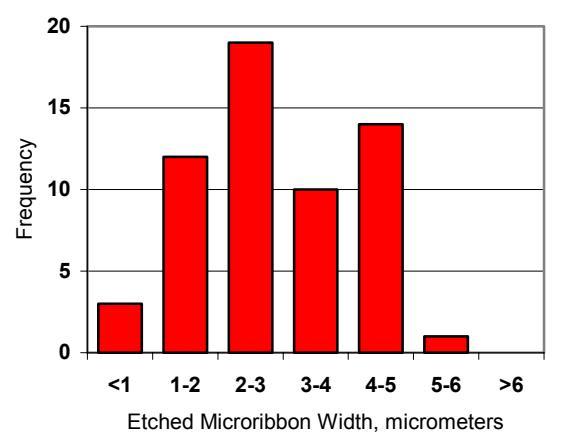
*Figure 18. Etched microribbon width data for etch-free deposit M14.*

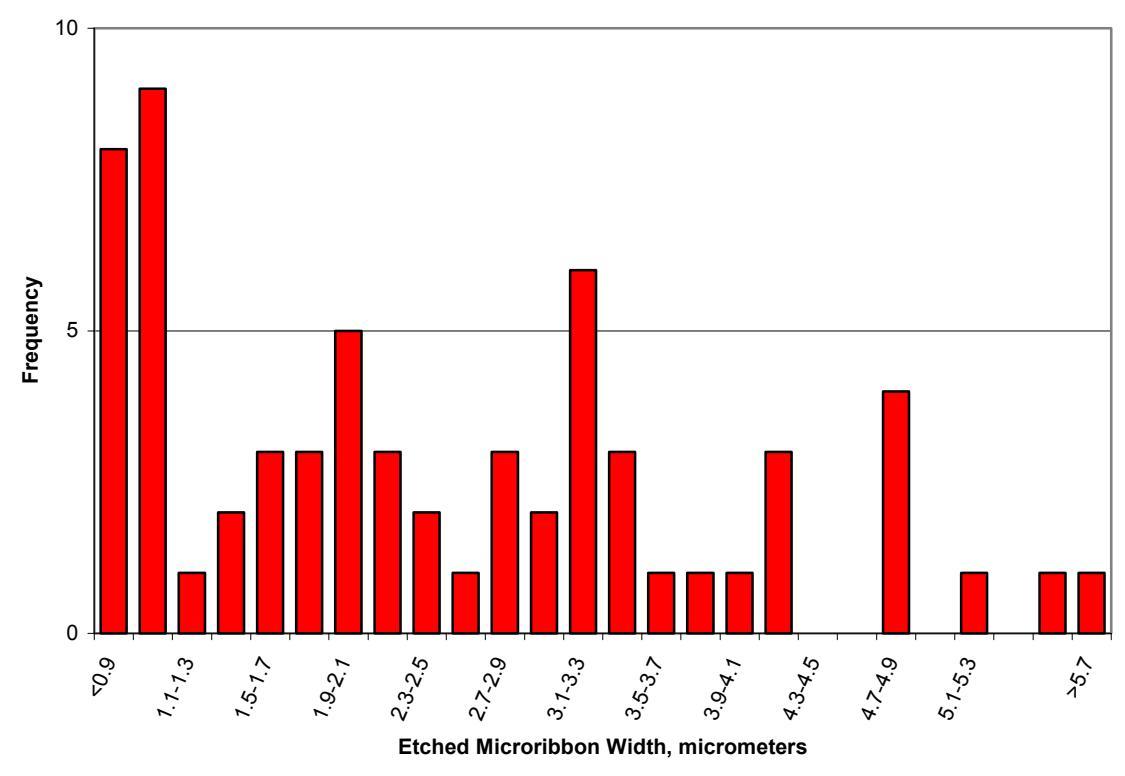
Figure 19. Etched microribbon width data for etch-free deposit M7.

Figure 19 shows a more detailed distribution of the data from Figure 16 for sample M7. This data shows at least three different microribbons episodes. The deepest episode is represented by the narrowest ribbons; <0.9 and 0.9-1.1  $\mu$ m. The next layer is delineated by microribbons with widths of 1.9-2.1  $\mu$ m, and a third layer exhibits ribbon widths of 3.1-3.2  $\mu$ m. There may yet be another layer with ribbon widths of 4.1-4.3 or 4.7-4.9 $\mu$ m. The outer most layers may be less distinct because the ribbons are wide and may overlap with other ribbons.

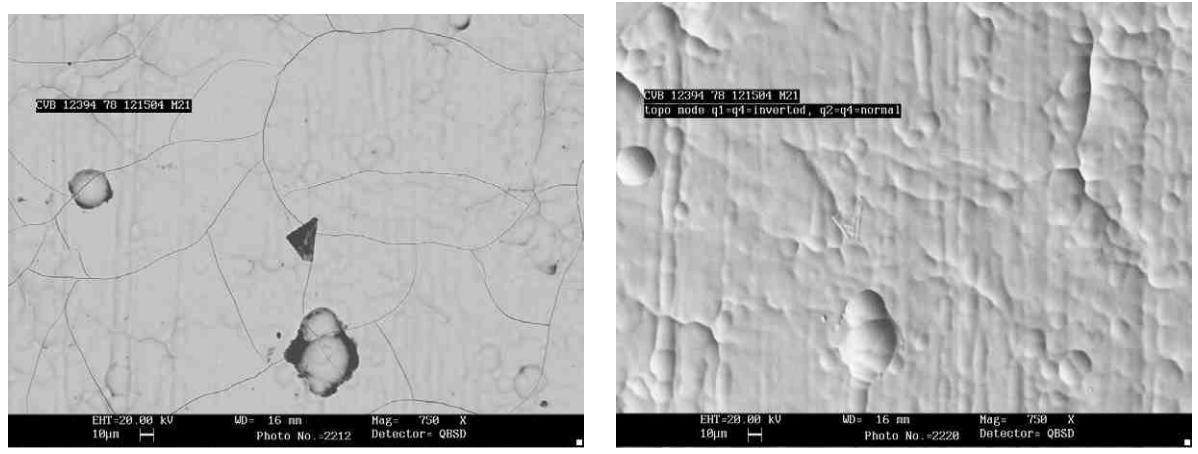
Figure 20. Composition mode, unetched. (12150402) Figure 21. Topographical mode, unetched. (12150409)

Figures 20 and 21 show scanning electron micrographs (SEM) of the same sample of an etchfree deposit as plated. The SEM used was a LEO 430 with an EDAX (CDU, LEAP) detector. Both images were recorded with the same accelerating voltage, magnification, tilt, and working distance. The high contrast four quadrant backscatter detection compositional (atomic number) mode image in Figure 20 shows microribbons and some of the surface details. The backscatter coefficient is proportional to the atomic number. Thus, in the compositional mode, brighter areas represent higher atomic number elements like chromium. This figure shows that all of the surface microribbons terminate when they meet another microribbon. This results in intersections of three microribbons but is only true for microribbons in the same layer. Microribbons in different layers can appear to have four microribbons intersecting as in Figure 3 for ribbons #1 and #2. The topographic backscatter contrast mode, from the same detector, image in Figure 21 shows very faint ridge and valley lines corresponding to the microribbons and shows the topographical features of the surface in greater detail.

These images show that even the surface microribbons may be filled in and are not cracks in the surface to any significant depth. Additional images using secondary electron detection show more microribbons as the accelerating voltage is increased. In these images the under lying microribbons were visible at higher accelerating voltages. Topographical mode shows the topography of the surface in greater detail than the composition mode, thus if the microribbons

were cracks, they should be more visible in the topographical mode. The microribbons are more apparent in the compositional mode, which indicates that the microribbons are chemically different than the bulk of the chromium deposit. The darker microribbons in Figure 20 may be due to the presence of elements with an atomic number less than chromium. Those elements would include: hydrogen, carbon, oxygen, and sulfur, with hydrogen and oxygen the most likely elements in the microribbons.

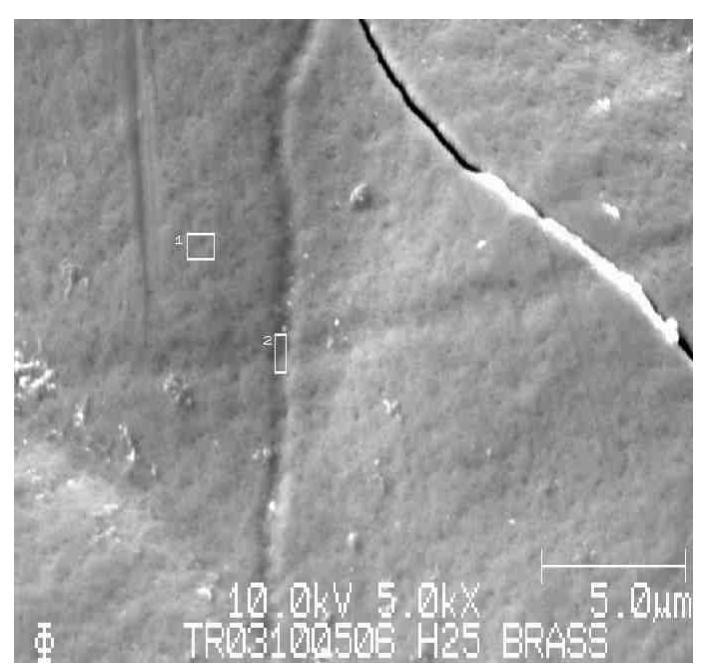
Figure 22. SEM image of 25-µm etch-free deposit.

Microprobe (FE-SAM). The FE-SAM used is Perkin-Elmer PHI 680 located at CASE Western Reserve University in the Department of Materials Science and Engineering. The plating conditions for this sample were the same as the conditions used for sample M7, in Table 2. The areas analyzed are shown in Figure 22, a bulk chromium area (#1) and a microribbon area (#2). Area #2 will etch more rapidly in a chemical or an anodic etch, than the bulk chromium. FE-SAM spectra in Figure 23 showed no difference in composition between the areas. This technique will not detect hydrogen. These results were not expected since Jones<sup>5</sup> reported that the bulk oxygen content of conventional deposit is 0.36% and etch-free deposit is 0.84%. The source of the additional oxygen in the etch-free deposits was theorized to be from the increased amount of microribbons. Analysis of chromium deposits on steel substrate also showed no compositional difference between the bulk and microribbon areas. The surface crack in Figure 22 appears to have a width of approximately 0.2  $\mu$ m, after sputtering.

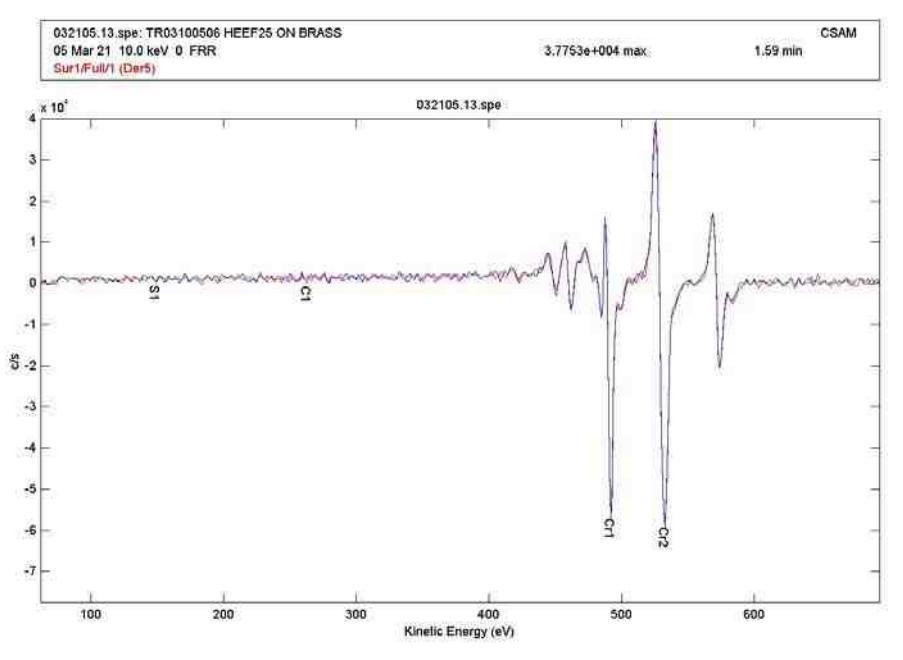
Figure 23. FE- SAM of 25-µm etch-free deposit on brass.

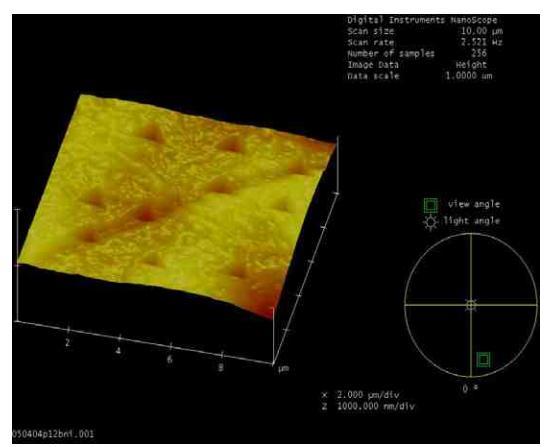
Figure 24. Test #1 nanoindents.

microribbons to determine if the mechanical properties of the two areas are different. Figure 24 shows three nanoindents in a microribbon and four in the bulk chromium. Figure 25 shows four

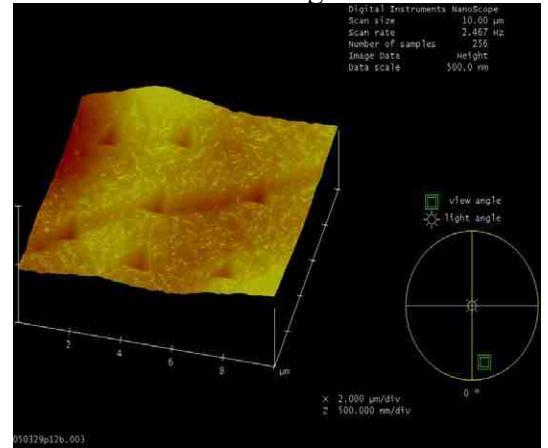
Figure 25. Test #2 nanoindents.

nanoindents in a microribbon and six in the bulk chromium. The differences in Young's modulus values compared to the average bulk value in each test are shown in Figure 26. This data shows that in 90% confidence intervals, Young's modulus values for the microribbons are statistically higher than the values for the bulk chromium. The scatter in the data may be due to the difficulty of placing the nanoindent in the microribbons or due to the presence of underlying microribbons. This data shows that the material in the microribbons is a different composition or crystal structure.

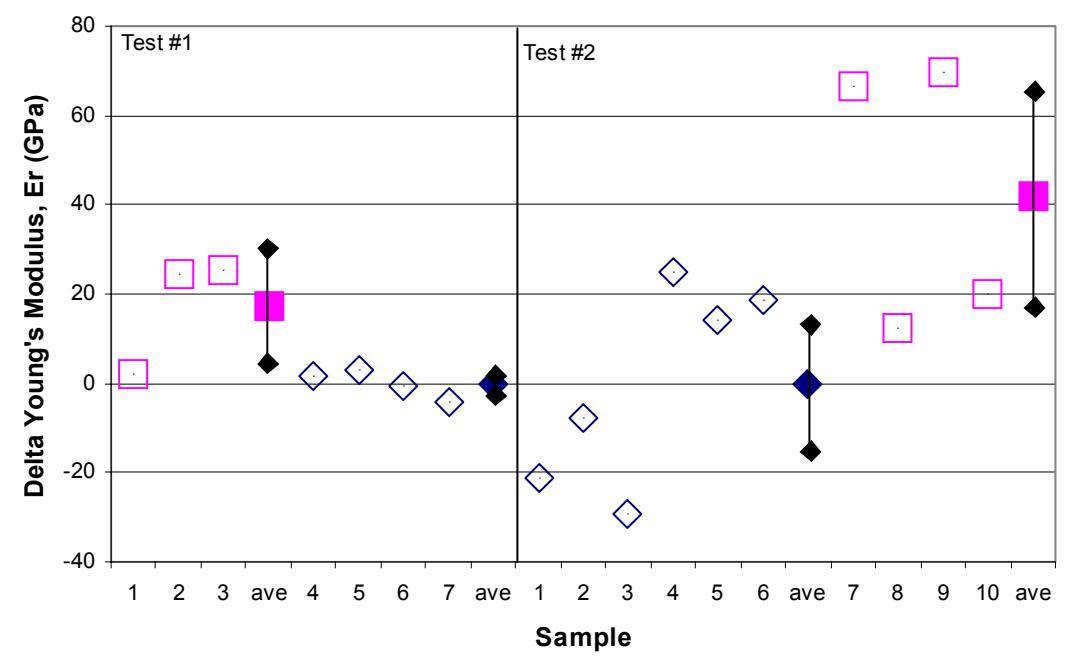
Figure 26. Change in Young's modulus for microribbon areas vs. bulk chromium areas.

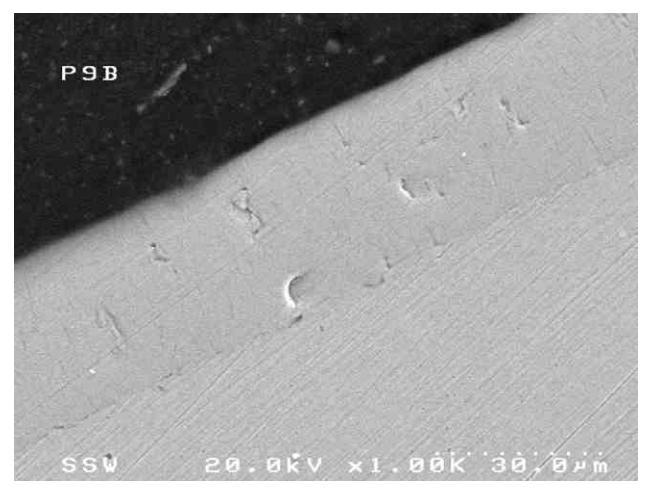
Figure 27. Field Emission secondary electron micrograph etch-free deposit.

The results in Figures 27 and 28 depict the dramatic effect of microribbons and heat treatment on the chemical distribution in the chromium deposits. Concentration SIMS image maps are shown in Figure 28 for Cr, H, O, and  $CrO_2$  for the as-plated and heattreated chromium deposits. The iron substrate

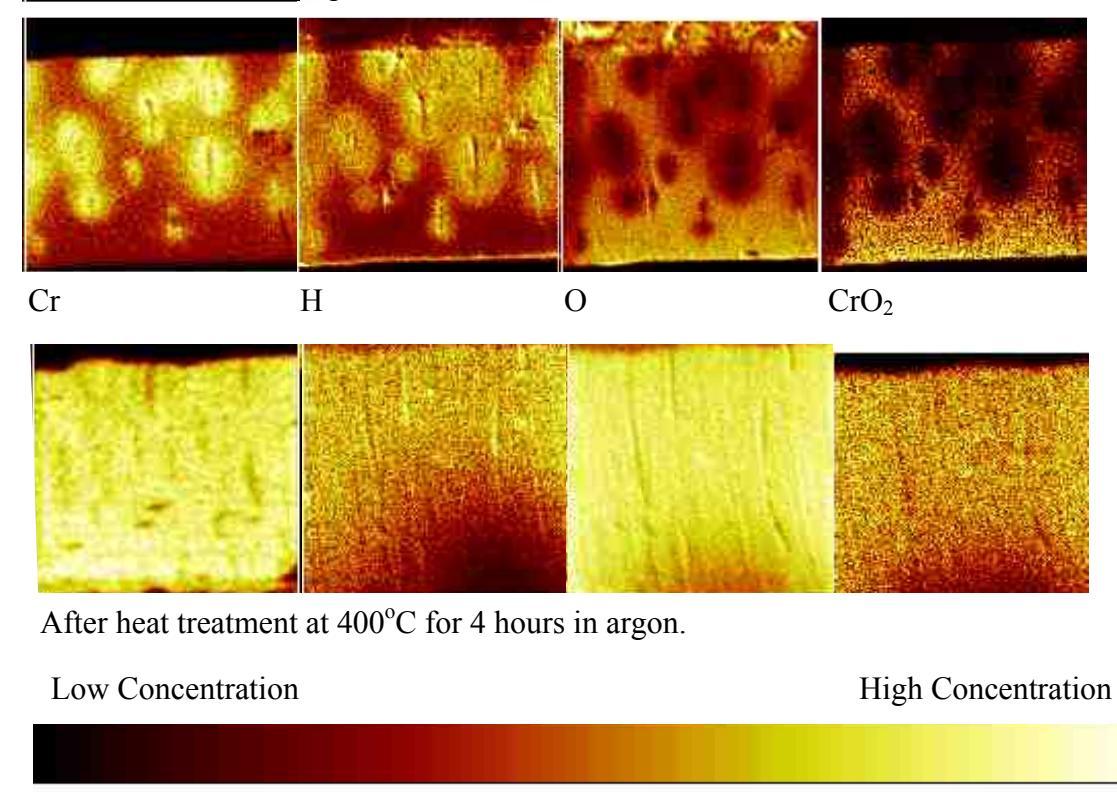
Figure 28. ToF-SIMS images of etch-free deposits. The as-plated image sizes are 35 micrometers by 35 micrometers. The heat- treated image sizes are 19 micrometers by 19 micrometers.

is located at the top of each image and the mounting medium is at the bottom of the images. The dark areas near the mounting medium in the heat-treated images are due to topography and are considered to be artifacts of the sample. The as-plated sample shows that near the microribbons the concentrations of Cr and H are elevated where as in the bulk the concentrations of O and  $CrO_2$  are increased. The chromium deposits contain > 99% chromium<sup>5</sup>. During plating copious quantities of hydrogen emanate from the microribbons. After heat treatment the chemical composition of the chromium coating is very uniform. The heat treatment temperature is not high enough to reduce the deposits microhardness.

This data demonstrates that the microribbons are not chromium oxide rich areas and definitely contain higher concentrations of hydrogen than the bulk areas. The microribbons affect the chemistry of the areas that surrounds them. They can alter the chemistry in an area about 10 times their actual area. This sphere of altered chemistry may explain why etching widens the microribbons and the "footprints" of microribbons. Depending upon the microcrack density the microribbons can alter the chemistry of a small fraction of the coating or can alter the chemistry of the entire chromium deposit.
