# **Evaluation of Advanced Coatings for Improved Performance on Military Hydraulic Equipment**

Robert B. Mason, Martin Konrad, Paul Galbraith, and Mark F. Singleton, PhD, Concurrent Technologies Corporation, Largo, FL, 33773

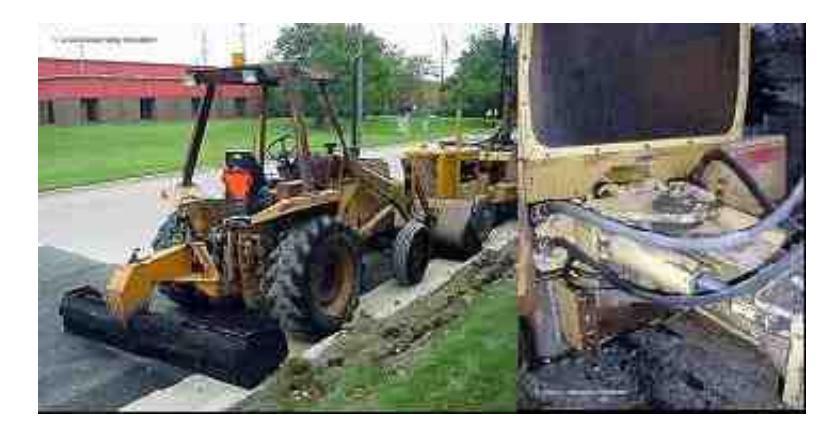
Figure 1. Commercial Front-End Loader (left), with Blackened Hydraulic Lines and Extensive Rust and Paint Chipping on Cylinders (right)

The main disadvantage of hydraulics is the constant need to maintain the precision components within the system. Hydraulic components are often exposed to aggressive climates, bad weather, and dirty atmospheres in daily operation, and this can lead to significant corrosion and material degradation of components. Figure 1 depicts significant corrosive attack on the hydraulic components of a front-end loader<sup>1</sup>.

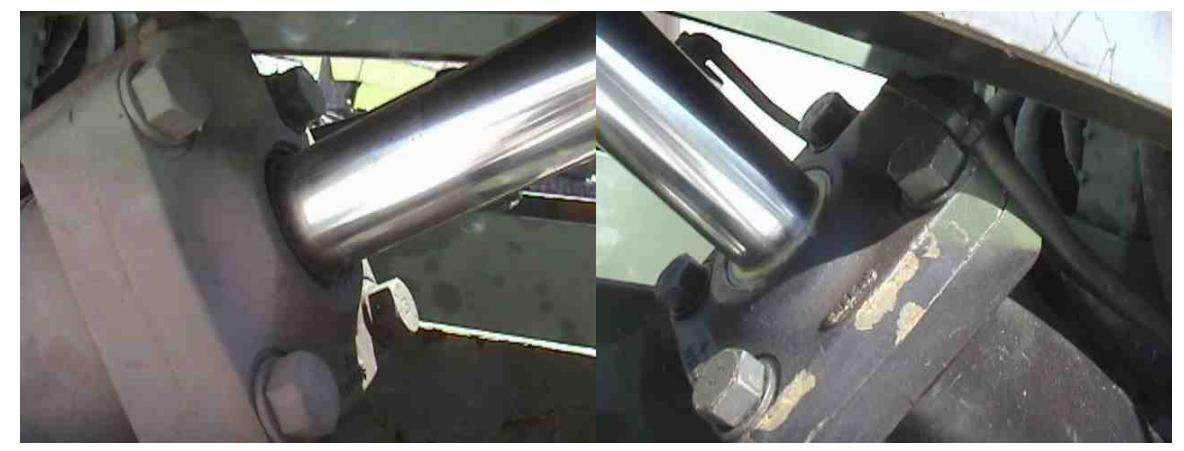
Figure 2. Ram and Cylinder from D7 Bulldozer: Before Repair (left), Showing Pitting and Worn Seals, and After Repair (right), with Smooth Ram Surface and New Seals

Examples of visual corrosion on actuators are presented photographically in this section. These photographs were taken during military depot visits that were conducted under earlier work, and are representative of assets that have been sent for depot-level repair. Therefore, the corrosion shown in these photographs is indicative of aggressive attack requiring repair. Figure 2 presents the condition of the ram and cylinder on a military D7 Bulldozer at one of the depots visited, before and after repair.

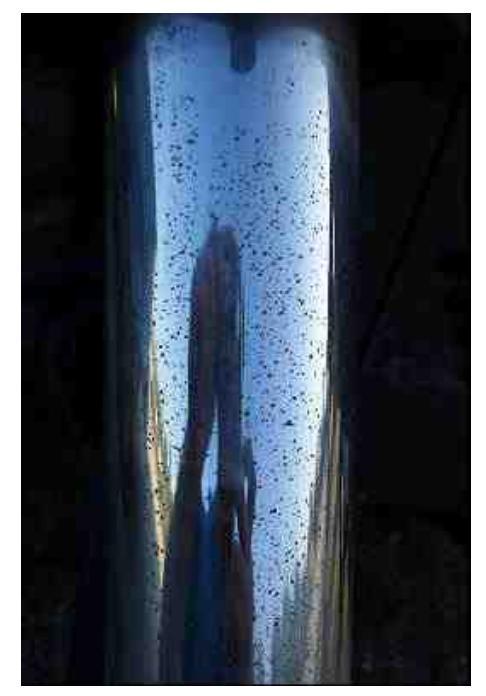
Figure 3. Close-up of Pitting on Hydraulic Actuator Arm

A close-up photograph of aggressive pitting attack on a hydraulic actuator arm from another military bulldozer is presented in Figure 3. It should be noted that this asset was still in service at the time that this photo was taken. Further use of the actuator in this condition would most likely rupture the seals and cause fluid leakage.

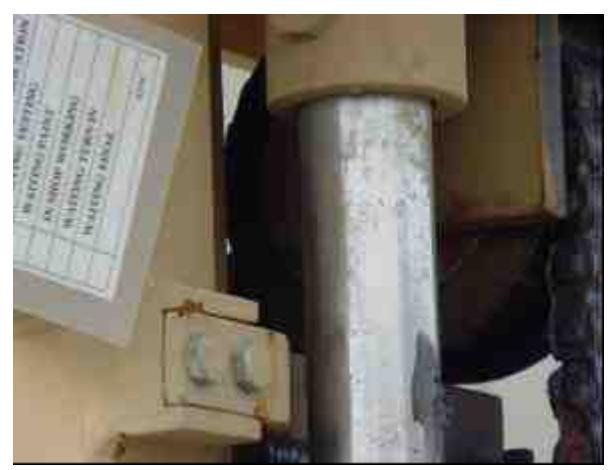
Figure 4. Cylinder on M4K Tactical Forklift, with Corrosion on Extended Portion of Main Vertical Actuator Arm

Figure 4 displays significant pitting on the hydraulic actuator arm of an M4K tactical forklift. Once again, this asset was still in service at the time that the photo was taken.

The aggressive corrosive attack on the actuators of this asset can be partly attributed to the design. To comply with safety protocols, the M4K tactical forklift is normally stored in the "forks down" position, with the cylinder actuator arms extended approximately ten inches. This leaves the actuator arms exposed to the environment. Over time, the thin layer of hydraulic fluid that protects the arms disappears, and corrosion is initiated.

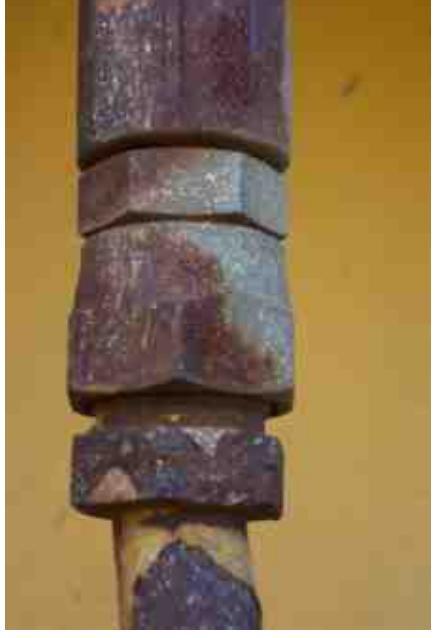
Figure 5. Hydraulic Hose-End Fitting Corrosion

The corrosion of hydraulic hose-end fittings was identified as a significant issue during the course of earlier work. A corroded hose-end fitting in need of maintenance is presented in Figure 5.

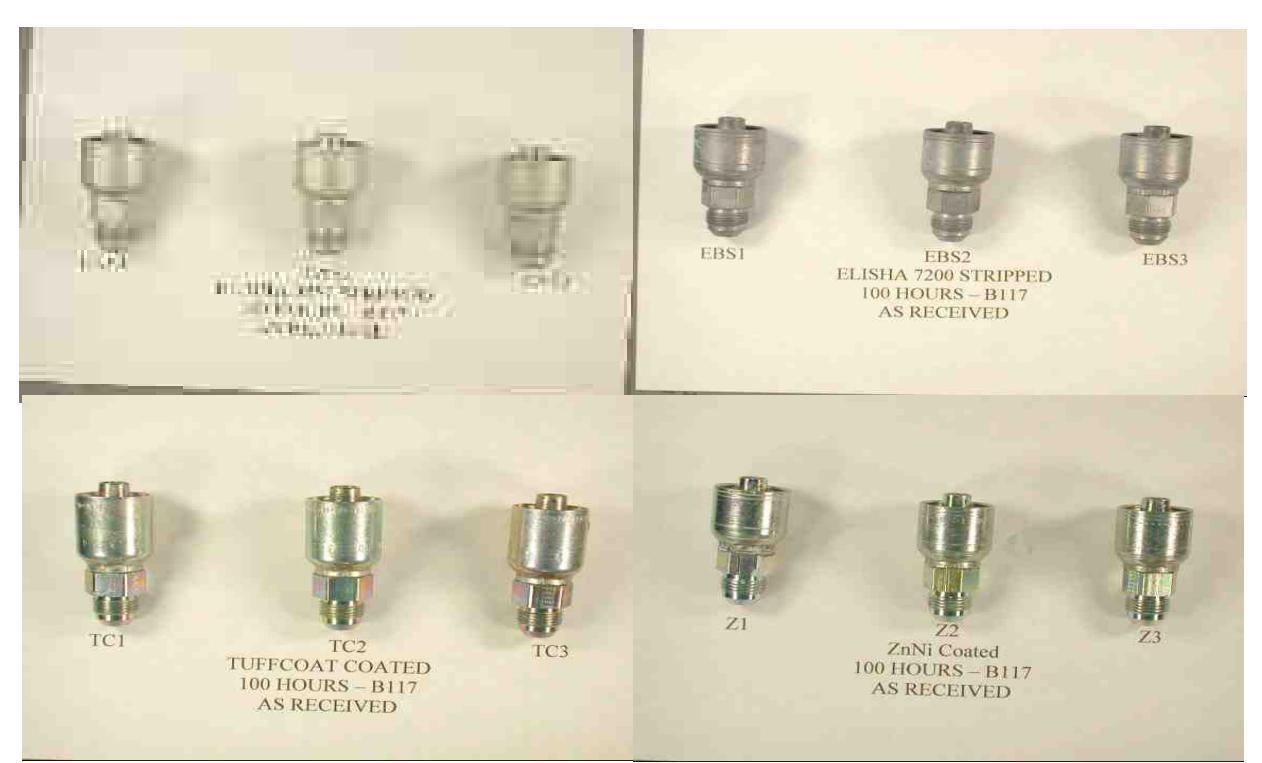
Figure 6. Hydraulic Hose-End Fittings After 100 Hours of B117 Exposure: Zinc-Nickel Electroplate (upper left), European (upper right), Experimental 1 (lower left), Experimental 2 (lower right)

The specimens were removed, cleaned, and photographed at 0, 100, 250, 500, 750, and 1000 hours of exposure. The 100-hour photographs are presented in Figure 6.

As witnessed above, none of the tested coatings exhibit red rust after 100 hours of salt spray exposure, and thus all of the coatings are acceptable for military procurement under SAE J516.

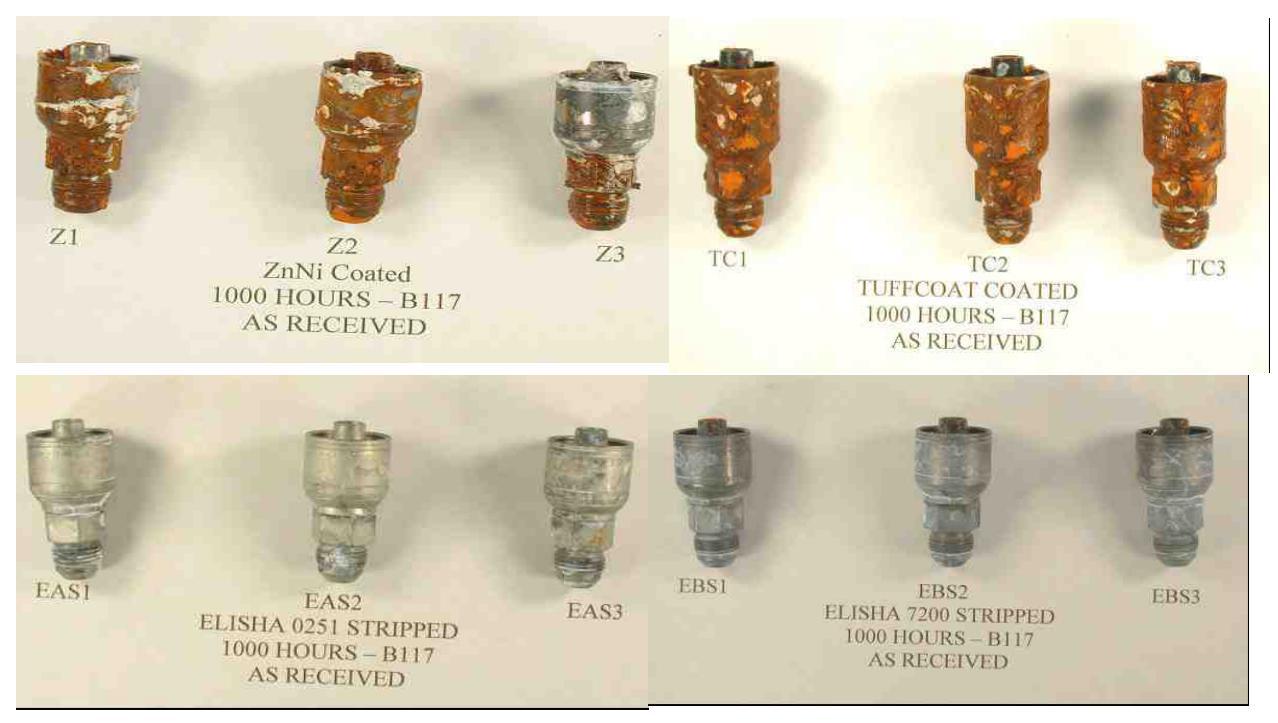
Figure 7. Hydraulic Hose-End Fittings After 1000 Hours of B117 Exposure: Zinc-Nickel (upper left), European (upper right), Experimental 1 (lower left), Experimental 2 (lower right)

After 1000 hours of exposure, there is a more clear separation of performance. Both of the experimental coatings have outperformed the standard zinc-nickel electroplate and the European coating system. Once again, while this extended test exposure exceeds that required by the procurement specification, the benefits of the experimental coatings would be appealing to the military community if an associated positive return on investment could be realized. Such determinations will be provided under future efforts of this activity.
