BSAA Salt Spray Failure Troubleshooting

Fullen, Warren J; Boeing Commercial Airplanes; Auburn, Washington, U.S.A

The purpose of the salt spray test is to validate the "health" of an anodize process line. This test requires two weeks, which makes effective corrective action decisions paramount to avoiding long periods of downtime. By assimilation of many decades of Boeing documentation, external literature and consultation, an *Anodize Troubleshooting Guide* (ATG) has been developed. The ATG is a simple checklist and is mostly categorized by process solution but also includes sections on other non tankline processes, equipment, and salt spray test conditions. Although this guide is specific to Boric Acid - Sulfuric Acid Anodizing many references can be applied to a broader application that can help guide process engineers to a quick and effective remedy.

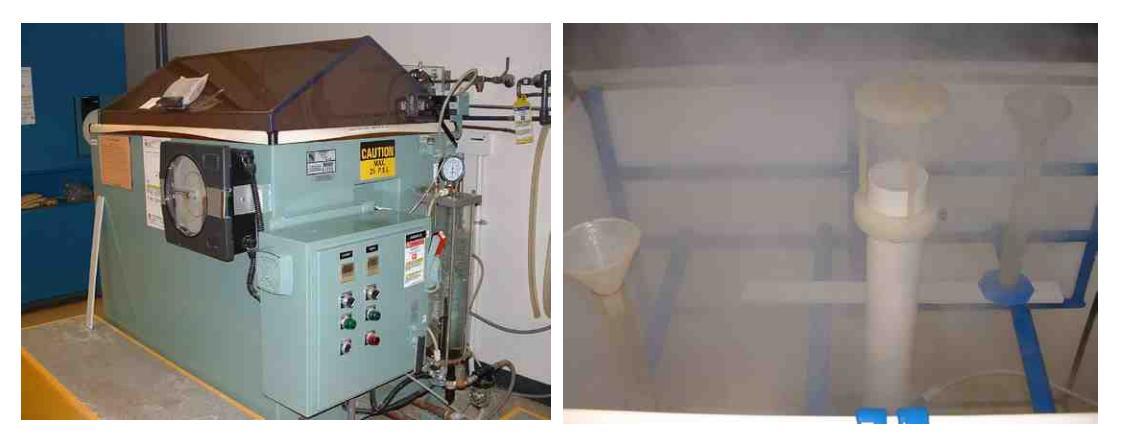
At Boeing, salt spray (SS) failure of anodized aluminum structure is a Quality Assurance (QA) test that determines the "health" of the process line chemical solutions. Repeated SS failures will cause the anodize process solution to be "tagged". QA then renders the process to be unavailable for further processing, until corrective action and passing SS results have been obtained. The test method ASTM B117 dictates that the test panels shall be kept in a salt fog chamber (Figure 1) for 336 hours (2 weeks).

Figure 1. Salt Fog Chamber

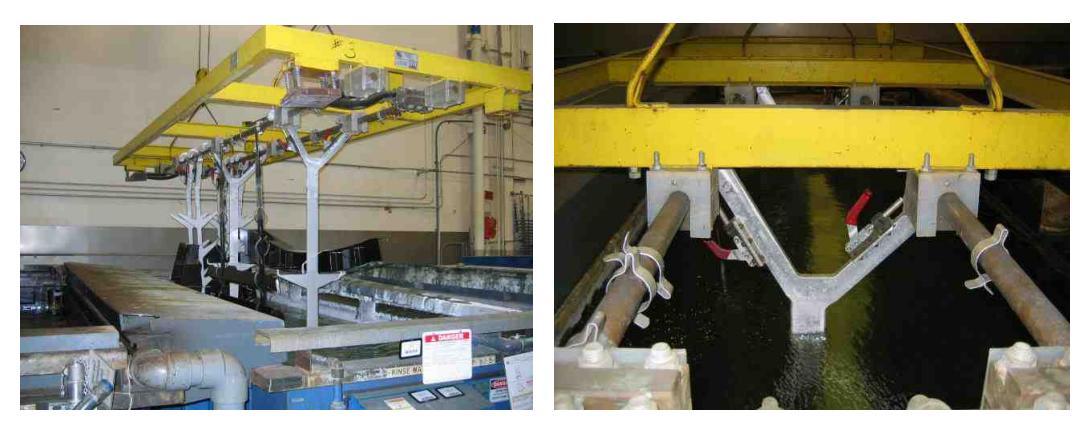
There are several equipment checks that can be performed when investigating a SS failure. Anodize Racks and Bus bars (Figure 2) should be kept clean and relatively free of heavy oxides^{4,8}, since poor contacts can cause low anodize coating weights^{4,11,12,38}.

Figure 2. Anodize Bus Bars and Racks

Additionally, any notice of red gelatinous film, on the anodize tank walls, may be attributable to copper impurities and may be removed by plating out onto 1100 series aluminum. Anodize power requirements must be adhered to strictly⁸. Specifically, the voltage ramp up must be 1.5 V/minute minimum and the processing voltage is to be maintained at 15+/-1 V. Too quick of a voltage ramp-up may result in arc mark burning, localize coating dissolution, or powdery coatings³¹. If the operating voltage is too low, the resulting lower current density might contribute to SS failure again due to low resulting coating weights⁴⁴.

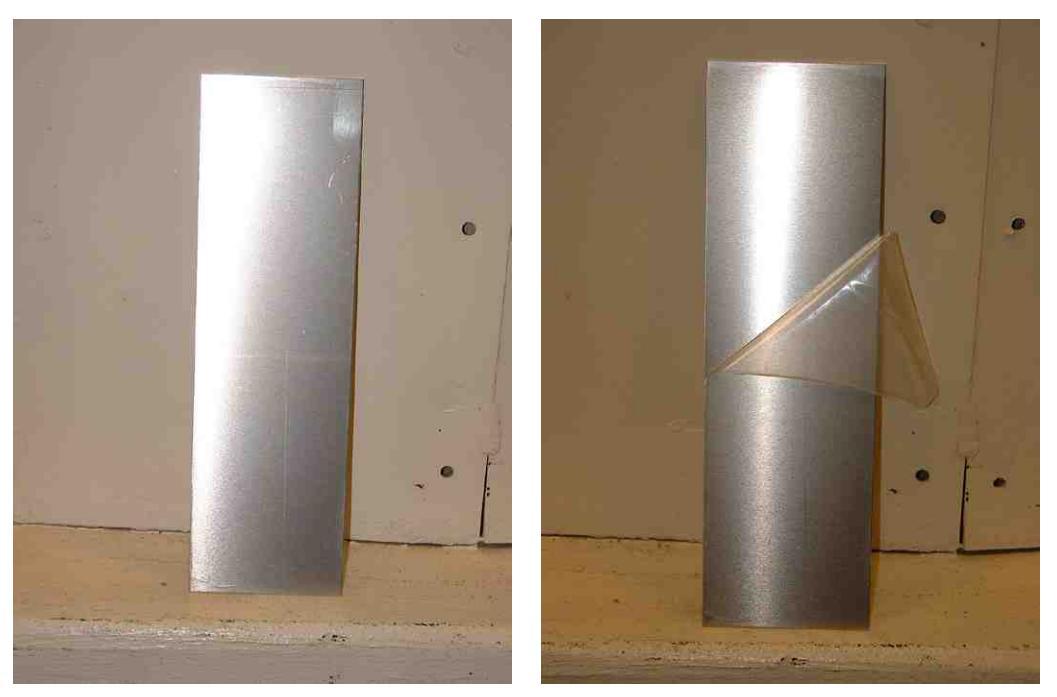
An understatement is that the SS test is not celebrated for being infallible^{15,30,39,40}. A thorough investigator should determine, visually, whether the test panels are in good condition and avoid the use of panels that have been in storage for an excessive period. Of course, the storage conditions will establish more exact storage times. To lengthen storage life, the SS panels can be kept in a cabinet and ideally be wrapped in Mylar. Salt spray failure investigations have been previously traced to the condition of the test panels where under magnification, defects have been visible on the panel surface¹³.

Figure 3. Salt Spray Test Panels (Mylar On and Off)

Additionally, incomplete removal of roll code ink markings, from SS test panels, has been attributed⁴¹ to premature salt spray failures. The anodized test panels⁸ should be a light gray color, have no burn marks, be free of cracks and pits, and have no powder residue before placing in the SS chamber. There are many parameters that can be audited in relation to the proper operation of a salt fog chamber^{46,47}. Of particular importance are: the position of panels to avoid splatter and drips onto test surfaces^{40,47}; nozzle air pressure⁴⁸; and most recently, at Boeing, even the type of supply water⁴⁹. Additionally, the investigator should inspect the interior of a SS chamber for areas of rust that might then be contributing to failures¹⁵.
