# Replacement of zinc phosphating and e-coating by a one-step primer?

Puomi, P., Van Ooij, W.J., Yin, Z. and Seth, A., University of Cincinnati, Department of Chemical and Materials Engineering, Cincinnati, OH 45221-0012, USA

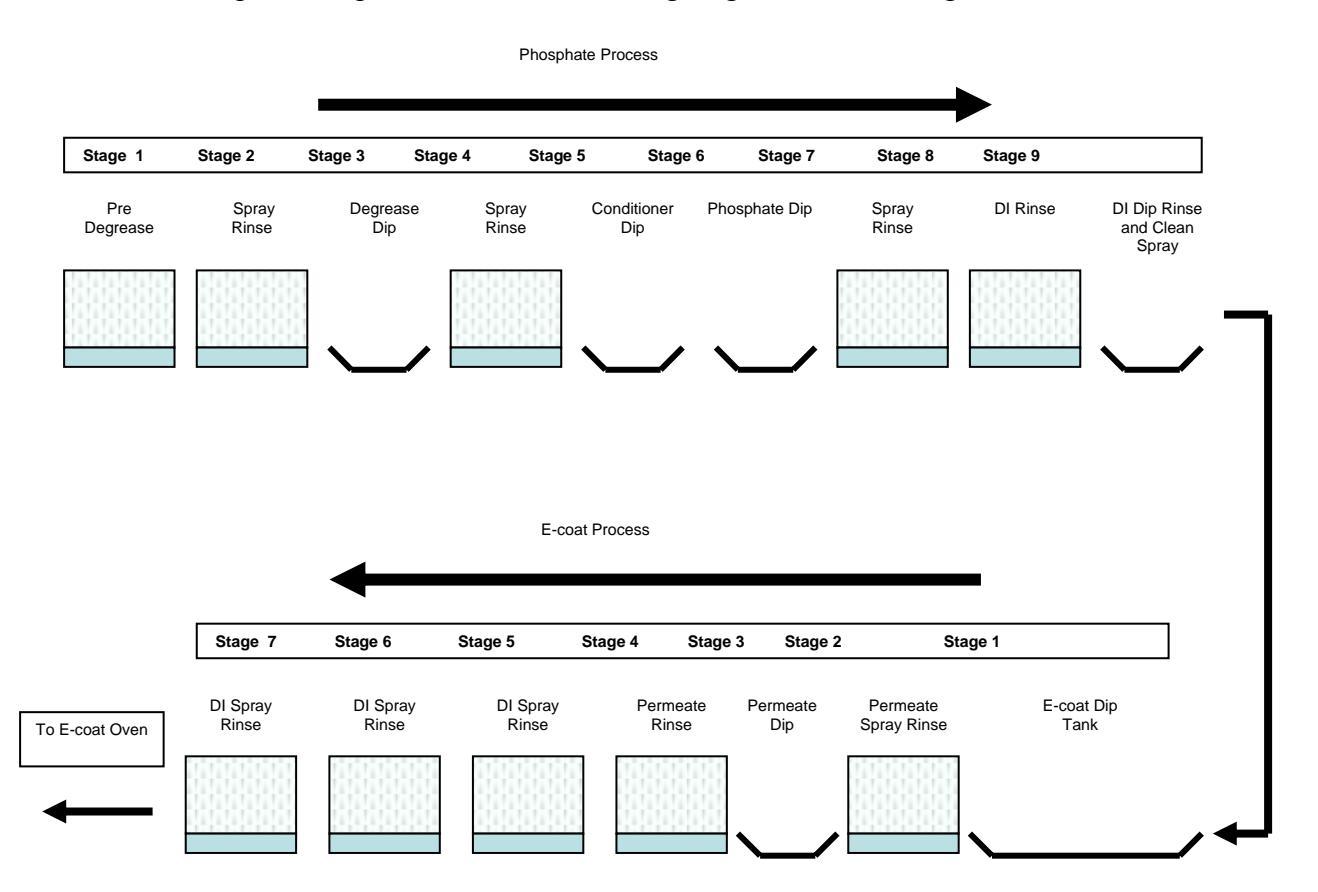
Figure 1. The pretreatment and e-coating steps of a typical finishing line in the automotive industry.

The problems that this paper will discuss are those that exist in the finishing line in the automotive industry. Currently the finishing line comprises approximately of the following steps: alkaline cleaning, rinsing, activation, phosphating, rinsing, sealing (by chromate or non-chromate rinses), rinsing, drying, e-coating, baking, base coating, baking, topcoating and baking. A schematic of the process up to the the e-coat baking stage is shown in Fig. 1.

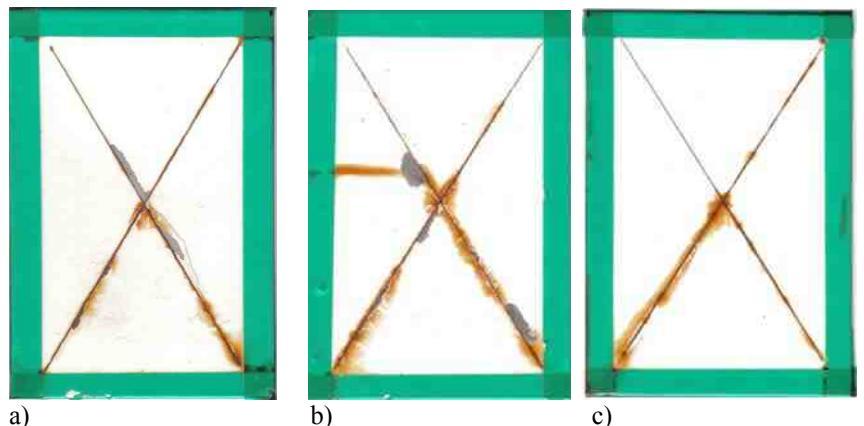
Figure 2. Salt water immersion test results of CRS panels after 7 weeks; a) first epoxy-acrylate, b) second epoxy-acrylate and c) automotive reference.

The CRS panels were kept in the salt water immersion test only for 7 weeks. After the test any loose paint at the scribes was scraped off. As can be seen from Fig. 2, the first epoxy-acrylate and the reference panel are very similar when it comes to the extent of red rust in the scribes. The scribes of the second epoxy-acrylate seem slightly worse, but the surface appearance of the coating was better on this sample than on the first epoxy-acrylate, which showed slight blistering of the coating. The EZG and HDG steel panels were kept in the salt water for 3 months. When the images presented in Fig. 3 are compared with the ones shown in Fig. 2, one can clearly see the difference in substrate performance. The scribes of the EZG panels hardly show any red rust even after 3 months of salt water immersion test. After the test the superprimed EZG panels showed blisters here and there. The blisters were, however, not very clearly visible after the panels had dried. Therefore, they cannot be distinguished easily in Fig.s 3a and 3b. The performance of the HDG steel panels in the salt water immersion test were almost exactly the same as for the presented EZG panels.

As the scans in Figs. 2 and 9 are compared with each other, it can be concluded that during continuous salt water immersion, of about 7 weeks, the red rust formation is significantly less than during about 7 weeks of salt spray testing (1250 hrs is about 7 weeks).

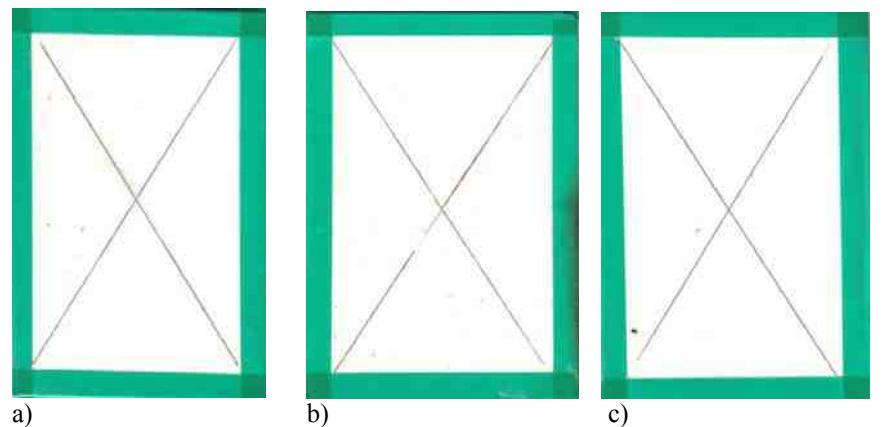
Figure 3. Salt water immersion test results of EZG panels after 3 months; a) first epoxy-acrylate, b) second epoxy-acrylate and c) automotive reference.

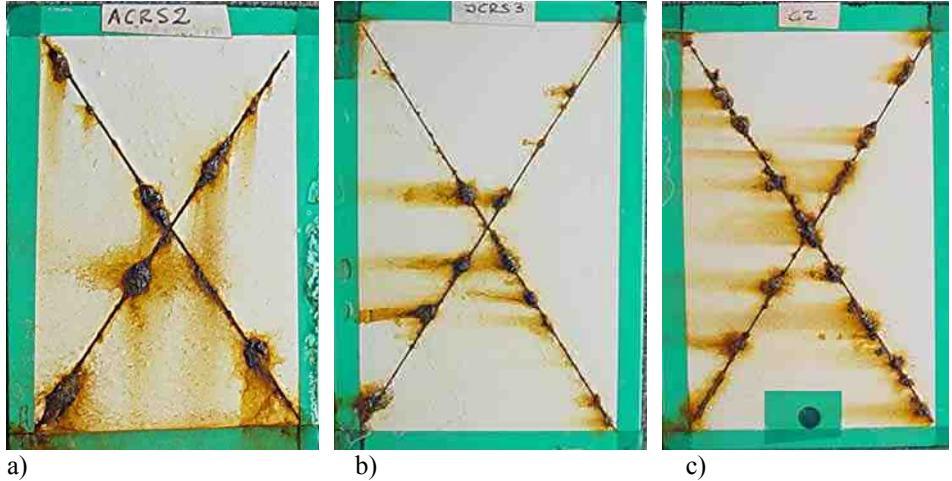
Figure 4. Ford test results of CRS panels after 38 cycles; a) first epoxy-acrylate, b) second epoxy-acrylate and c) automotive reference.

The replica panels had very similar performance in the Ford test. The pictures chosen for Figs. 4 and 5 represent the performance of each sample. As can be seen from Fig. 4, the scribes of the second epoxy-acrylate were slightly better than for the two other CRS panels and the surface of the second epoxy-acrylate sample was also better than for the first. However, in Fig. 4b, slight blistering very close to the scribe can be detected. It seems that when salt water or humidity is able to come in contact with the epoxy-acrylate superprimer underneath the automotive coating, it is prone to blistering. Here again, when the images presented in Fig. 5 are compared with the ones shown in Fig. 4, one can clearly see the difference in substrate performance. The scribes of the HDG steel panels in Fig. 5 hardly show any red rust after 50 Ford test cycles. Some blistering close to the scribes were observed for the superprimed HDG steel panels exposed to Ford test. In this test the first epoxy-acrylate showed slightly more blistering than the second version. The results of the EZG and HDG panels in the Ford test were again very similar, i.e., analogous to the salt water immersion test results.

The red rust formation in the scribes on all three samples in the salt spray test (Fig. 9) is quite different from the red rust formation in the Ford test (Fig. 4). This is most probably due to the fact that in the salt spray test when the samples are exposed to a continuous mist of salt water the red rust is not allowed to dry and form less soluble or more passive corrosion products such as in the cyclic Ford test. Therefore, the red rust formed in the scribes during salt spray testing has no chance to "recover" and just keeps on forming, which results in the bleeding pattern. The red rust formed in the cyclic Ford test has a chance to dry during the 105 minute ambient drying cycle. This is most likely the reason why the red rust in the scribes during Ford test is formed in small lumps, from which the red rust does not bleed off in the same extent as from the scribes in the salt spray test. Locally, where the red rust lumps have been formed they might in fact slightly suppress further red rust formation in that particular spot.

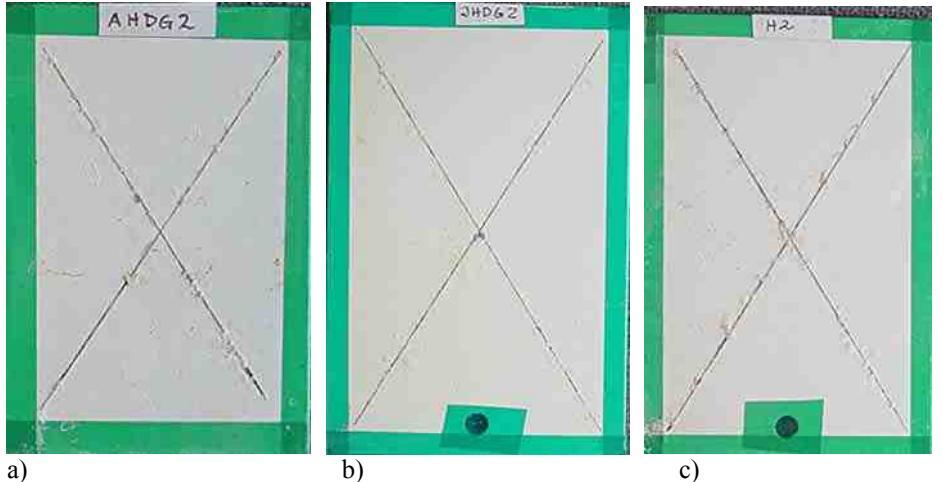
Figure 5. Ford test results of HDG steel panels after 50 cycles; a) first epoxy-acrylate, b) second epoxy-acrylate and c) automotive reference.

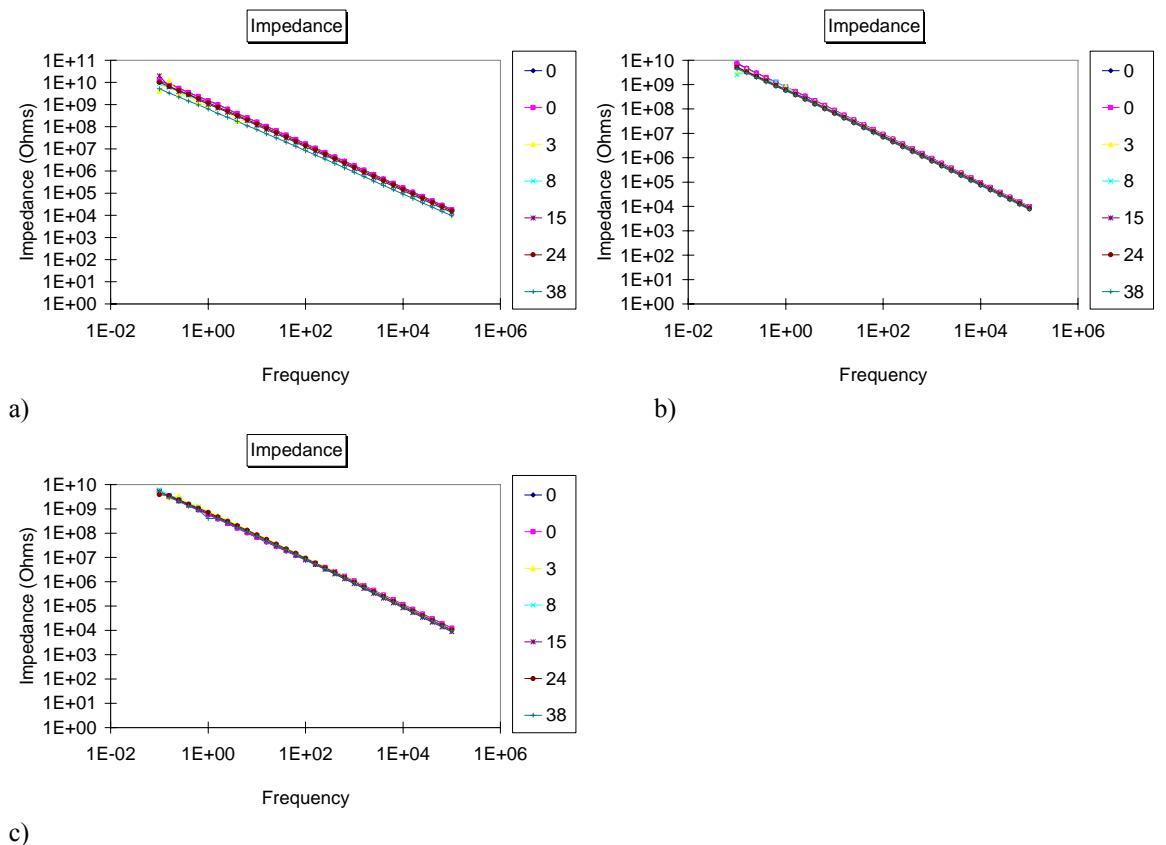
Figure 6. The impedance as a function of frequency for the a) first epoxy-acrylate, b) second epoxy-acrylate and c) automotive reference on CRS.

As can be seen from Figs. 6 a) to c), the impedance curve of the exposed coating does not change during exposure to the Ford test. It is mainly the scribed part of the CRS panel that deteriorates due to the corrosion reactions of the steel, which is exposed to the aggressive environments of the test through the scribe.

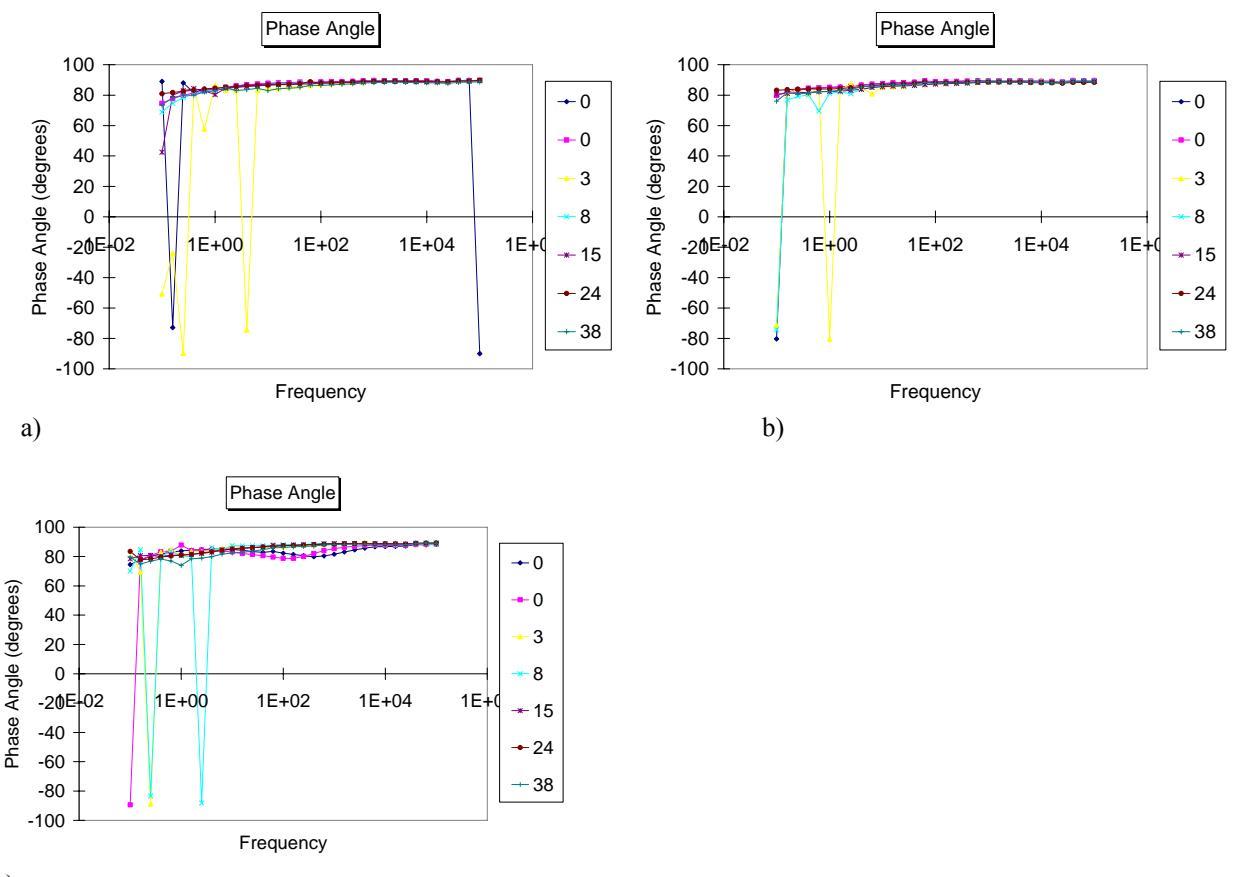
Figure 7. The phase angle as a function of frequency for the a) first epoxy-acrylate, b) second epoxy-acrylate and c) automotive reference.

Figures 7 a) to c) show, however, that there is no change in the phase angle curves of the CRS samples during exposure to the Ford test. The phase angle remains high between 80° to 90° throughout the frequency range on all samples. The impedance and phase angle results in the Ford test of the coatings on the EZG and HDG steel panels gave very similar results as on the CRS panels. Figure 8 presents the impedance results of the coatings containing the new epoxy-acrylate primer on all three substrates during Ford test.

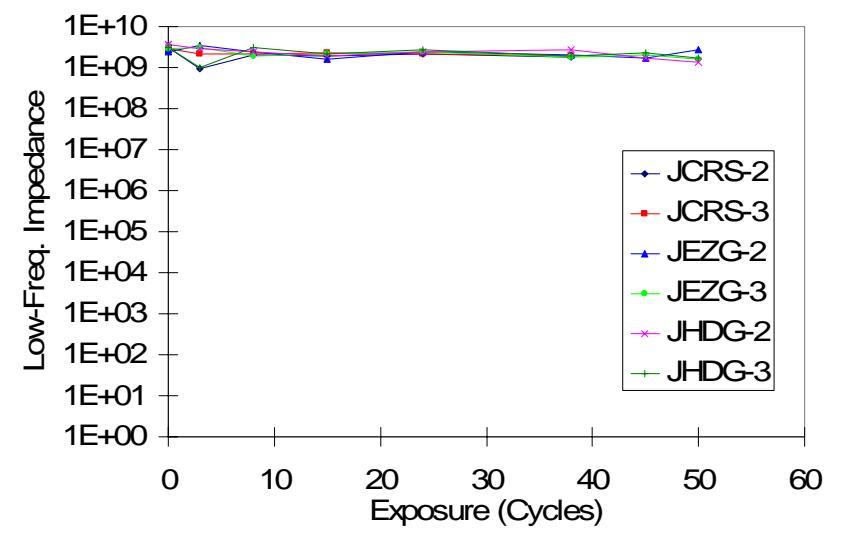
Figure 8. Impedance results of the coatings containing the second epoxy-acrylate primer on all three substrates during the Ford test.

As can be seen from Fig. 8, the substrate does not affect the impedance values of the coating during Ford testing ( $\leq$  50 cycles).

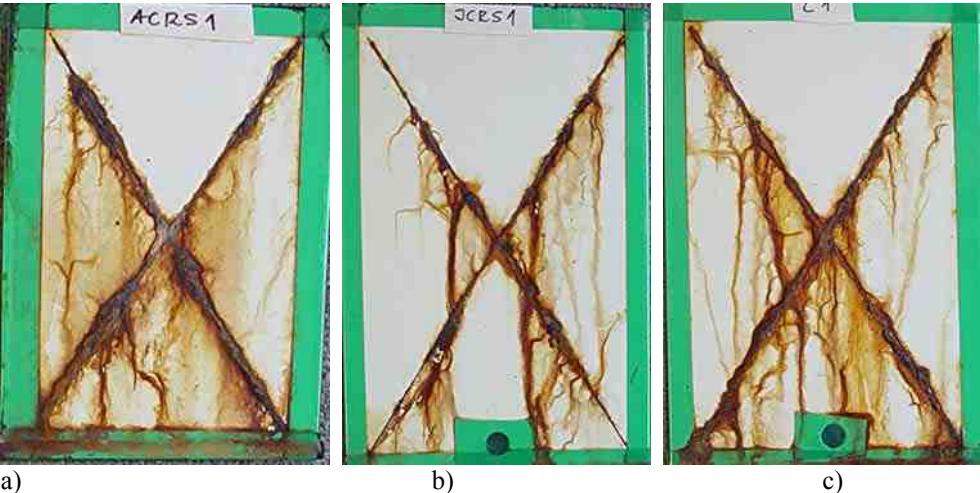
Figure 9. Salt spray test results of CRS panels after 1250 hours a) old epoxy-acrylate, b) new epoxy-acrylate and c) automotive reference.

Figure 9 shows a similar trend as the Ford results in Fig. 4; the scribe of the second epoxy-acrylate sample looks slightly better than for the two other samples. However, Fig. 9b) shows again, slight blistering near the scribe in the left upper corner of the scan.

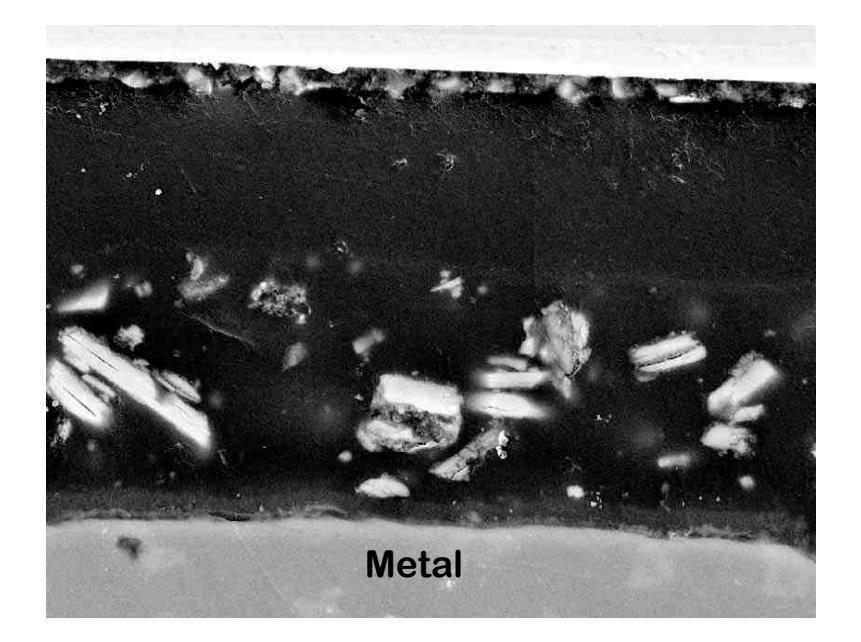
Figure 10. The SEM cross-section of the epoxy-acrylate coating on the metal after 30 days of salt immersion testing.

Figure 10 shows the SEM micrograph of the cross-section of the epoxy-acrylate primer on a metal surface. As can be seen from Fig. 10, the primer layer comprises three distinct layers. Closest to the metal there is a layer rich in silane. The middle of the coating consists of a resinsilane-particle layer. The cross-section was analyzed by SEM/EDX and the primer film by FTIR<sup>12</sup>. These results showed that the acrylate interacts with the silane forming an acrylate-siloxane layer, which situates in the middle of the coating, where also the zinc phosphate particles are incorporated. The epoxy, however, does not interact much with the other ingredients except for the crosslinker. Therefore, the epoxy forms virtually a layer of its own on top of the acrylate-siloxane-zinc phosphate layer.

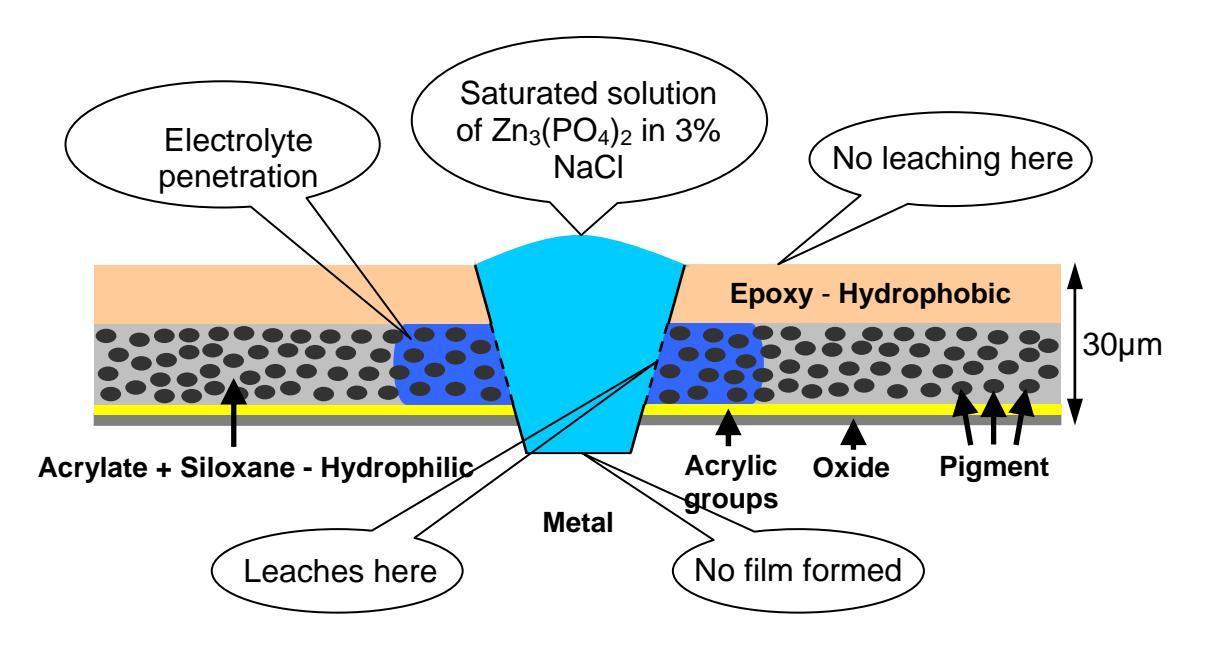
**Figure 11.** Principle of the corrosion inhibiting mechanism of the acrylate-epoxy-silane superprimer containing the zinc phosphate pigments, which protect the metal on-demand.

The water and electrolyte uptake results showed that the epoxy layer of the coating is hydrophobic and the acrylate-siloxane layer is hydrophilic. There is, however, good interfacial adhesion between these two layers due to the silane present in the acrylate-siloxane layer. When the entire coating on aluminum is scribed and immersed in the 3.5 wt.-% NaCl solution, the ions of the solution  $Na^+$ ,  $Cl^-$ ,  $OH^-$  and  $H^+$  start to attack all layers of the coated metal. As the epoxy layer is hydrophobic, hardly any water or electrolyte will be able to penetrate into this layer of the coating, but as the acrylate-siloxane layer is hydrophilic, the water including the ions are able to penetrate into the middle layer of the coating. As this happens, the zinc phosphate pigment particles of the acrylate-siloxane layer are able to actively leach out into the salt water that surrounds the scribe. The phenomena described is presented schematically in Fig. 11.

As shown in Fig. 11 the zinc phosphate leached out into the scribe forms a saturated solution of  $Zn_3(PO_4)_2$  in the 3.5 wt.-% NaCl solution and thereby prevents any further ingress of electrolyte into the coating. The bis-sulfur silane film close to the metal protects the metal from
