## Electroplating of Zinc-Base Die Castings in a System Incorporating Dual Chromium

by James H. Lindsay,<sup>1</sup> William E. Lovel<sup>p</sup> and David W. Hardesty<sup>3</sup> <sup>1</sup>Ternstedt Division, General Motors Corporation, Flint, Michigan. <sup>2</sup>Ternstedt Division, General Motors Corporation, Detroit, Michigan. <sup>3</sup>General Motors Corporation, Research Laboratories, Warren, Michigan.

Editor's Note: Paper originally presented on June 22, 1961 at the 48<sup>th</sup> Annual Convention of the American Electroplaters' Society, in Boston, Massachusetts. Published as: J.H. Lindsay, W.E. Lovell and D.W. Hardesty, Tech. Proc. Am. Electroplaters' Soc., 48, 165 (1961).

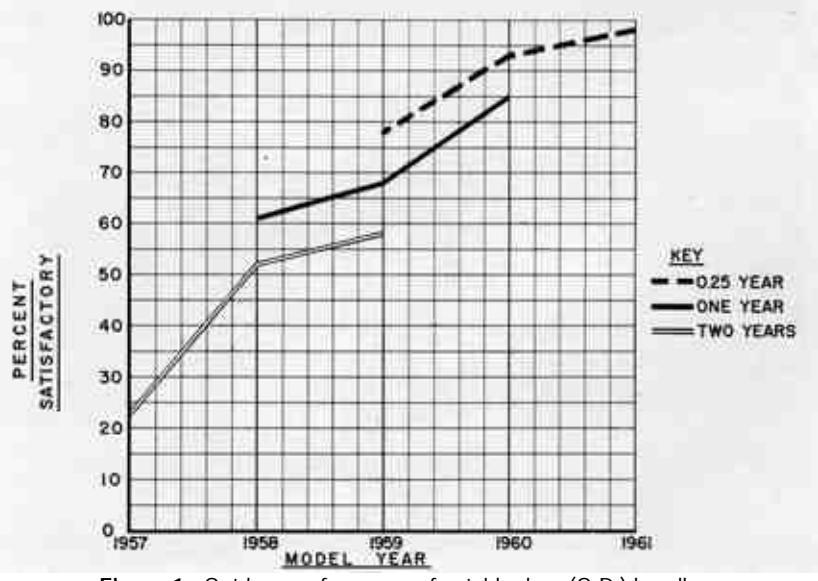
Figure 1 - Outdoor performance of outside door (O.D.) handles.

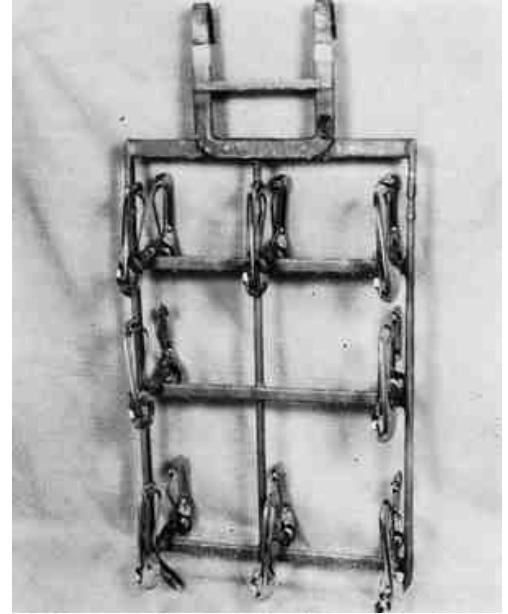
Figure 2 - O.D. handle plating rack.

While capable of producing outstanding results, the operation of the system does require carefully detailed engineering and control if the maximum results are to be realized. This is particularly true of die castings, most of which have shapes of some degree of complexity, and this plant has been forced upon occasion to slow down machines by as much as 30%, to replace racks, and to take other measures to meet the demands of the process. The problem can perhaps be best appreciated by considering experiences, good and bad, with a comparatively simple part, and for the purpose the outside door handle is well suited. During the period about to be discussed, more than ten million handles were plated, and more than 2,500 were CASS tested. Handles racked as they are plated are shown in Fig. 2.

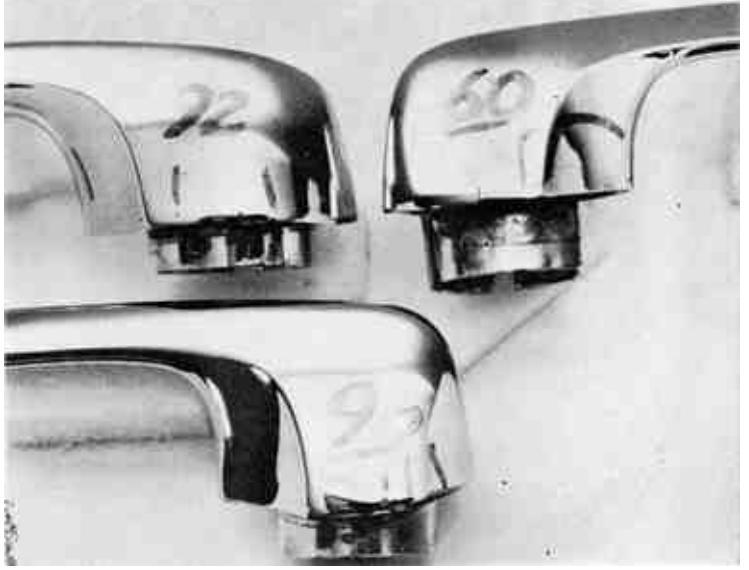
In order that the data which follows be understood, it is necessary to define the corrosion rating system employed. As developed by the Cadillac Motor Division,<sup>1</sup> the surface of the part is divided into squares. A perfect part is rated 100, and four points are deducted from the rating for every 1% of the squares in which corrosion occurs down to a rating of 80. In the case of the O.D. handles, the significant surface of the part is divided into 200 quarter-inch squares. A rating of 100 is given a perfect handle, two points being deducted for every square in which corrosion occurs, so that a handle with a 92 rating has corrosion in four squares. As a point of reference, an ASTM rating of 8 would be regarded as being much worse than a 92 in this system. Also, a handle or other part with a rating of 92 is felt to represent a quality level which would be acceptable to a customer after a car had one year's service. The target, and in most cases the performance, is much higher. Typical ratings are illustrated in Fig. 3. It is important to note that all parts are cleaned with magnesium oxide before exposure to the CASS test. The test is therefore severe.

Figure 3 - Rated O.D. handles.

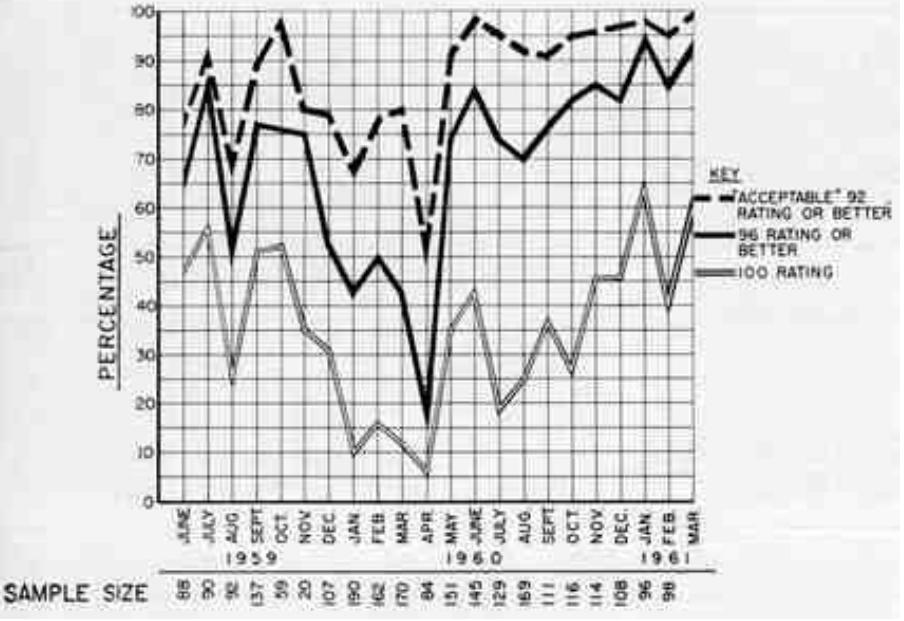
Figure 4 shows the percentages of production handles meeting various standards of performance after sixteen hours CASS test. The top line shows the percentages having a rating of 92 or better; that is, commercially acceptable. The center line shows those with no more than two spots of corrosion; that is, rated 96 or better. The bottom line shows the percentages with no corrosion. All of the data shown is for dual chromium production, though much of it, as will be seen, did not have the proper micro-crack pattern. All of the plating was done in the same plating machine.

Figure 4 - 16-hour CASS performance on O.D. handles.

The dual chromium operation was applied to O.D. handles beginning in early 1959, and the immediate effect was to raise the CASS performance. Self-regulating baths were used throughout in this particular machine. In the beginning the first chromium was a crack-free type; the second was a low-concentration, micro-cracking type, which it still is.

Performance fell off in August, and surging of the current was resorted to in both tanks. In this system, first developed by Guide Lamp Division, and a subject of patent application, a current higher than the normal burning point is applied. Before the metallic ion concentration can become sufficiently depleted to cause burning, the current is dropped, and this cycle is repeated as plating progresses. In this particular machine the current was held at a high for five seconds, then dropped to the low for three seconds. Some improvement in thickness resulted from this practice, particularly in low current density areas.

In September and October, performance was somewhat better, but in November a decline set in which continued for some months. During this time chromium thicknesses on failed parts were reasonably high, but the proper micro-crack pattern could not be maintained with any degree of consistency. In February additional generator capacity was added to the second chromium tank, but with no more than a slight temporary improvement.

In April, as the chart shows, performance fell to its low point, and since the difficulty appeared to lie in obtaining the micro-crack pattern, the approach was taken of supplying more of the cracking type chromium (*i.e.*, that used in the second bath). Tests made some time before had shown that the desired micro-crack pattern and corrosion resistance could be obtained from a single, low concentration bath if sufficient time was allowed. It was therefore argued that the crack-free chromium in the first bath should be replaced with the low concentration type used in the second in order to build more stress into the deposit to favor formation of the micro-crack pattern. As a compromise, however, it was decided that this bath should be operated at a somewhat higher concentration in order to preserve covering power and throwing power. An advantage to this change also lay in the fact that both catalysts were identical, permitting the rinses to be shut off between the two baths, thus eliminating dragout losses from the first chromium plating bath. The economics and waste disposal situation were therefore highly favorable.

The first solution was therefore changed over in mid-May, starting with 35 oz. of chromic acid and about 0.14 oz. of sulfate per gallon. The result was an immediate improvement in ability to maintain the crack pattern and corrosion resistance. It was noted, however, that chromium thicknesses in low current density areas were lower. An increase in throwing power was therefore sought by manipulating the chemical composition of the bath and the operating conditions, along conventional lines. These measures were taken primarily in the first solution, but they were tried also in the second. The net result, however, was that corrosion resistance began to drop, despite some improvement in thickness. Faced with the apparent choice of obtaining the micro-crack pattern or plate thickness, the crack pattern was chosen as being most important, with the CASS test serving as a guide. The results of CASS tests since then have been gratifying, as the chart shows.

Returning briefly to Fig. 4, it will be noted that April 1960 was the worst month; November and December among the best, from the standpoint of corrosion resistance. Turning to Table 4 however, the thicknesses shown for these months, particularly in the case of chromium, might have led one to expect the reverse to be true. Further, the thicknesses shown for parts rated 92 and 94 happen to be, on the whole, lower than those for the group rated 60 to 88.

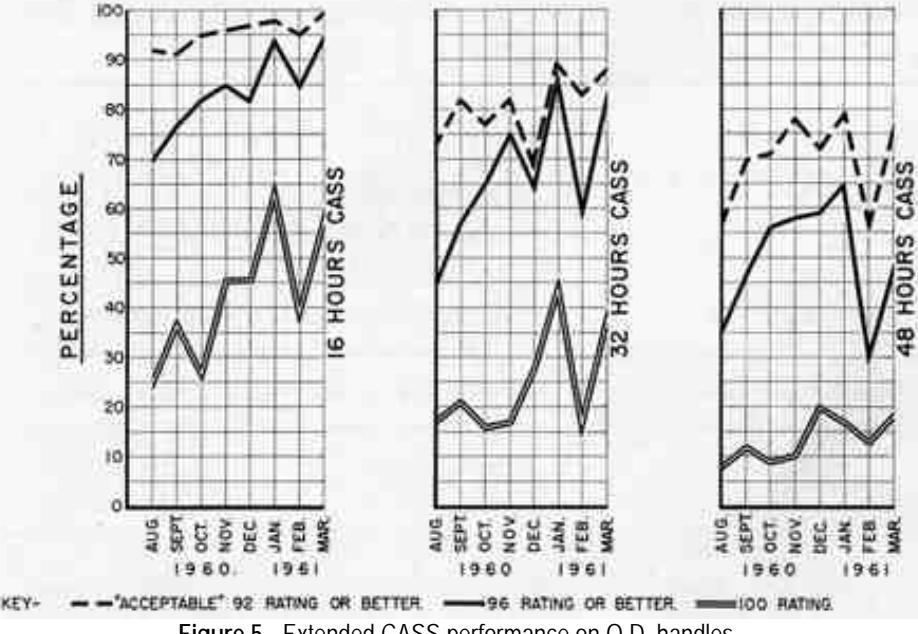
In view of the prospect of increasingly drastic requirements, a measure of performance upon prolonged exposure at the present time is in order. Figure 5 shows the CASS results for 1961 handles after 16, 32, and 48 hours, grouped as to ratings as was Fig. 4, and indicating fairly steady deterioration with continued exposure, particularly at the expense of the 100 ratings.

Figure 5 - Extended CASS performance on O.D. handles.

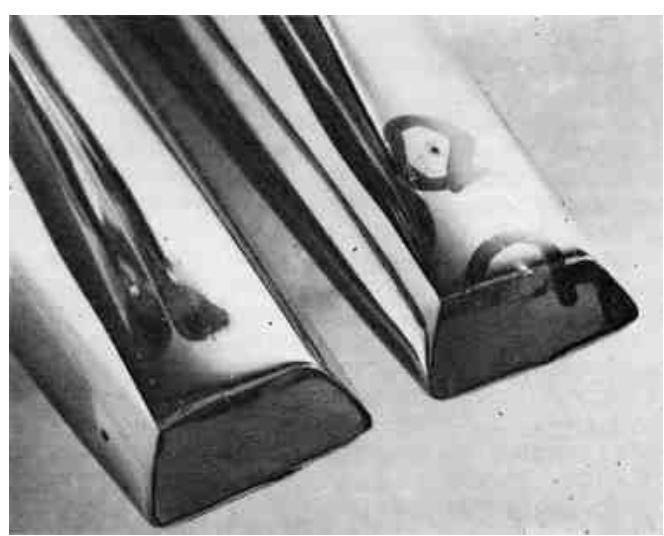
The mirror base, as Fig. 6 demonstrates, is subject at times to corrosion failure arising from porosity in a parting line. Blisters which developed in the CASS test are encircled. The other part shown has not been exposed, but shows clearly the porosity from which the corrosion arises. Only 69% of these parts met the 16-hour CASS test acceptably, as Fig. 7 shows, and it is obvious that corrective measures lay in the province of the die caster. The mirror head, however, combines a sound casting with a relatively simple shape from the plater's viewpoint. CASS results (Fig. 8), consequently, have been excellent.

Figure 6 - Mirror base CASS failure caused by casting porosity.

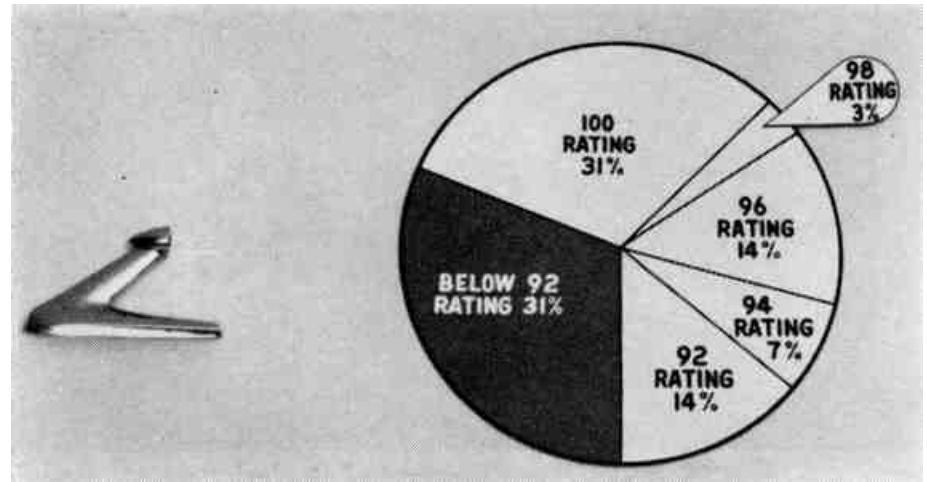
Figure 7 - CASS performance of mirror base.

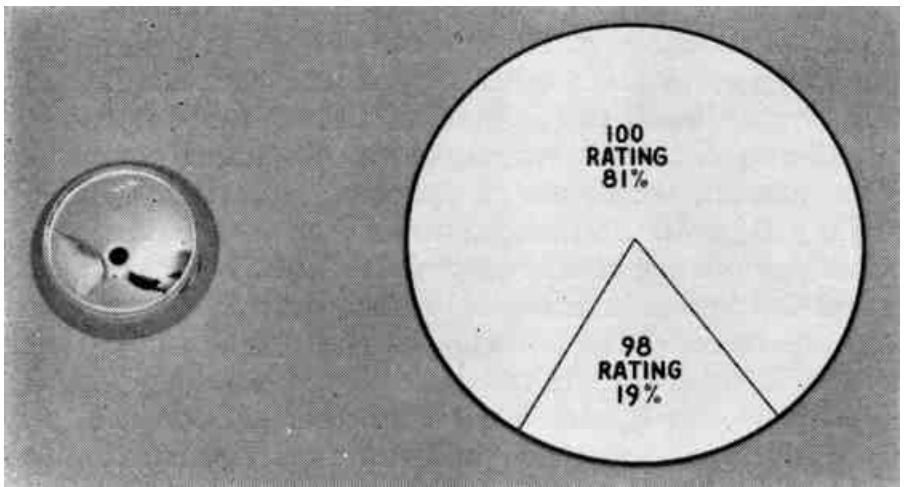
Figure 8 - CASS performance of mirror head.

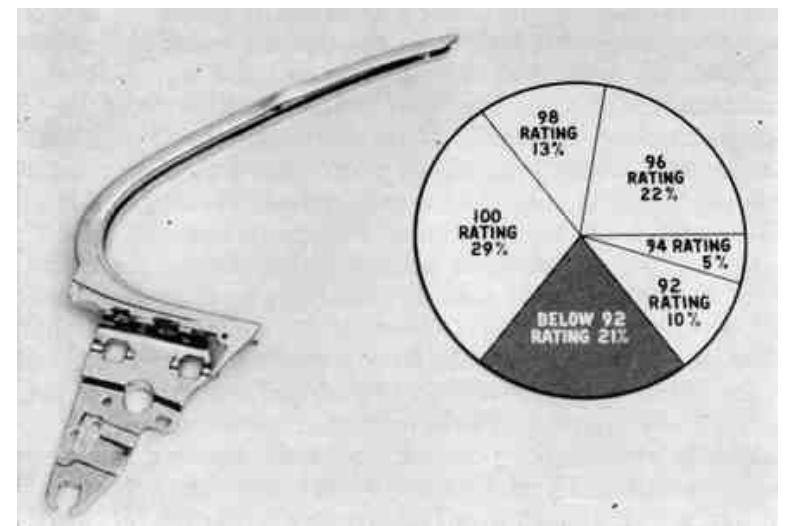
Figure 9 - CASS performance of CV frames.

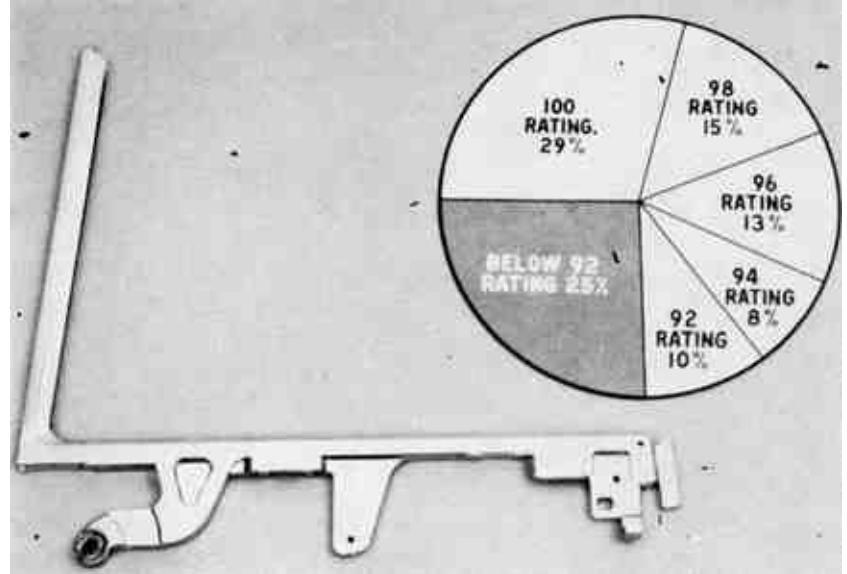
Rear window frames (Fig. 10) were 75% acceptable after CASS test. Some porosity is encountered in the rather long, thin sections involved, but the primary source of difficulty is the necessity of having one part cross another in balancing rack areas within the physical dimensions of the machine. Even a six-inch separation does not entirely eliminate the shading effect in terms of the micro-crack pattern.

Figure 10 - CASS performance of rear window frames.

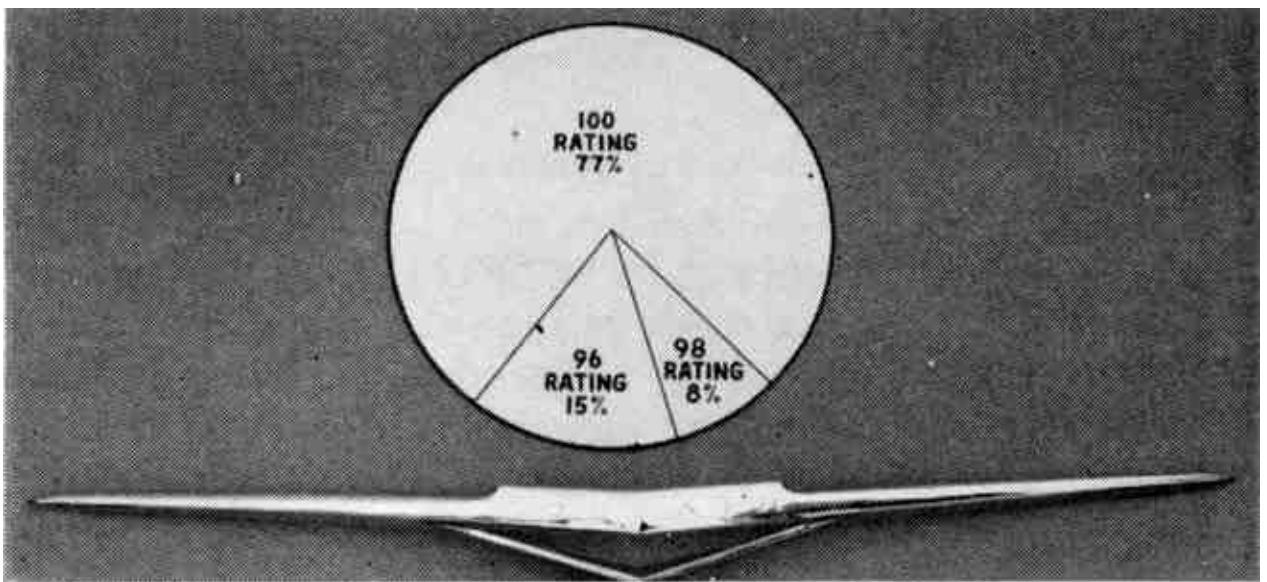
The front emblem (Fig. 11) is an excellent example of the capabilities of the dual chromium system properly applied on sound castings.

Figure 11 - CASS performance of front emblem.

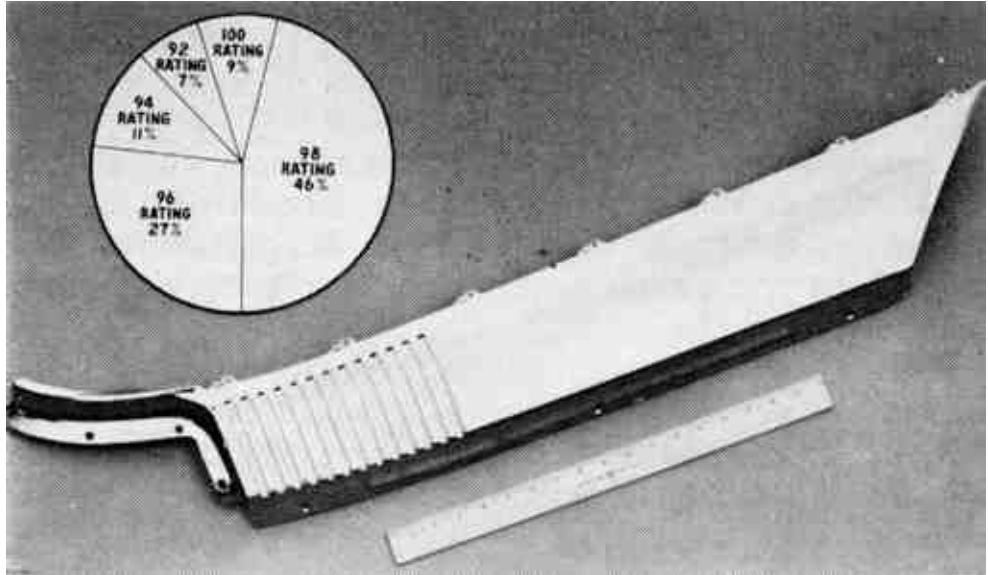
Figure 12 shows the performance for the rear wheel house molding, a rather large, but generally sound die casting. Corrosion which did occur lay in the recess of the tail section. It is interesting to note that the use of auxiliary anodes across the face of this

part, in an attempt to build up chromium thickness, was disastrous to CASS performance due to gross cracking through the nickel, coupled with thin copper caused by the shading effect of the auxiliary, which was not connected in the copper tank. The performance shown does not involve the use of auxiliary anodes.

Figure 12 - CASS performance of rear wheel-house molding.

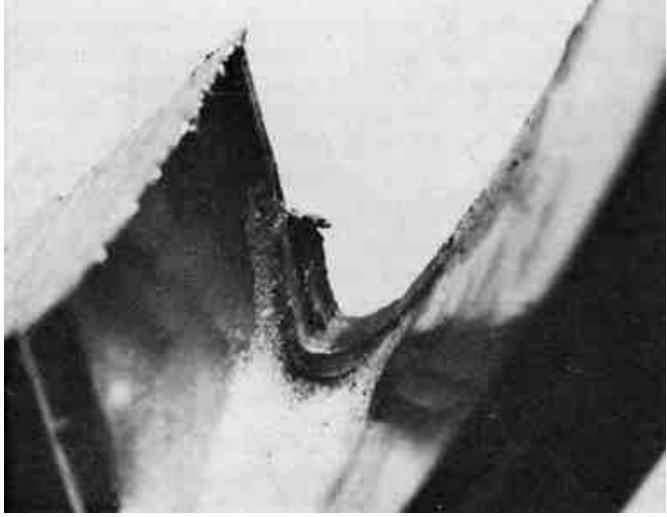
Figure 14 - Corrosion failure of script due to die cast flash.

Script lettering (Fig. 13) is particularly susceptible to corrosion arising from trimmed edges, which are difficult to maintain true and clean because of the configurations involved. For the most part, at least in Ternstedt Flint operations, scoring of these edges is not a problem, nor is the break, which is quite readily sealed over. While deep recesses, particularly when they involve sharp interior corners, do cause trouble, the chief source of corrosion lies in small fragments of flash folded over, or redeposited by the trim punch. An example is shown in Fig. 14 which is a cut-away script section. This figure also shows white corrosion in the deeply recessed area.

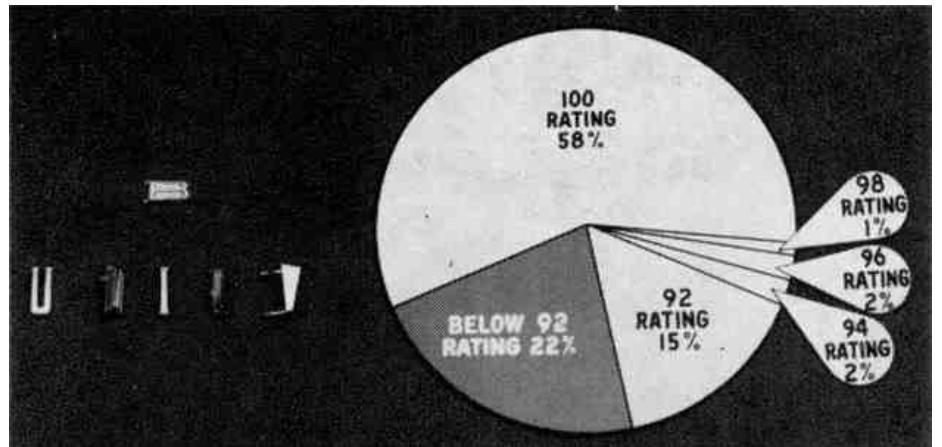
Separate letters, while subject to the same comments made regarding script, are much less seriously affected, presumably because of their simpler outlines. Figure 15 shows 78% of the parts tested to be within the acceptable range. Figure 16 again shows corrosion arising from a fragment of flash. It can be seen that the trimmed edges on the outer surfaces were sealed over by the copper and nickel. Such areas usually develop the micro-crack pattern quite readily, and corrosion there is not a problem.

Figure 15 - CASS performance of single letters.

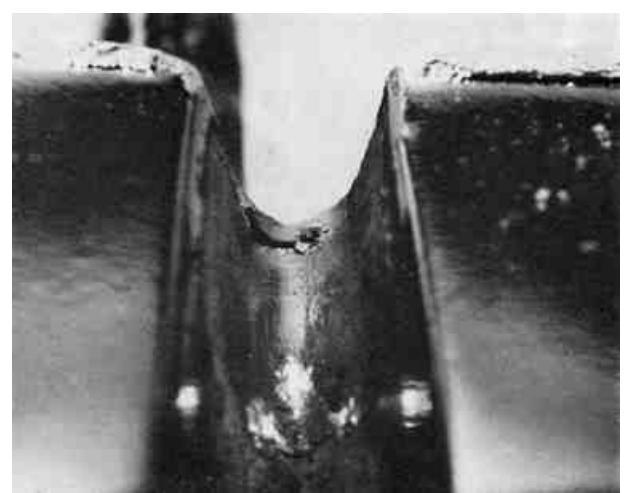
Figure 16 - Corrosion failure of single letter due to die cast flash.

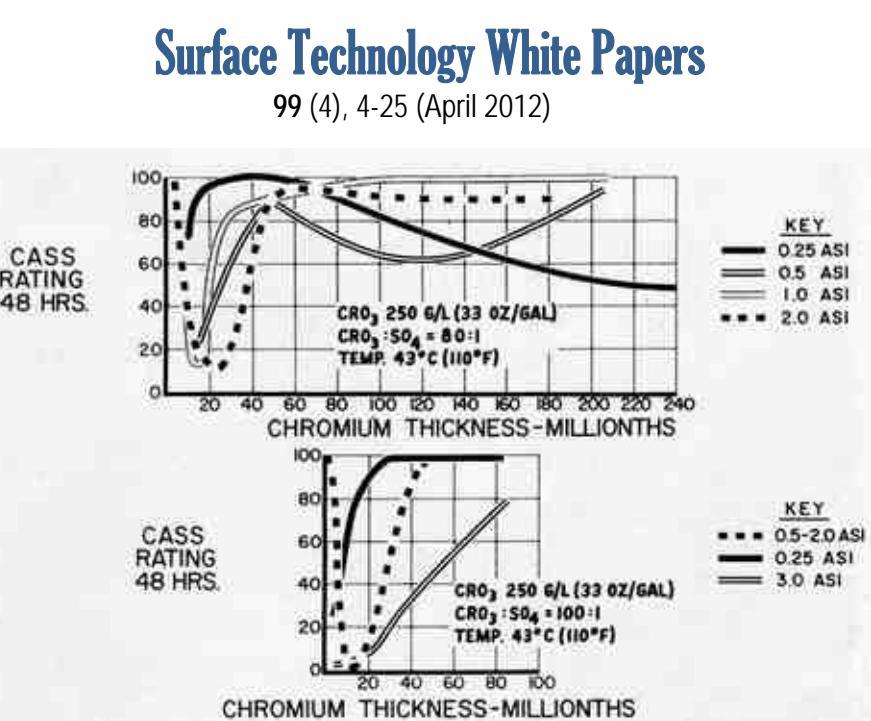
The results obtained are summarized in Fig. 17 in which average CASS ratings after 48 hours exposure are plotted against chromium thicknesses. The upper chart, for the 80:1 bath, shows that basis metal protection first decreases, with increasing chromium thickness to about 20 to 40 millionths, for current densities from 0.5 to 2.0 A/in.<sup>2</sup> As thickness increases beyond 40 millionths, basis metal protection becomes substantially complete. The 0.25 A/in.<sup>2</sup> curve however, shows good basis metal protection at low chromium thicknesses, and gradually deteriorates in this respect as thickness is increased. The plots shown in the lower chart for the 100:1 bath, show similar trends up to 2.0 A/in.<sup>2</sup>, though the dip in performance is deeper, and the rate of recovery for the 0.25 A/in.<sup>2</sup> curve is much slower. The 3.0 A/in.<sup>2</sup> curve included here, however, is quite startling. There was essentially no protection against basis metal corrosion at low chromium thicknesses, and only gradual improvement is found as chromium thickness increases.

Figure 17 - Relationship of chromium thickness, current density and CASS performance.

Examination of the panels before and after CASS testing led to some interesting observations. The 0.25 A/in.<sup>2</sup> panels from the 80:1 bath had no visible crack pattern before or after exposure, at any thickness, and basis metal attack increased in the form of rust spots as thickness increased beyond 50 millionths. Very numerous pits were found in the very low thicknesses (as many as 250,000 per square inch), it being apparent that the relatively good corrosion resistance noted was related to the nickel exposed through pores in the chromium.

Other panels up to 2.0 A/in.<sup>2</sup> from both baths showed no physical discontinuities other than those attributable to the nickel or basis metal, in the lower thicknesses before exposure, when examined under the microscope. As the thickness increased in the area of twenty to forty millionths, widely spaced, parallel cracks were noted. These became less widely spaced as thicknesses increased, and the fine pattern reported most effective by Lovell<sup>3</sup> appeared at thicknesses above fifty millionths. After exposure, panels in the very low thicknesses were substantially free from rust, but were dull and stained with a greenish material. Even after removal of the stain, the dullness remained, and upon microscopic examination numerous pits were found. Stripping the chromium revealed that the nickel was severely pitted.

At chromium thicknesses only slightly greater, the deposits remained bright, but there were numerous rust spots. Upon removal of the rust, relatively large, widely spaced pits were found (from one to two per square inch to perhaps one or two hundred). These thicknesses correspond to the minimum protection areas of the curves shown for both solutions. As the chromium thickness increased further, the rust spot density decreased, but unsightly gross cracks appeared. The rust spots were almost invariably located along these cracks. Brightness was not appreciably affected.

At still greater thicknesses, rust spots almost completely disappeared (those found were usually associated with nickel imperfections). There was a greyish surface stain, but upon its removal the original brightness was very nearly restored. Microscopic examination showed the presence of the desirable fine network of cracks (on the order of 500 to 1000 per inch).

Panels plated from the 100:1 solution at 3.0 A/in.<sup>2</sup> developed parallel, widely spaced cracks associated with rust spots. While not yet adequately explored, it is surmised that these cracks possibly extended through the nickel, a condition which has been observed on some production part areas chromium plated at very high current densities.

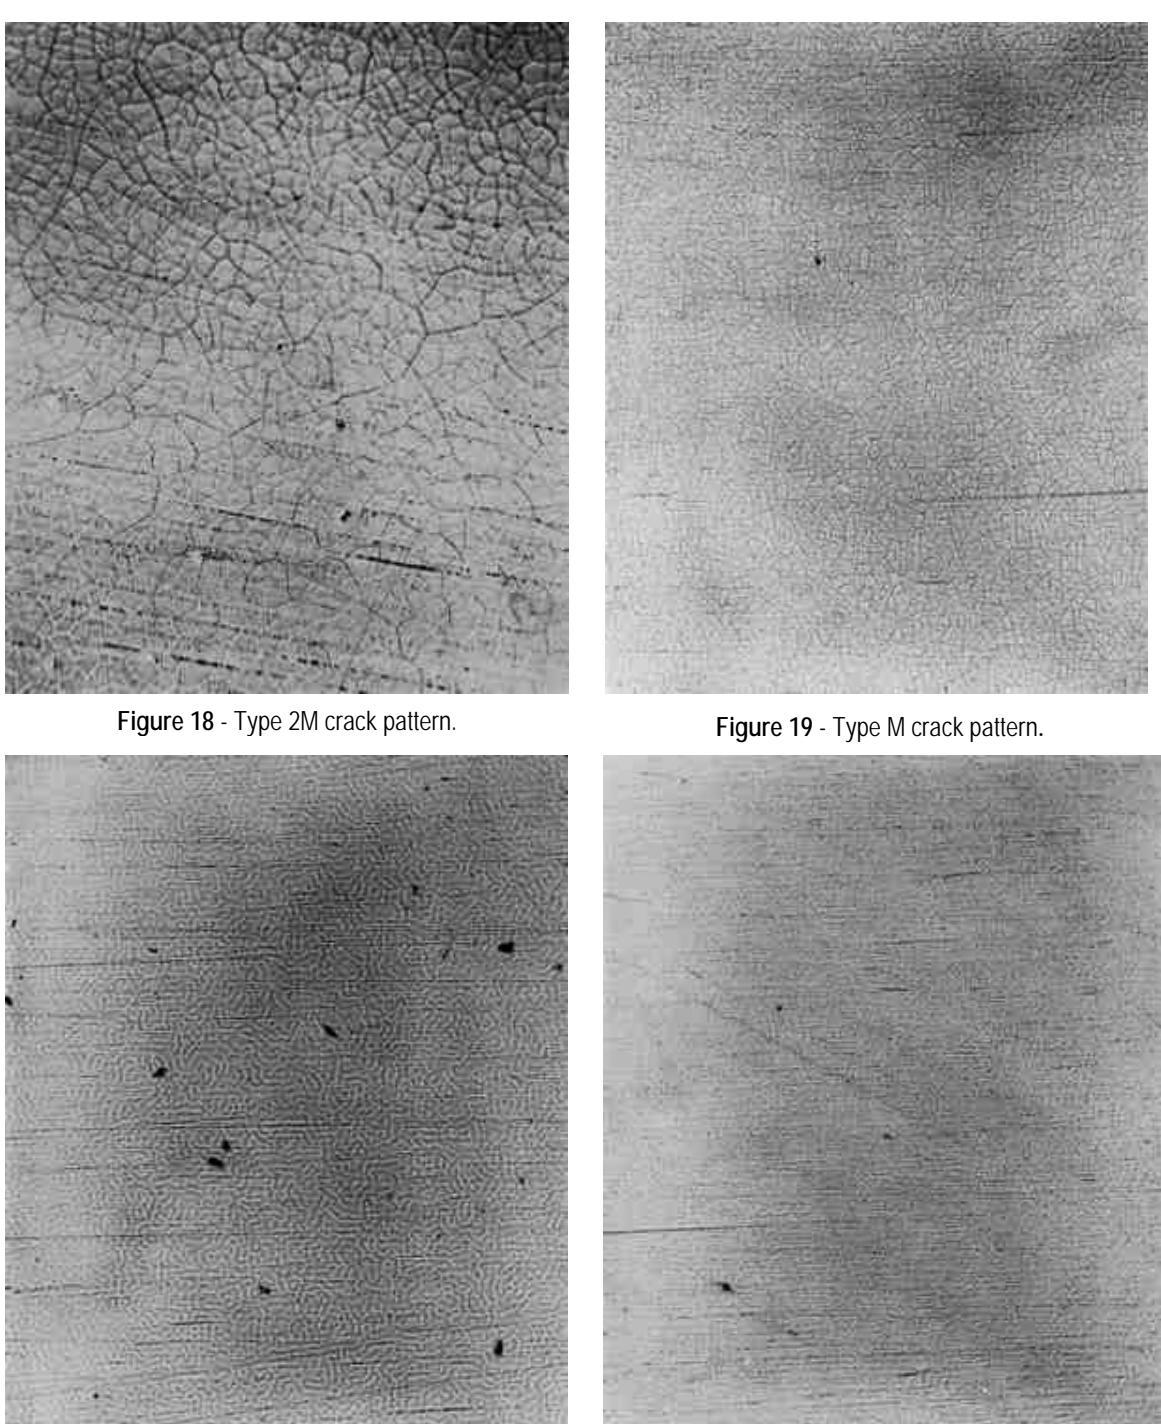
Type W: Incomplete formation of cracks, or "worm tracks" (Fig. 20).

Type P: Porous chromium (Fig. 21). Nickel exposed through pores instead of cracks in the chromium layer.

Figure 20 - Type W crack pattern.

Figure 21 - Type P crack pattern.

Type W, incomplete formation of cracks or "worm tracks."

Next is Type P, porous chromium. Nickel exposed through pores instead of cracks in the chromium layer.

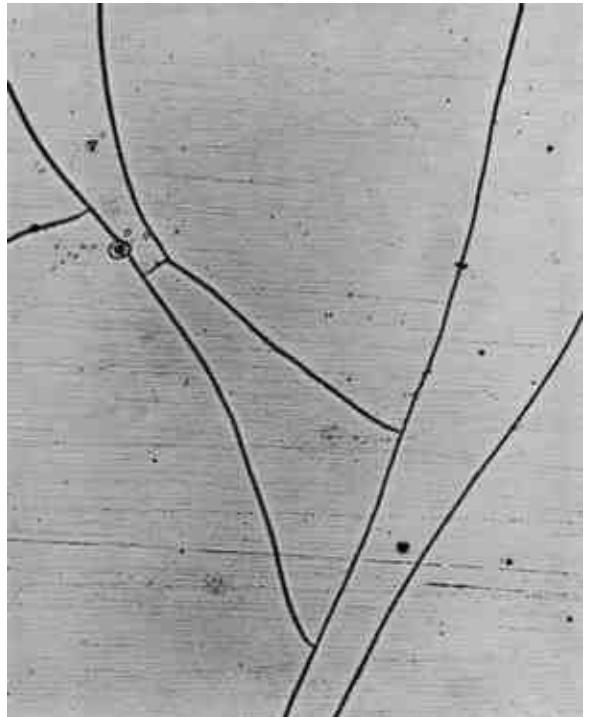
Type Y: Coarse or forked pattern with fewer than 300 cracks per lineal inch (Fig. 22).

Figure 22 - Type Y crack pattern.

Type Y is the coarse or forked pattern with fewer than 300 cracks per lineal inch.

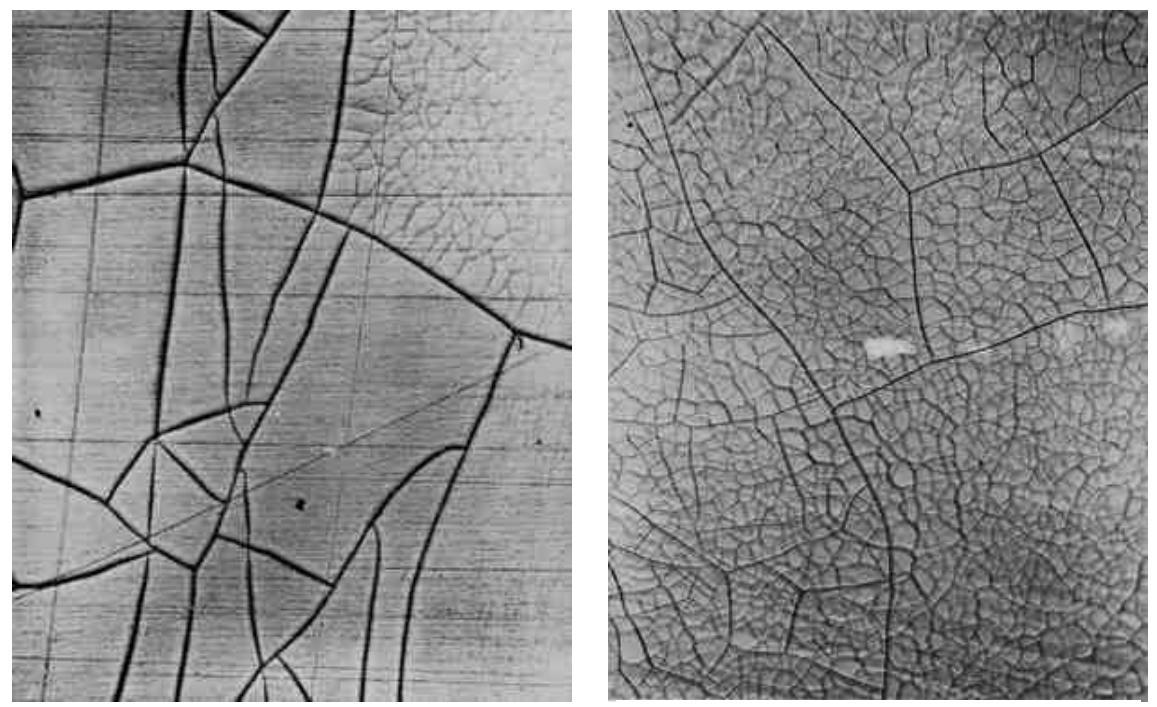
Generally there will be areas in which these basic patterns will occur in combinations, and such patterns would be designated by combinations of the appropriate letters. For example (Fig. 23), a pattern combining type Y and M in which the Y cracks predominate would be designated YM. Where the M is predominant in such a combination (Fig. 24), the designation would be MY.

Figure 23 - Type YM crack pattern.

Figure 24 - Type MY crack pattern.
