NRL/MR/6170--04-8762

# **Validation of HVOF WC/Co Thermal Spray Coatings as a Replacement for Hard Chrome Plating on Aircraft Landing Gear**

March 31, 2004

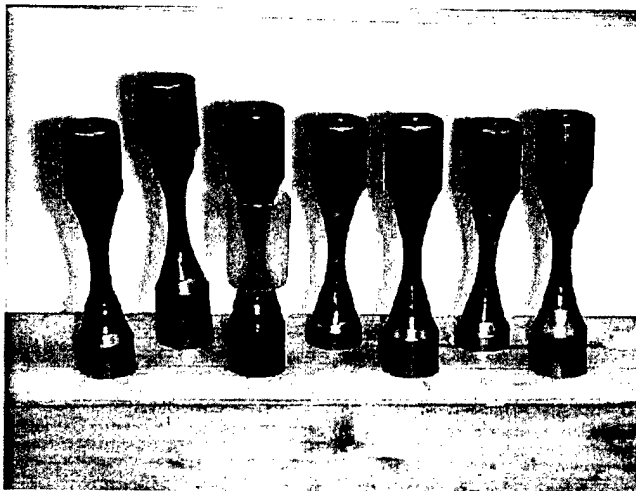
**Figure 3-10. Small (1/4" dia) Hourglass Bars for Corrosion Fatigue Testing**

The testing set-up is shown in Figure 3-10., Figure 3-11., and Figure 3-12.. These figures illustrate corrosion-fatigue testing, but the same arrangement was used for in-air testing (minus the stop-off paint and liquid receptacle).

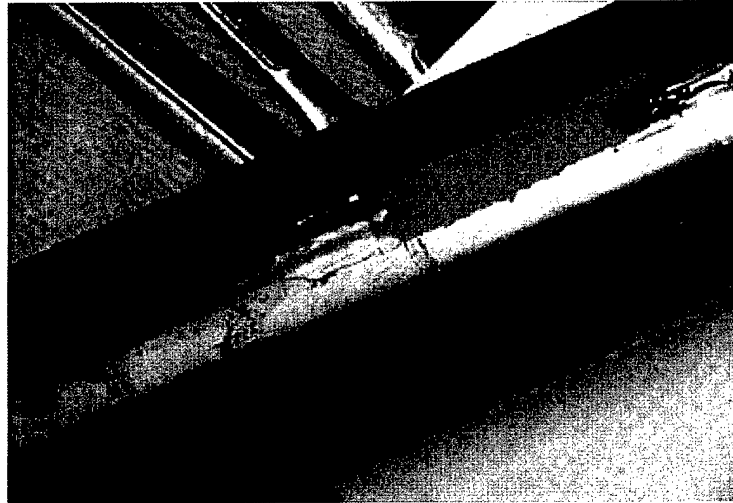
**Figure 4-6. Spallation of a 0.015"-thick WC/CoCr Coating from a Test Cylinder (OO-ALC)**

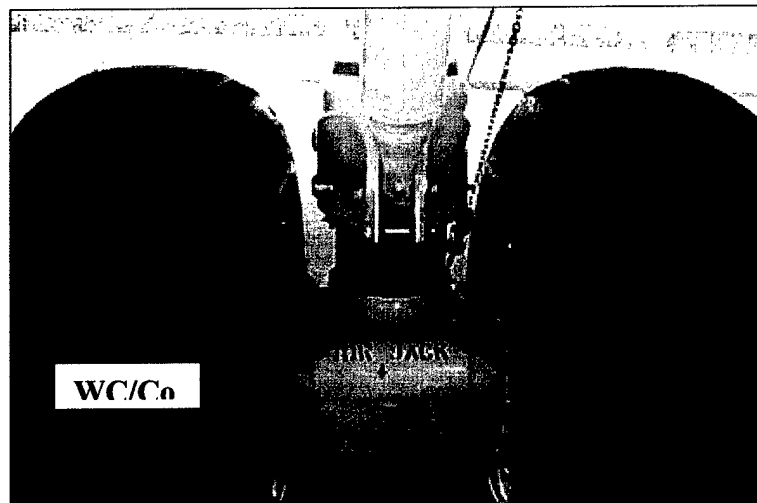
**Figure 5-8. P-3C Main Landing Gear with HVOF WC/17Co-coated Piston Cylinder (indicated) and Axle Journals**
