AGARD CONFERENCE PROCEEDINGS No. 317

## Maintenance in Service of High Temperature Parts

MAINTENANCE IN SERVICE OF  
HIGH-TEMPERATURE PARTS

Papers presented at the 53rd Meeting of the AGARD Structures and Materials Panel held  
in Noordwijkerhout, the Netherlands 27 September-2 October 1981.

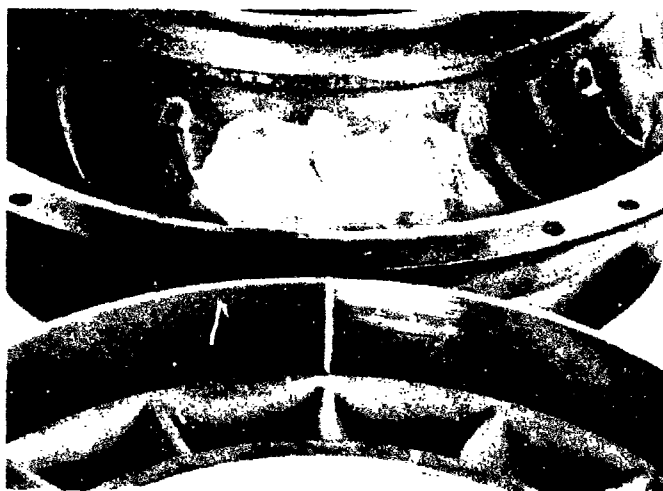
Figure 6.

Turbine tip rub on the Nimbus Stage 2 nozzle guide vane and staining of the outer shroud.

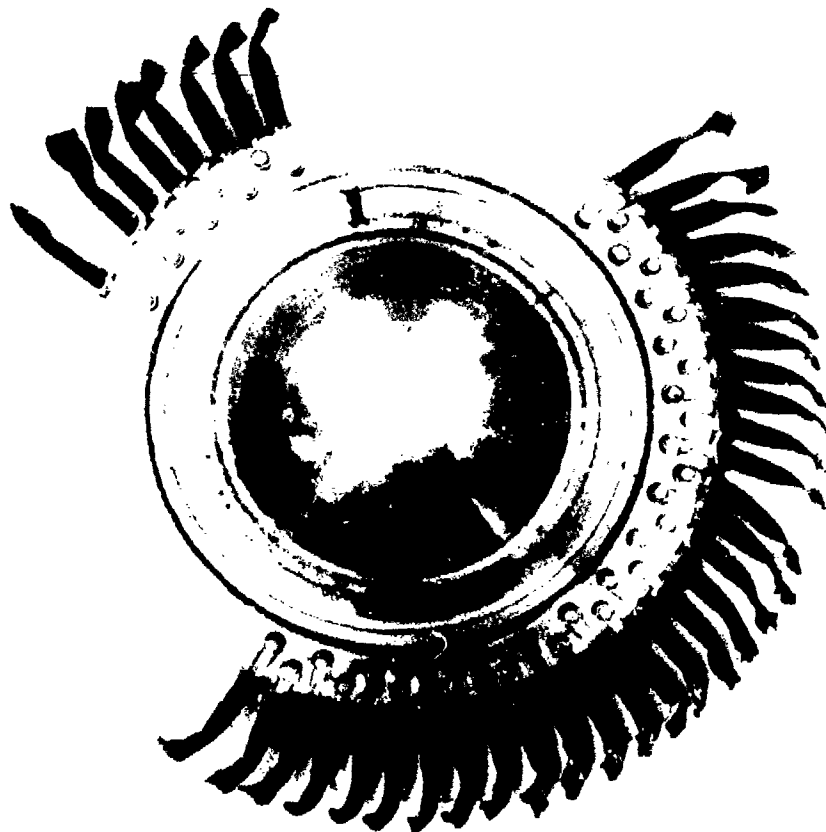
Fig.1 - Failed Turbine Disc - Whittle Mk 3 Engine  
(Courtesy Proc. Inst. Mech.  
Eng. 1945 152 419)
