Project R-118 Q4

Crack Formation during Electrodeposition and Post-deposition Aging of Thin Film Coatings

4th Quarterly Report
October-December 2016
AESF Research Project #R-118

by
Prof. Stanko R. Brankovic
University of Houston
Houston, Texas, USA

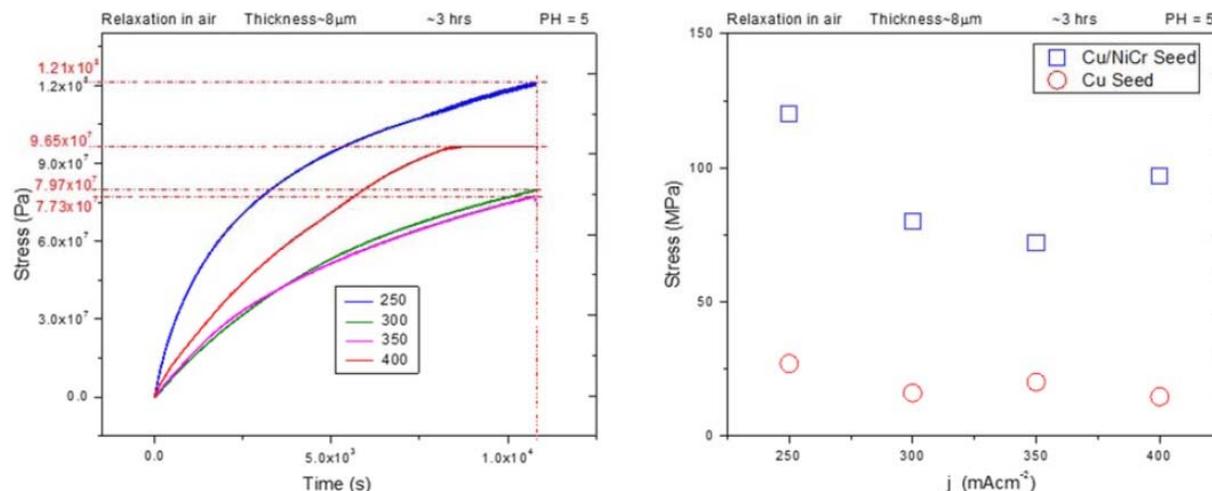
Figure 1 - (a) *In situ* stress transients during room temperature aging of ~8 micron thick chromium films deposited on Cu/NiCr seed at different current densities used for chromium deposition; **(b)** comparison between the maximum stress observed during room temperature aging of chromium films deposited on copper seed (red) and Cu/NiCr seed (blue).

The one issue that had to be addressed from our previous report (3rd Quarterly Report) was the complete comparability among the samples for air and annealing studies. In that report, the air relaxation experiment was performed on the samples that were deposited on copper seed, which is much more conductive than Cu/NiCr (rest of the samples) but with poorer adhesion. Therefore, small changes in the copper seed conduction/delamination during the aging process could be the reason for the large impedance change during air aging that we observed. For this reason, a set of new *in situ* stress and impedance measurements was performed on chromium films deposited on 1 micron Cu/20 nm NiCr (Cu/NiCr) seed during air aging, representing the same situation as in our annealing studies at 250°C; fast ramping rate, (3rd quarterly report, R-118-Q3). The resulting *in situ* stress data are shown in Fig. 1(a), for chromium films of ~8 micron thickness. A comparison between the data obtained on chromium films deposited on copper seed (3rd quarterly report, R-118-Q3) and chromium films on Cu/NiCr seed (this report) is shown in Fig. 1(b).

Qualitatively, the stress transients have the same shape for chromium films deposited on Cu/NiCr and copper seed (3rd quarterly report, R-118-Q3, Fig. 5). They exhibit a continuous rise with time but in the case of the Cu/NiCr seed, no steady stress state is reached. The comparison between the maximum stress values observed after 3 hr of room temperature aging in air for these two sets of samples indicates that tensile relaxation in chromium films in the case of Cu/NiCr seeds reaches much higher values. They range between ~120 MPa for 200 mA/cm² to ~71 MPa for 350 mA/cm². The maximum stress versus deposition current dependence exhibits a pronounced minimum for the 350 mA/cm² sample (Fig. 1(b), blue). This differs from what we have seen in the case of chromium films deposited on copper seed, which had more or less a constant value. Therefore, the nature of the seed layer, its adhesion to the glass substrate, as well as the deposition current have a significant effect on room temperature stress relaxation in chromium films deposited from Cr⁺³-containing electrolytes. Further analysis of this data will be addressed later in the text after presenting the *in situ* impedance measurements for the chromium films during room temperature aging in air.

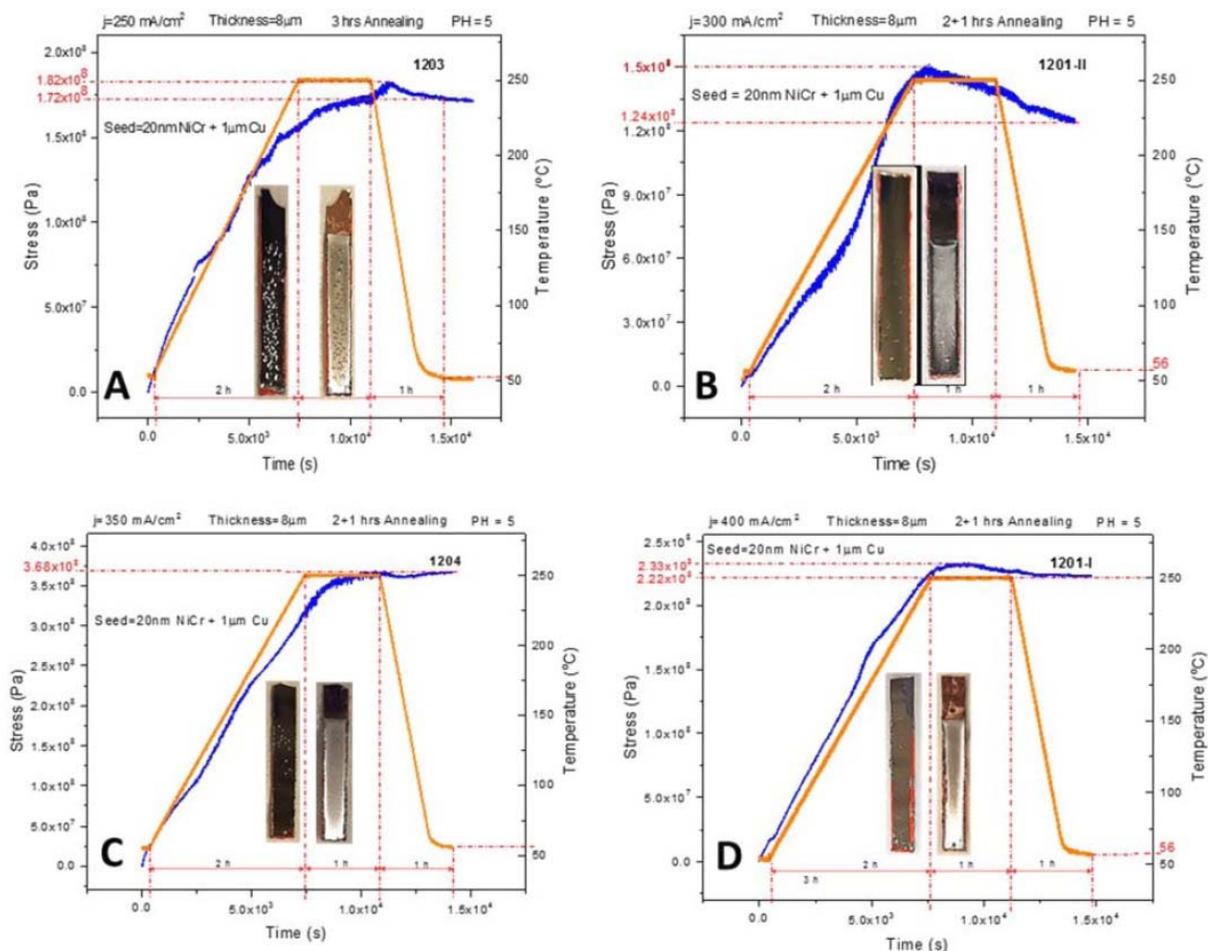
Figure 2 - *In situ* stress and temperature transients of 8-micron chromium films deposited on Cu/NiCr seed during 250°C annealing: (a) $j = 200 \text{ mA/cm}^2$, (b) $j = 300 \text{ mA/cm}^2$, (c) $j = 350 \text{ mA/cm}^2$ and (d) $j = 400 \text{ mA/cm}^2$. The optical images show the representative appearance of the chromium films on glass cantilevers after annealing.

The *in situ* stress and temperature transients recorded during 250°C annealing of ~8 micron thick chromium films deposited on Cu/NiCr seed are shown in Fig. 2(a-d). The temperature profile involved three steps. The first step involved a slow ramp rate of 1.6°C/min for two hours to reach 250°C. Second is a one-hour hold at 250°C. The third step is a subsequent temperature decrease with at a rate of approximately -3°C/min to room temperature (Fig. 2). The observed stress transients show a common behavior, in that the stress rises (tensile relaxation) during temperature ramping, then it shows small change or remains constant during the temperature hold, and then remains constant or shows a small compressive relaxation during cooling. The annealing process produces a significant appearance of defects in the films in the form of blistering, cracking and partial delamination.

Optical images of the cantilevers are shown as insets in Fig. 2. It is obvious that the annealing process produced irreversible changes in the stress state of the chromium films. A tensile relaxation of 200-350 MPa was observed. These values are close to the ultimate tensile strength for chromium films (200-250 MPa). The largest degree of relaxation is observed for chromium films produced at a current density of 350 mA/cm². A closer inspection of the stress transients shows that there were occasional discontinuities, indicative of thin film cracking (Fig. 2a & d). The qualitative tensile relaxation behavior also indicates that the stress state in the chromium films was mostly influenced by the solid state processes in the film rather than by thermal stress developed from the different thermal expansion coefficients of metal and glass. In each of the measurements, the stress increase is not a monotonic function of time for a constant temperature or temperature ramping rate, but rather a more complex

One important observation to note is that the noise in the data increases during the holding stage (2nd state, $T = \text{constant}$), which could mean that the fluctuations in the stress-time data are indeed related to the formation of microcracks. The tensile relaxation produced by the annealing process is larger than that for either room temperature (RT) aging in solution or in air. We will return to analysis of this data later in the text after presenting the impedance results.

removed. The oxide formation as a phase with a larger volume than that of the original metallic chromium contributes to compressive relaxation (Fig. 2). This is what we observed in our experiments. Oxide growth in the chromium films is the likely reason for the observed increase in impedance during temperature hold and cooling steps (Fig. 5).

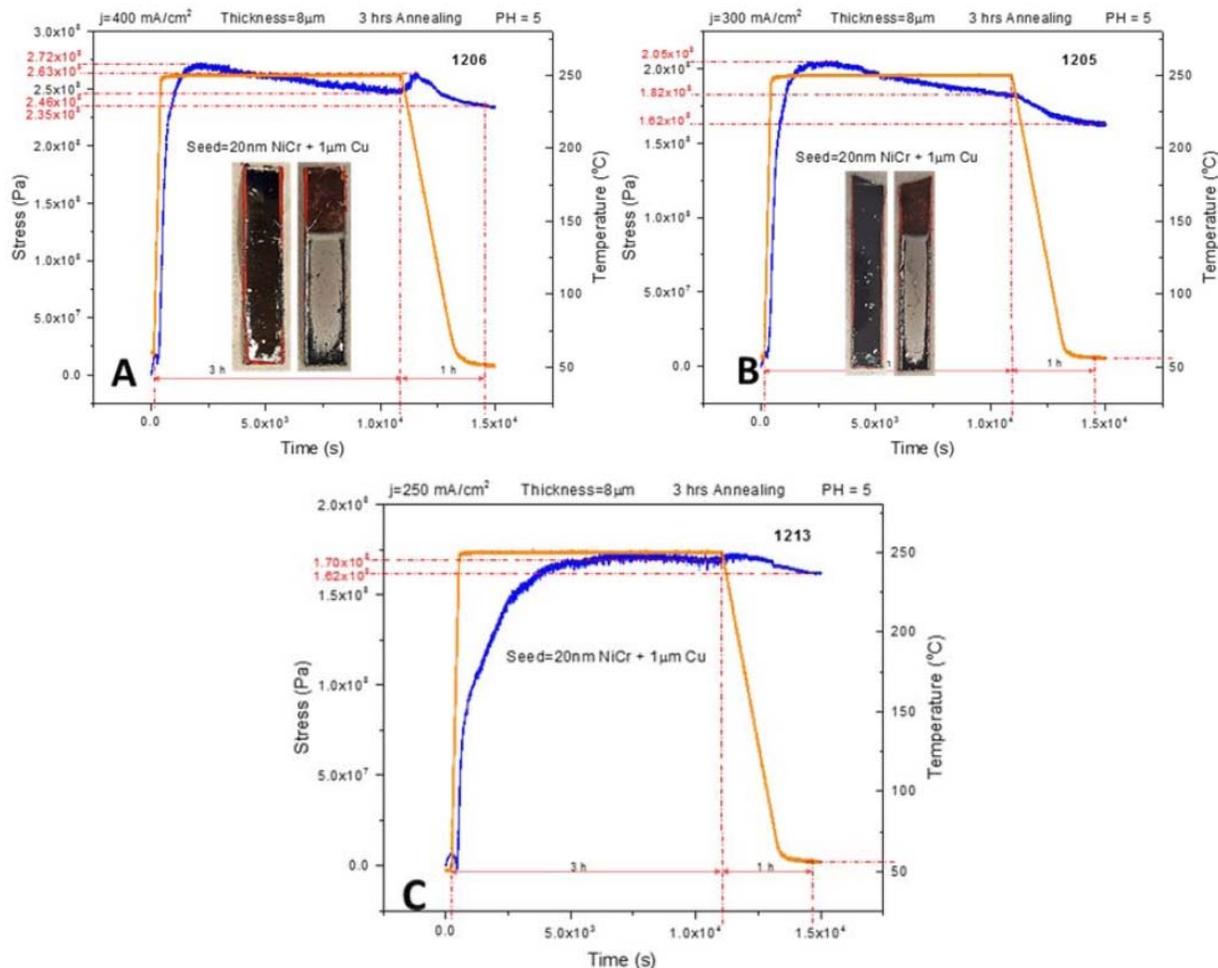
Figure 3 - *In situ* stress and temperature transients for 8-micron thick chromium films deposited on Cu/NiCr seed during 250°C annealing: (a) $j = 400 \text{ mA/cm}^2$, (b) $j = 300 \text{ mA/cm}^2$ and (c) $j = 250 \text{ mA/cm}^2$. The temperature ramp rate was 50°C/min, while the cooling rate was -3°C/min. The time interval for holding at $T = 250^\circ\text{C}$ was 2 hr. The overall length of each interval is indicated in each graph.

In order to complement the impedance data provided in previous report (3rd Quarterly Report, R-118-Q3, Fig. 4(a-d)), we performed *in situ* stress measurements on 8-micron chromium films deposited on Cu/NiCr seed using the identical temperature profile from the previous report. This includes a fast temperature ramp rate of 50°C/min, followed by 2 hr at the 250°C temperature hold, then cooling at a rate of -3°C/min. All stress transients showed a complex behavior, as in Fig. 3(a-c).

The rapid temperature ramp rate is matched by a rapid tensile relaxation, reaching values between 170 and 270 MPa. Tensile relaxation does not rise monotonically with time and temperature but rather shows a dependence with the changing slope. In particular, an interesting result is that the change in the slope of the stress-time data occurs at the moment when the temperature reaches above a range of 150-175°C. The compressive relaxation is observed as the maximum tensile stress is reached during the temperature hold at 250°C, and during the cooling stage. The sample deposited at 250 mA/cm² shows somewhat different behavior. The tensile relaxation was more gradual, extending to the region of constant temperature, while the compressive relaxation during that stage was almost negligible. The overall comparison between the maximum levels of tensile stress developed during annealing of the chromium samples using two different temperature profiles (Fig. 2 vs. Fig. 3) indicates similar values for samples deposited at 250 and 400 mA/cm², while the largest discrepancy was observed for samples deposited at 300 mA/cm² (Figs. 2b & 3b). The same trend was also observed when comparing the impedance data, as will be discussed next.

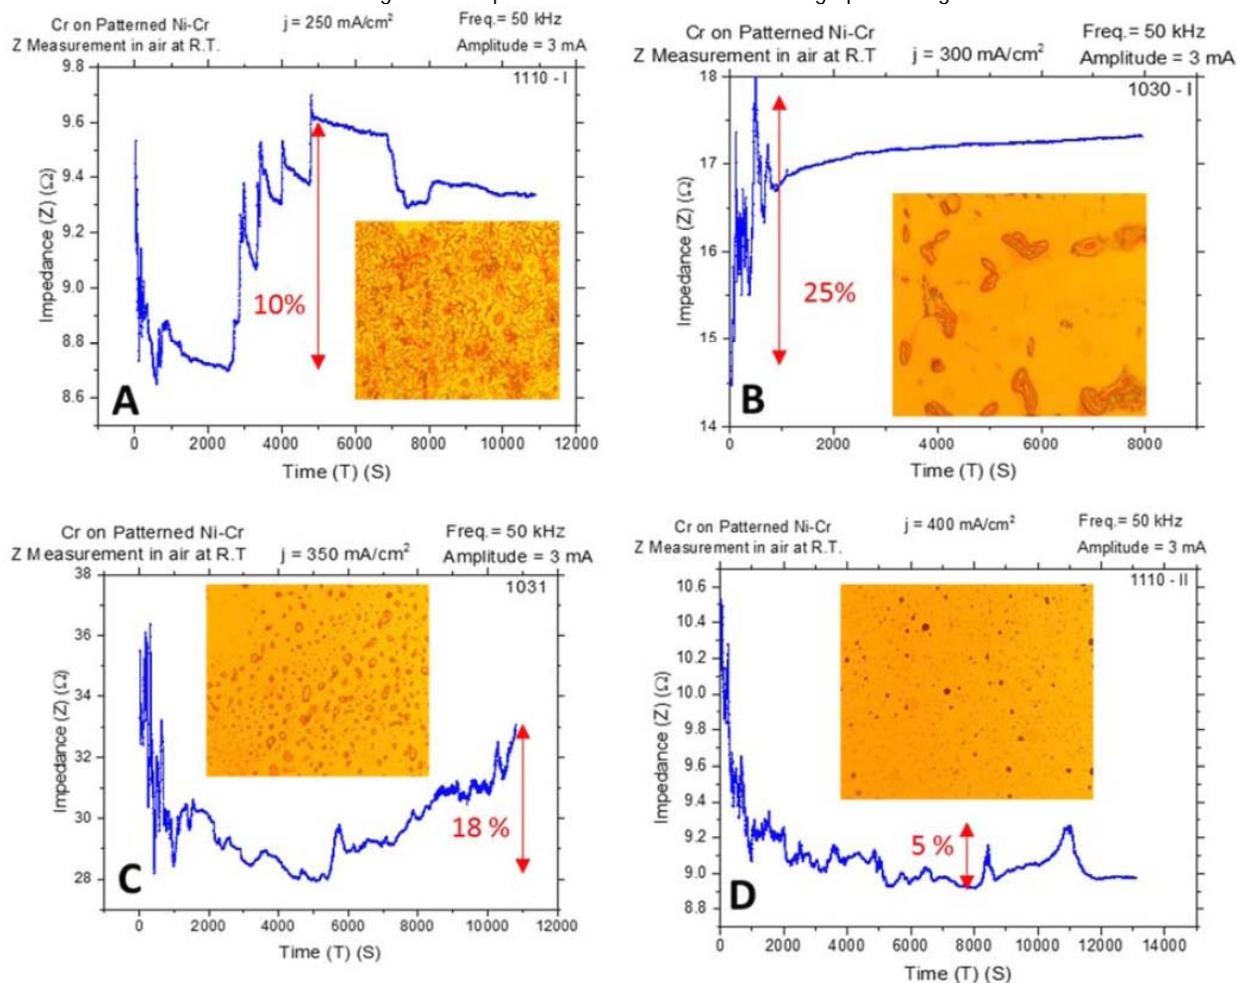
Figure 4 - *In situ* impedance measurements of 8-micron chromium films during aging at room temperature in air. The impedance of the chromium films was monitored for ~3 hr and the maximum percentage change of impedance from absolute minimum to the maximum over time is indicated. Samples were deposited at (a) $j = 250 \text{ mA/cm}^2$, (b) $j = 300 \text{ mA/cm}^2$, (c) $j = 350 \text{ mA/cm}^2$ and (d) $j = 400 \text{ mA/cm}^2$. Optical images were taken from the center of the sample; AC amplitude 3 mV, frequency 50 kHz.

During this quarter, we performed *in situ* impedance measurements during chromium film aging in air at room temperature and during annealing at 250°C. The impedance measurements for aging in air represent a repetition of the measurements from the last report while here the chromium films were grown on Cu/NiCr seed, allowing direct comparison with other measurements and complementing our stress data. The experimental apparatus for *in situ* room temperature impedance measurements and sample configuration have been described in detail in previous reports (2nd and 3rd quarterly reports, R-118-Q2 & Q3). The observed resistance changes during room temperature aging for chromium films deposited at different current densities are shown in Fig. 4(a-d). The optical images of the representative morphology of the chromium surface for each transient sample are also shown as insets. Impedance transients were recorded over time intervals of 3 hr, while the approximate chromium film thickness was around 8 microns. The maximum change in the impedance value is indicated in the graph. It ranges from 5% to 25%.

The impedance change with respect to the deposition current density shows a bell-like shape dependence (Fig. 4 and the summary plot of Fig. 6(a)). The maximum change is observed for deposition current densities of 300 and 350 mA/cm². The common feature of all results in Fig. 4 is the presence of quite pronounced discontinuities manifested as: random impedance jumps, and sudden abrupt increases or decreases as the aging process progresses. Optical inspection of the chromium samples does indicate that no crack formation occurred in the chromium films. However, a sudden change of impedance is characteristic for each of the transients and is indicative of significant structural change within the chromium films. Perhaps, these impedance changes could have arisen from the formation of microcracks not detectable by optical microscopy, or via some phase transformation that could be related to the disintegration of Cr-hydride upon deposition and its conversion to Cr-oxide and H₂O when in contact with oxygen from air.

One important observation is that in each transient, immediately upon completion of the deposition process and after the solution is drained to start impedance measurements, a common decrease is observed (Fig. 4(a-d)). Depending on the sample, the time varies until the subsequent onset of impedance increase is observed. Yet, this is an indication that the initial dominant process occurring in the chromium films on deposition is qualitatively different than the ones dominating/occurring later due to exposure to air. One explanation could be that the Cr-hydride in the chromium film is stable only when the significant overpotential for H₂ evolution and H-radical exist near the surface. In our case, for each sample this occurs during deposition since the potential transients are well below the water electroreduction potential (see 1st report). When the electrodeposition is stopped, the Cr-hydride starts to decompose, leaving products of chromium and H₂ in the film. The latter is trapped within the grain boundaries or within the grains as dissolved interstitials. Hydride disintegration results in decreased resistivity of the chromium films since metallic chromium is likely a better conductor than Cr-hydride. Later on, in contact with O₂, hydrogen as well as chromium react, forming Cr-oxide which is the process that produces higher resistivity. Since no cracks are observed in the optical microscopy, it is unclear if these two stages result in cracking of the films during room temperature aging. The stress data shown in Fig. 1 do not indicate an abrupt change in stress but rather a gradual tensile relaxation, which can be explained by Cr-hydride decomposition. Yet, void formation and microcrack generation cannot be excluded.

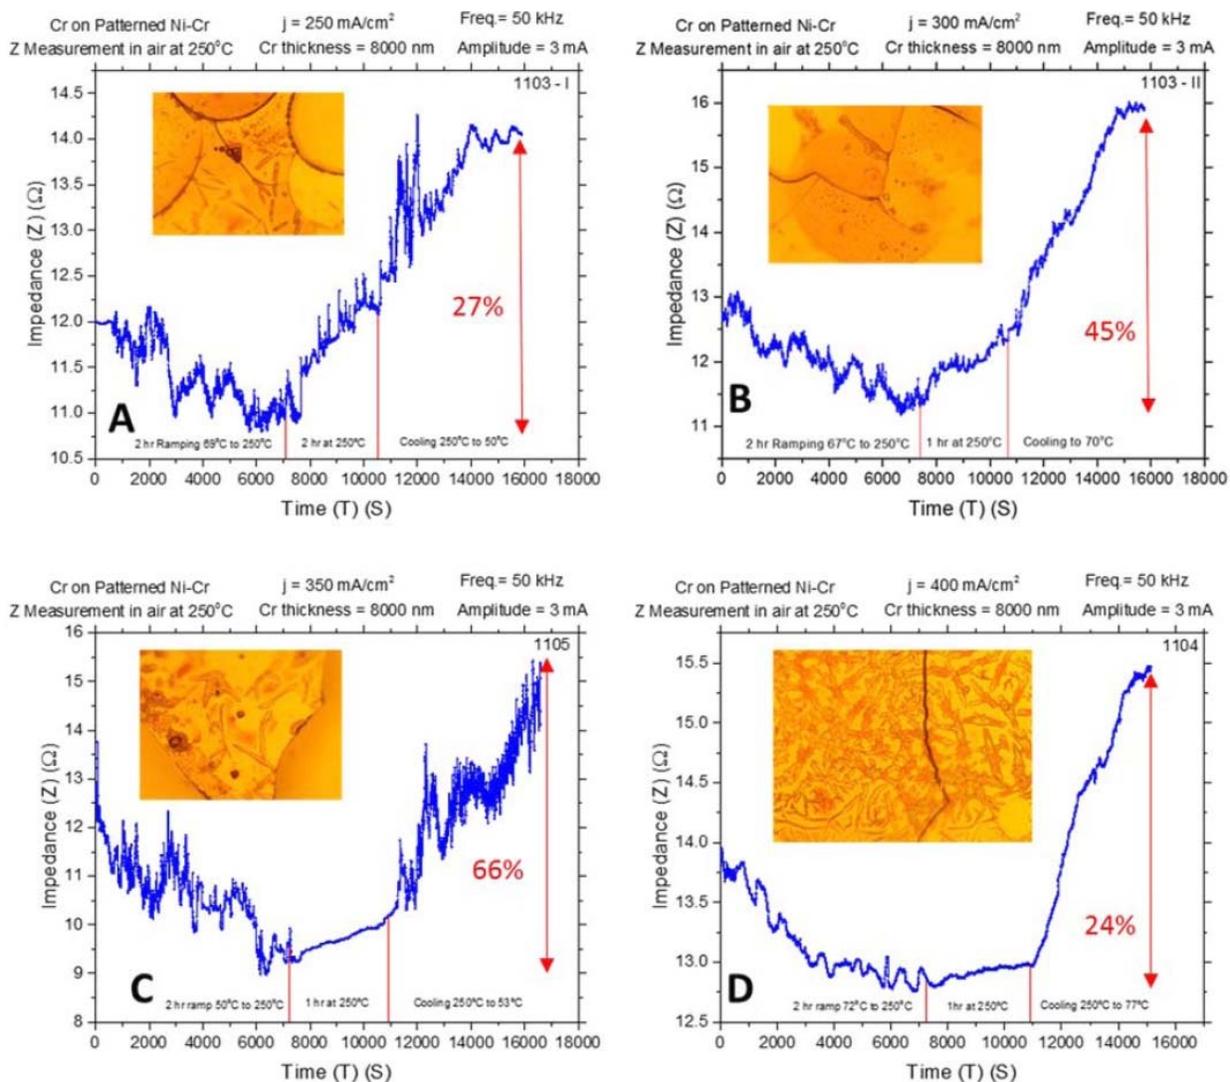
Figure 5 - *In situ* impedance measurements of 8-micron chromium films during annealing at 250°C in air. The impedance of the chromium films was monitored for ~3 hr and the maximum percentage change of impedance from absolute minimum to the maximum from the increasing trend is indicated. Samples were deposited at (a) $j = 250$ mA/cm², (b) $j = 300$ mA/cm², (c) $j = 350$ mA/cm² and (d) $j = 400$ mA/cm². Optical images were taken from the center of the sample; AC amplitude 3 mV, frequency 50 kHz.

The *in situ* stress measurements made during chromium thin film annealing at 250°C using a slow temperature ramp rate (Fig. 2) were complemented with the impedance measurements as well. The temperature profile, ramp rate (1.6°C/min) and film thickness were the same. The results are shown in Fig. 5(a-d). The common feature observed on all impedance transients is that the temperature increase (2 hr) is associated with initial decrease of impedance/resistance of the chromium films, while the further temperature hold (1 hr), and cooling step (-3°C/min), are associated with increase of the chromium film impedance. The described regions are identified in the graphs by the presence of bordering red lines.

The optical images of the chromium film surfaces indicate the appearance of the cracks. Therefore, the common feature of the impedance transients, such as sudden discontinuities and increasing/decreasing spikes, could be attributed to microcracking and some additional structural changes in the chromium films.

The maximum percentage impedance change measured from the absolute minimum to the apparent maximum obtained due to a rising part of the transient are indicated in the graphs. The summary of this data is presented in Figure 6(a). If one compares these transients (Fig. 5) with the stress transients (Fig. 2), it seems that tensile stress relaxation is associated with the overall decrease in impedance of the chromium films. The further small compressive relaxation during the temperature hold or cooling steps is associated with the overall increasing impedance of the chromium films.

We can therefore hypothesize that the tensile stress associated with the temperature rise during annealing is governed by hydride decomposition and water losses. Both are responsible for the decrease in the resistance of the chromium film (Fig. 5). At higher temperatures, chromium liberated from hydride and potentially the chromium in the metallic state that is deposited are subjected to oxidation by oxygen from air penetrating through the porous grain boundaries where hydride and water have been

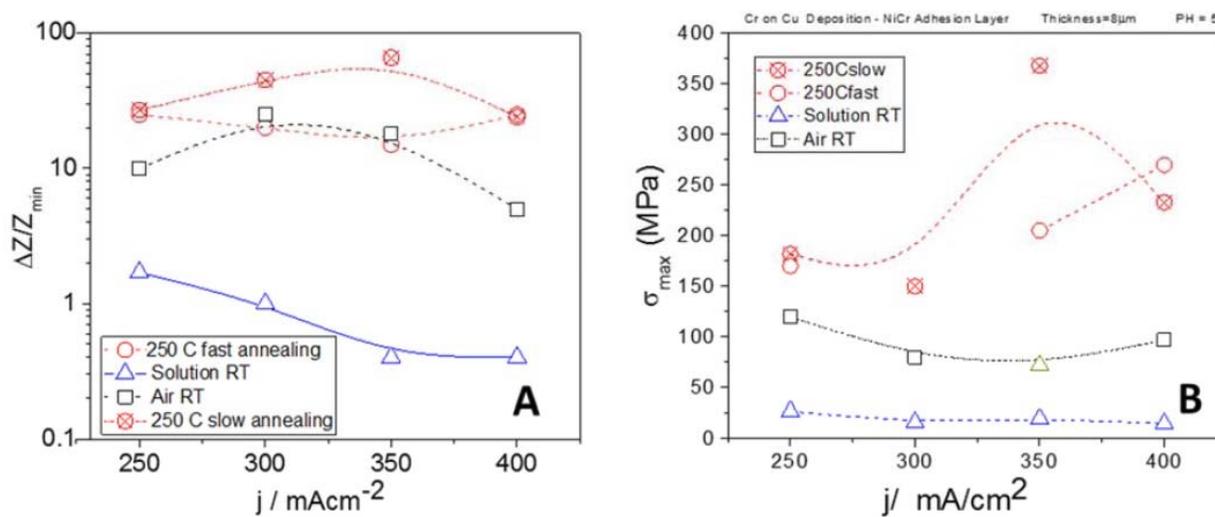
Figure 6 - Summary of (a) *in situ* impedance measurements, change presented in % units and (b) *in situ* stress measurements as a function of deposition current density.

Further studies have focused on the stress state in the chromium films during aging process in solution, in air and during annealing at 250°C. The summary of these data is shown in Fig. 6. Our studies clearly indicate that the tensile relaxation in the chromium films is directly related to the environment to which the chromium films are exposed. During relaxation in the solution, which could be considered as an oxygen deprived environment, the maximum change of stress observed was very modest, over the course of several hours (Fig. 6(b)). This modest tensile relaxation was most likely associated with decomposition of the Cr-hydride phase once the potential for hydrogen evolution and the presence of hydrogen ions was removed. However, we expect that the hydrogen gas molecules released from the hydride phase remains trapped in the deposit as an atomic interstitial, or as gas phase in microvoids formed at the grain boundaries, or within the grains which can act as the crack nucleation sites.
