4th Quarterly Report
October-December 2016
AESF Research Project #R-118

Crack Formation during Electrodeposition and Post-deposition Aging of Thin Film Coatings

by
Prof. Stanko R. Brankovic*
University of Houston
Houston, Texas, USA

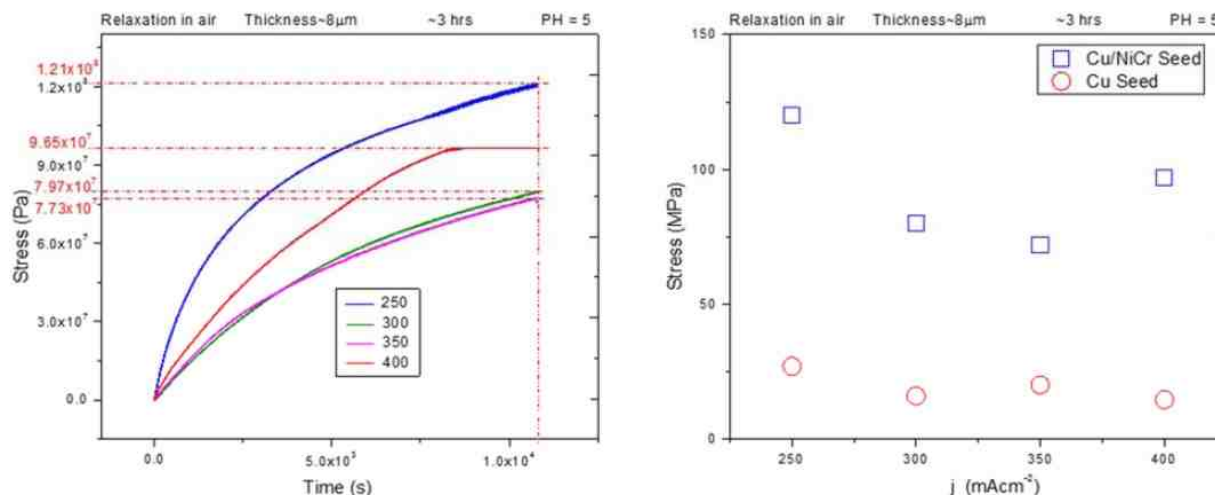
Figure 1 - (a) *In situ* stress transients during room temperature aging of ~8 micron thick chromium films deposited on Cu/NiCr seed at different current densities used for chromium deposition; (b) comparison between the maximum stress observed during room temperature aging of chromium films deposited on copper seed (red) and Cu/NiCr seed (blue).

The one issue that had to be addressed from our previous report (3rd Quarterly Report) was the complete comparability among the samples for air and annealing studies. In that report, the air relaxation experiment was performed on the samples that were deposited on copper seed, which is much more conductive than Cu/NiCr (rest of the samples) but with poorer adhesion. Therefore, small changes in the copper seed conduction/delamination during the aging process could be the reason for the large impedance change during air aging that we observed. For this reason, a set of new *in situ* stress and impedance measurements was performed on chromium films deposited on 1 micron Cu/20 nm NiCr (Cu/NiCr) seed during air aging, representing the same situation as in our annealing studies at 250°C; fast ramping rate, (see previous report). The resulting *in situ* stress data are shown in Fig. 1(a), for chromium films of ~8 micron thickness. A comparison between the data obtained on chromium films deposited on copper seed (previous report) and chromium films on Cu/NiCr seed (this report) is shown in Fig. 1(b).

Qualitatively, the stress transients have the same shape for chromium films deposited on Cu/NiCr and copper seed (previous report, Fig. 5). They exhibit a continuous rise with time but in the case of the Cu/NiCr seed, no steady stress state is reached. The comparison between the maximum stress values observed after 3 hr of room temperature aging in air for these two sets of samples indicates that tensile relaxation in chromium films in the case of Cu/NiCr seeds reaches much higher values. They range between ~120 MPa for 200 mA/cm² to ~71 MPa for 350 mA/cm². The maximum stress versus deposition current dependence exhibits a pronounced minimum for the 350 mA/cm² sample (Fig. 1(b), blue). This differs from what we have seen in the case of chromium films deposited on copper seed, which had more or less a constant value. Therefore, the nature of the seed layer, its adhesion to the glass substrate, as well as the deposition current have a significant effect on room temperature stress relaxation in chromium films deposited from Cr³⁺-containing electrolytes. Further analysis of this data will be addressed later in the text after presenting the *in situ* impedance measurements for the chromium films during room temperature aging in air.

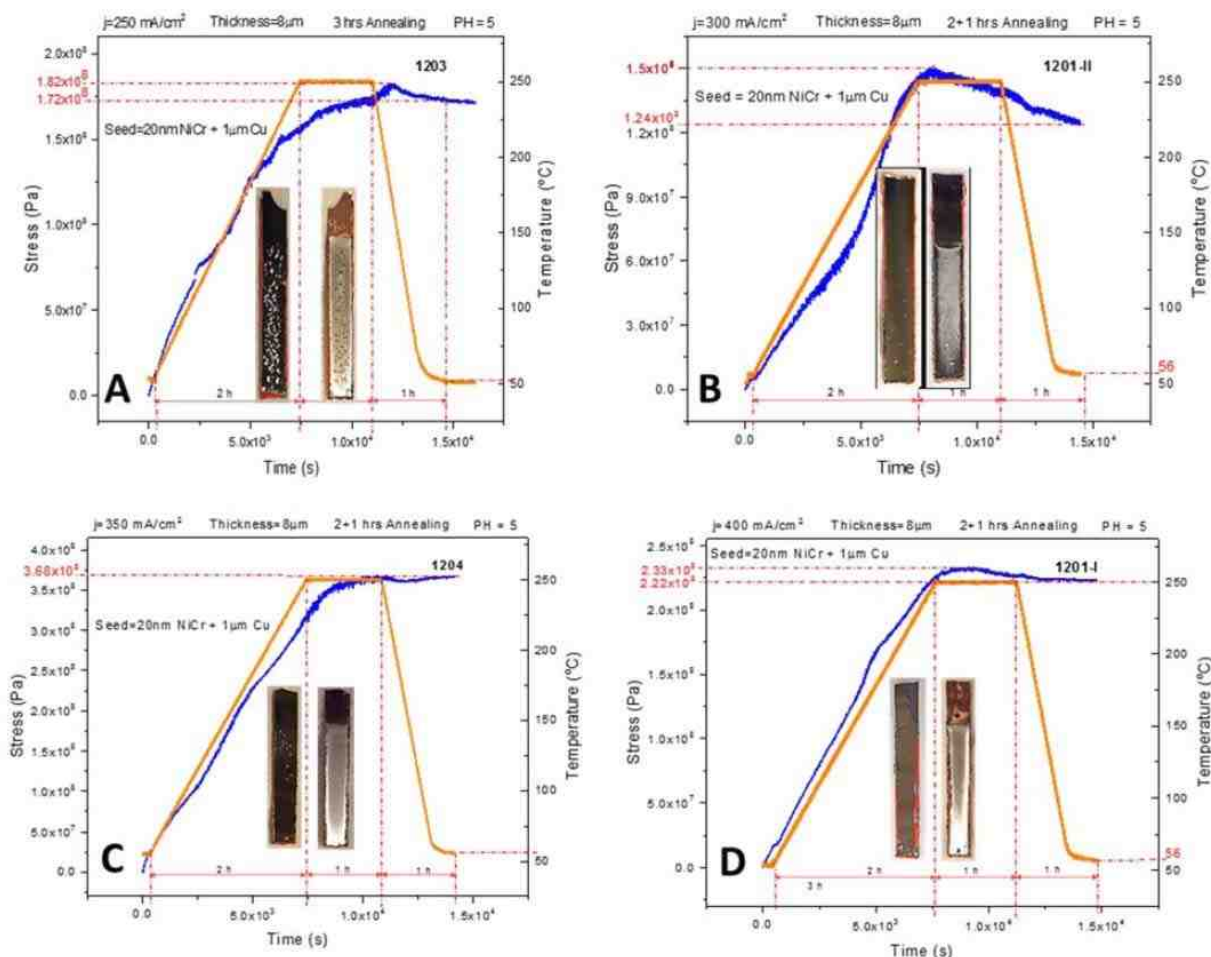
Figure 2 - *In situ* stress and temperature transients of 8-micron chromium films deposited on Cu/NiCr seed during 250°C annealing: (a) $j = 200 \text{ mA/cm}^2$, (b) $j = 300 \text{ mA/cm}^2$, (c) $j = 350 \text{ mA/cm}^2$ and (d) $j = \text{mA/cm}^2$. The optical images show the representative appearance of the chromium films on glass cantilevers after annealing.

The *in situ* stress and temperature transients recorded during 250°C annealing of ~8 micron thick chromium films deposited on Cu/NiCr seed are shown in Fig. 2(a-d). The temperature profile involved three steps. The first step involved a slow ramp rate of 1.6°C/min for two hours to reach 250°C. Second is a one-hour hold at 250°C. The third step is a subsequent temperature decrease with at a rate of approximately -3°C/min to room temperature (Fig. 2). The observed stress transients show a common behavior, in that the stress rises (tensile relaxation) during temperature ramping, then it shows small change or remains constant during the temperature hold, and then remains constant or shows a small compressive relaxation during cooling. The annealing process produces a significant appearance of defects in the films in the form of blistering, cracking and partial delamination.

Optical images of the cantilevers are shown as insets in Fig. 2. It is obvious that the annealing process produced irreversible changes in the stress state of the chromium films. A tensile relaxation of 200-350 MPa was observed. These values are close to the ultimate tensile strength for chromium films (200-250 MPa). The largest degree of relaxation is observed for chromium films produced at a current density of 350 mA/cm². A closer inspection of the stress transients shows that there were occasional discontinuities, indicative of thin film cracking (Fig. 2a & d). The qualitative tensile relaxation behavior also indicates that the stress state in the chromium films was mostly influenced by the solid state processes in the film rather than by thermal stress developed from the different thermal expansion coefficients of metal and glass. In each of the measurements, the stress increase is not a monotonic function of time for a constant temperature or temperature ramping rate, but rather a more complex

One important observation to note is that the noise in the data increases during the holding stage (2nd state, $T = \text{constant}$), which could mean that the fluctuations in the stress-time data are indeed related to the formation of microcracks. The tensile relaxation produced by the annealing process is larger than that for either room temperature (RT) aging in solution or in air. We will return to analysis of this data later in the text after presenting the impedance results.

The maximum percentage impedance change measured from the absolute minimum to the apparent maximum obtained due to a rising part of the transient are indicated in the graphs. The summary of this data is presented in Figure 6(a). If one compares these transients (Fig. 5) with the stress transients (Fig. 2), it seems that tensile stress relaxation is associated with the overall decrease in impedance of the chromium films. The further small compressive relaxation during the temperature hold or cooling steps is associated with the overall increasing impedance of the chromium films.

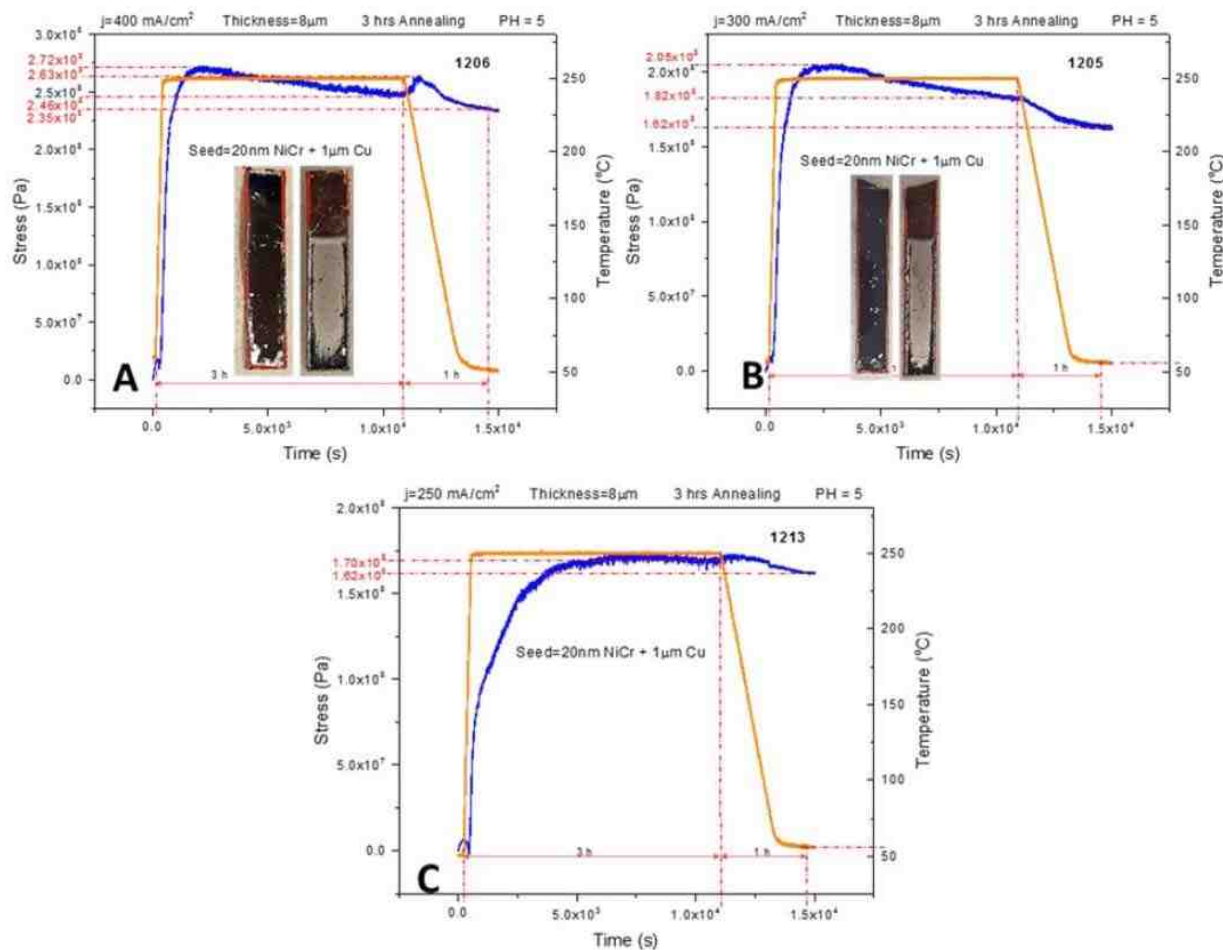
Figure 3 - *In situ* stress and temperature transients for 8-micron thick chromium films deposited on Cu/NiCr seed during 250°C annealing: (a) $j = 400 \text{ mA/cm}^2$, (b) $j = 300 \text{ mA/cm}^2$ and (c) $j = 250 \text{ mA/cm}^2$. The temperature ramp rate was 50°C/min, while the cooling rate was -3°C/min. The time interval for holding at $T = 250^\circ\text{C}$ was 2 hr. The overall length of each interval is indicated in each graph.

In order to complement the impedance data provided in previous report (3rd Quarterly Report, Fig. 4(a-d)), we performed *in situ* stress measurements on 8-micron chromium films deposited on Cu/NiCr seed using the identical temperature profile from the previous report. This includes a fast temperature ramp rate of 50°C/min, followed by 2 hr at the 250°C temperature hold, then cooling at a rate of -3°C/min. All stress transients showed a complex behavior, as in Fig. 3(a-c).

The rapid temperature ramp rate is matched by a rapid tensile relaxation, reaching values between 170 and 270 MPa. Tensile relaxation does not rise monotonically with time and temperature but rather shows a dependence with the changing slope. In particular, an interesting result is that the change in the slope of the stress-time data occurs at the moment when the temperature reaches above a range of 150-175°C. The compressive relaxation is observed as the maximum tensile stress is reached during the temperature hold at 250°C, and during the cooling stage. The sample deposited at 250 mA/cm² shows somewhat different behavior. The tensile relaxation was more gradual, extending to the region of constant temperature, while the compressive relaxation during that stage was almost negligible. The overall comparison between the maximum levels of tensile stress developed during annealing of the chromium samples using two different temperature profiles (Fig. 2 vs. Fig. 3) indicates similar values for samples deposited at 250 and 400 mA/cm², while the largest discrepancy was observed for samples deposited at 300 mA/cm² (Figs. 2b & 3b). The same trend was also observed when comparing the impedance data, as will be discussed next.

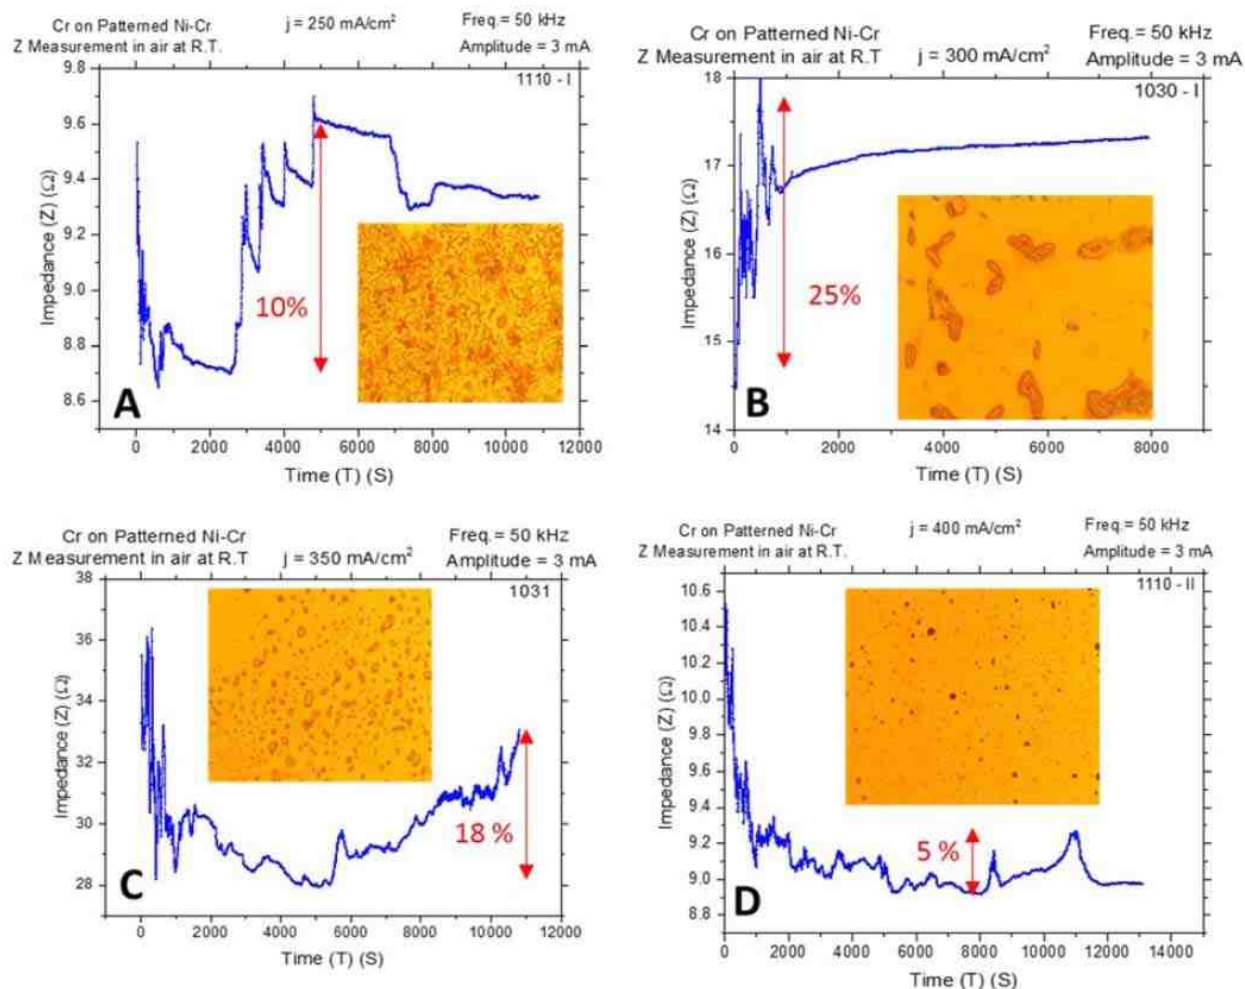
Figure 4 - *In situ* impedance measurements of 8-micron chromium films during aging at room temperature in air. The impedance of the chromium films was monitored for ~3 hr and the maximum percentage change of impedance from absolute minimum to the maximum over time is indicated. Samples were deposited at (a) $j = 250 \text{ mA/cm}^2$, (b) $j = 300 \text{ mA/cm}^2$, (c) $j = 350 \text{ mA/cm}^2$ and (d) $j = 400 \text{ mA/cm}^2$. Optical images were taken from the center of the sample; AC amplitude 3 mV, frequency 50 kHz.

During this quarter, we performed *in situ* impedance measurements during chromium film aging in air at room temperature and during annealing at 250°C. The impedance measurements for aging in air represent a repetition of the measurements from the last report while here the chromium films were grown on Cu/NiCr seed, allowing direct comparison with other measurements and complementing our stress data. The experimental apparatus for *in situ* room temperature impedance measurements and sample configuration have been described in detail in previous reports (2nd and 3rd Quarterly Reports). The observed resistance changes during room temperature aging for chromium films deposited at different current densities are shown in Fig. 4(a-d). The optical images of the representative morphology of the chromium surface for each transient sample are also shown as insets. Impedance transients were recorded over time intervals of 3 hr, while the approximate chromium film thickness was around 8 microns. The maximum change in the impedance value is indicated in the graph. It ranges from 5% to 25%.

The impedance change with respect to the deposition current density shows a bell-like shape dependence (Fig. 4 and the summary plot of Fig. 6(a)). The maximum change is observed for deposition current densities of 300 and 350 mA/cm². The common feature of all results in Fig. 4 is the presence of quite pronounced discontinuities manifested as: random impedance jumps, and sudden abrupt increases or decreases as the aging process progresses. Optical inspection of the chromium

One important observation is that in each transient, immediately upon completion of the deposition process and after the solution is drained to start impedance measurements, a common decrease is observed (Fig. 4(a-d)). Depending on the sample, the time varies until the subsequent onset of impedance increase is observed. Yet, this is an indication that the initial dominant process occurring in the chromium films on deposition is qualitatively different than the ones dominating/occurring later due to exposure to air. One explanation could be that the Cr-hydride in the chromium film is stable only when the significant overpotential for H₂ evolution and H-radical exist near the surface. In our case, for each sample this occurs during deposition since the potential transients are well below the water electroreduction potential (see 1st report). When the electrodeposition is stopped, the Cr-hydride starts to decompose, leaving products of chromium and H₂ in the film. The latter is trapped within the grain boundaries or within the grains as dissolved interstitials. Hydride disintegration results in decreased resistivity of the chromium films since metallic chromium is likely a better conductor than Cr-hydride. Later on, in contact with O₂, hydrogen as well as chromium react, forming Cr-oxide which is the process that produces higher resistivity. Since no cracks are observed in the optical microscopy, it is unclear if these two stages result in cracking of the films during room temperature aging. The stress data shown in Fig. 1 do not indicate an abrupt change in stress but rather a gradual tensile relaxation, which can be explained by Cr-hydride decomposition. Yet, void formation and microcrack generation cannot be excluded.

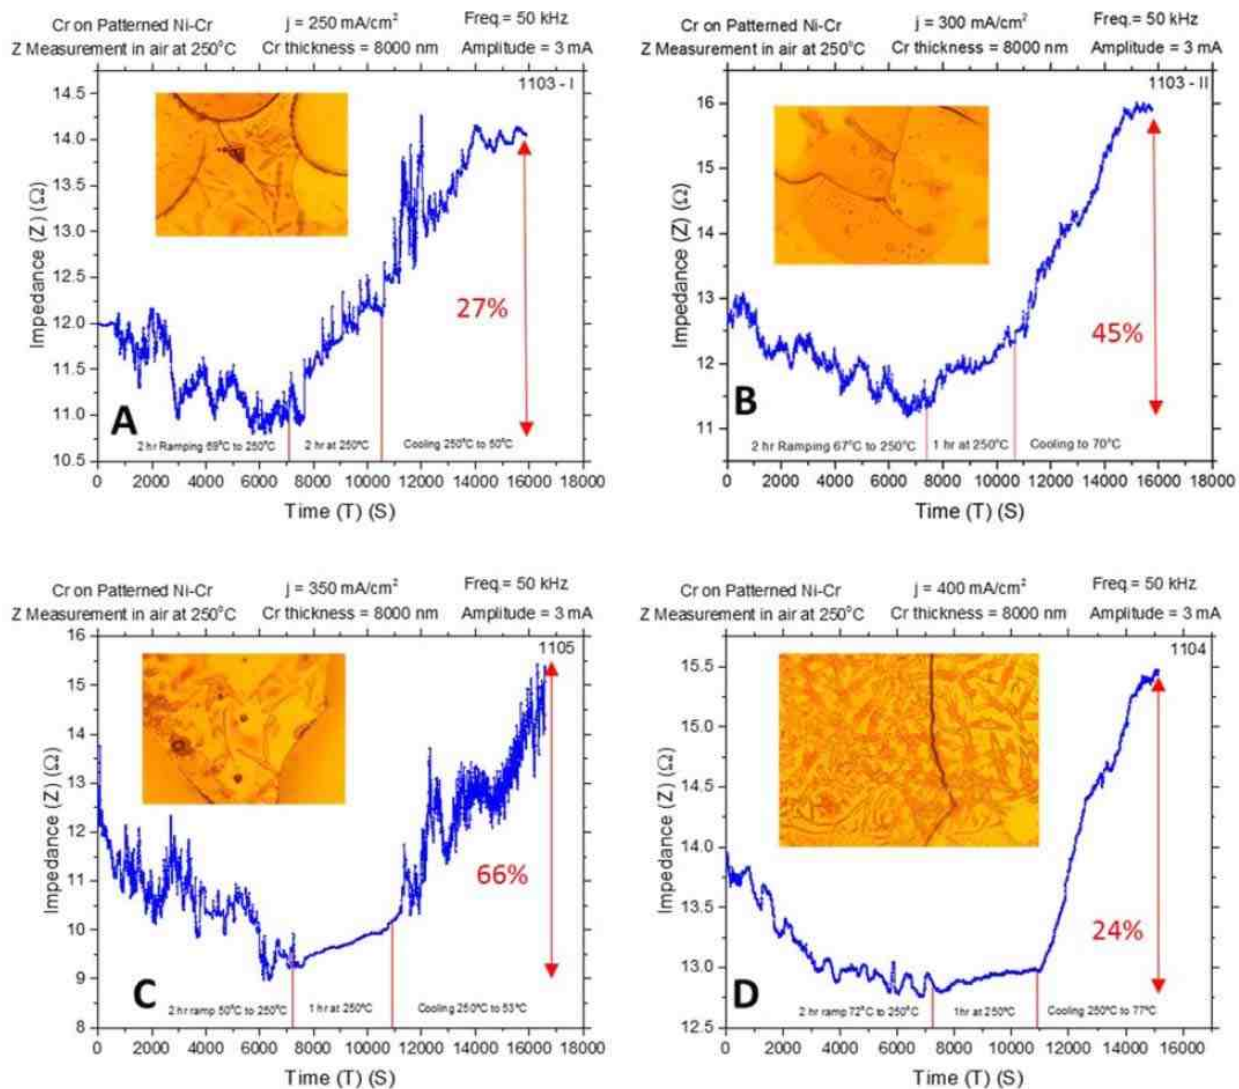
Figure 5 - *In situ* impedance measurements of 8-micron chromium films during annealing at 250°C in air. The impedance of the chromium films was monitored for ~3 hr and the maximum percentage change of impedance from absolute minimum to the maximum from the increasing trend is indicated. Samples were deposited at (a) $j = 250 \text{ mA/cm}^2$, (b) $j = 300 \text{ mA/cm}^2$, (c) $j = 350 \text{ mA/cm}^2$ and (d) $j = 400 \text{ mA/cm}^2$. Optical images were taken from the center of the sample; AC amplitude 3 mV, frequency 50 kHz.

The *in situ* stress measurements made during chromium thin film annealing at 250°C using a slow temperature ramp rate (Fig. 2) were complemented with the impedance measurements as well. The temperature profile, ramp rate (1.6°C/min) and film thickness were the same. The results are shown in Fig. 5(a-d). The common feature observed on all impedance transients is that the temperature increase (2 hr) is associated with initial decrease of impedance/resistance of the chromium films, while the further temperature hold (1 hr), and cooling step (-3°C/min), are associated with increase of the chromium film impedance. The described regions are identified in the graphs by the presence of bordering red lines.

The optical images of the chromium film surfaces indicate the appearance of the cracks. Therefore, the common feature of the impedance transients, such as sudden discontinuities and increasing/decreasing spikes, could be attributed to microcracking and some additional structural changes in the chromium films.

We can therefore hypothesize that the tensile stress associated with the temperature rise during annealing is governed by hydride decomposition and water losses. Both are responsible for the decrease in the resistance of the chromium film (Fig. 5). At higher temperatures, chromium liberated from hydride and potentially the chromium in the metallic state that is deposited are subjected to oxidation by oxygen from air penetrating through the porous grain boundaries where hydride and water have been removed. The oxide formation as a phase with a larger volume than that of the original metallic chromium contributes to compressive relaxation (Fig. 2). This is what we observed in our experiments. Oxide growth in the chromium films is the likely reason for the observed increase in impedance during temperature hold and cooling steps (Fig. 5).

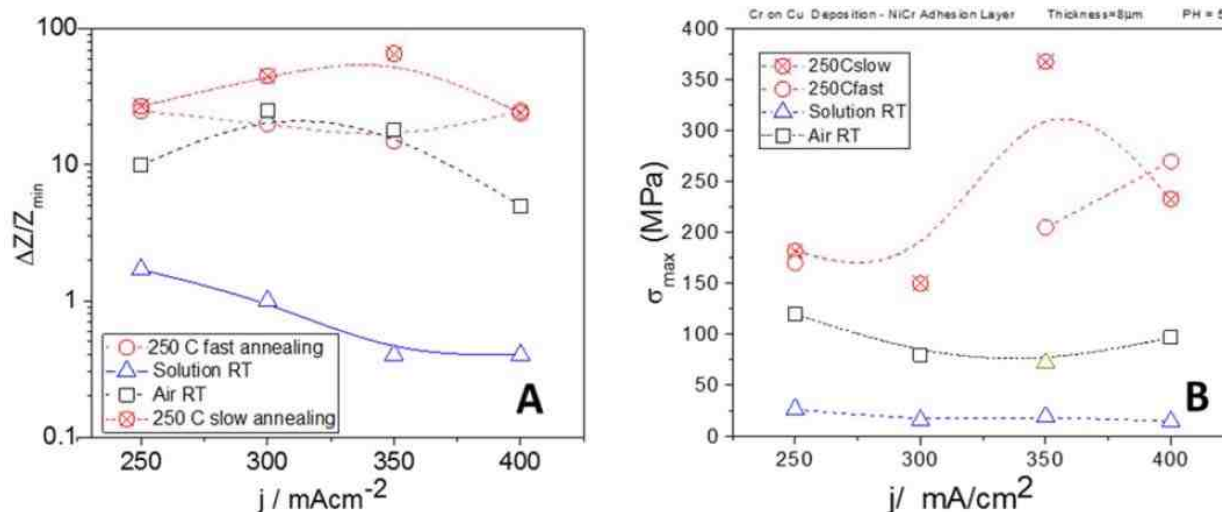
Figure 6 - Summary of (a) *in situ* impedance measurements, change presented in % units and (b) *in situ* stress measurements as a function of deposition current density.

Further studies have focused on the stress state in the chromium films during aging process in solution, in air and during annealing at 250°C. The summary of these data is shown in Fig. 6. Our studies clearly indicate that the tensile relaxation in the chromium films is directly related to the environment to which the chromium films are exposed. During relaxation in the solution, which could be considered as an oxygen deprived environment, the maximum change of stress observed was very modest, over the course of several hours (Fig. 6(b)). This modest tensile relaxation was most likely associated with decomposition of the Cr-hydride phase once the potential for hydrogen evolution and the presence of hydrogen ions was removed. However, we expect that the hydrogen gas molecules released from the hydride phase remains trapped in the deposit as an atomic interstitial, or as gas phase in microvoids formed at the grain boundaries, or within the grains which can act as the crack nucleation sites.
